**14 September 2014**

***Re: Environmental impact audit findings for the 22 kV Distribution Line Upgrade – Paksan to Ban Nonsomboun***

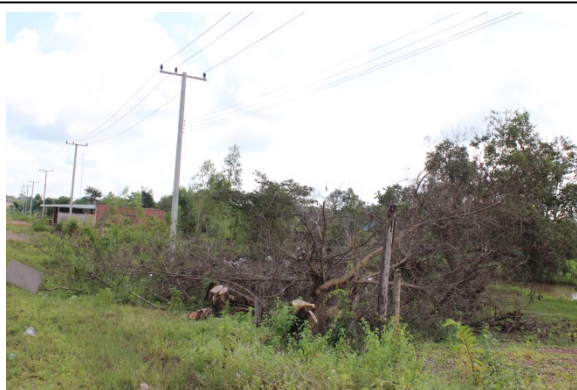
Environmental impacts associated with Project construction conducted to-date in the new and existing DL ROW were found to be minimal, temporary, and of short duration in rural areas and negligible in villages. Permanent vegetation loss / disturbance required in the new 1.12 km DL ROW required approximately 25 m<sup>2</sup> of land required for pole foundations (25 new poles x 1m<sup>2</sup>), some of which was vegetated prior to pole implementation. Approximately 12 trees appeared to have been removed for this Project given their respective location and apparent recent timeline for felling (based on visual assessment of stump/area). The trees were comprised of the following (refer Photos 1-3):

**Photo 1: Unidentified species of trees removed.**

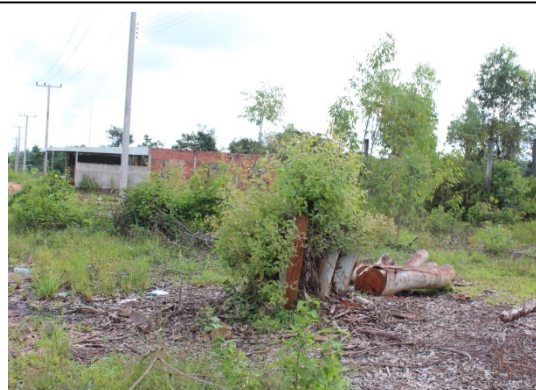
**Photo 2: Introduced *Eucalyptus* sp. trees removed.**

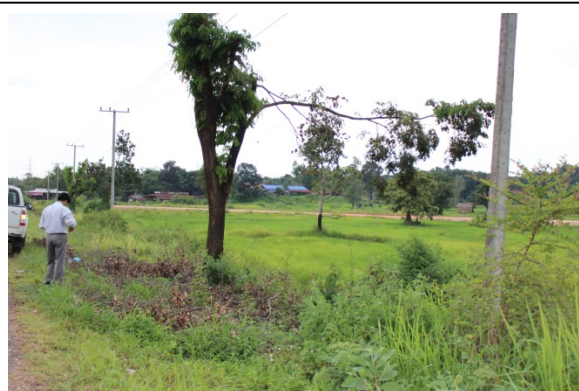
**Photo 3: Tree pruning to maintain operational safety clearance.**

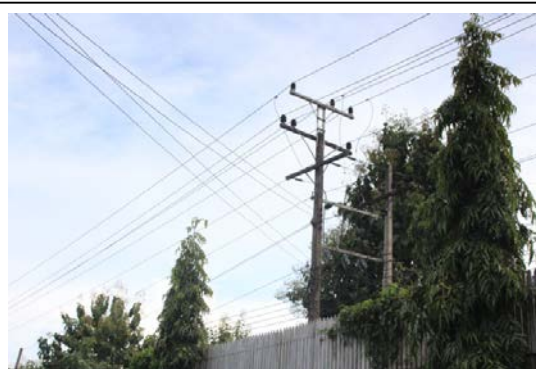
**Photo 4: Large trees requiring pruning for operational safety clearance.**

- Some trees occur within 2 m of the 22 kV DL (refer to Photo 4 and Annex B), creating a potential fire hazard.

4. Continue tree pruning operations to ensure at least 2 m clearance from 22 kV lines;
5. NN1PC should be informed of all future construction and planned power outage schedules for the Project in advance;

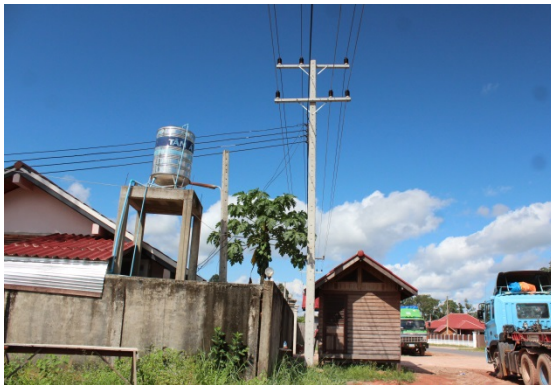
**Photo 5: Saw mill structures potentially within operational safety zone of 22 kV DL**

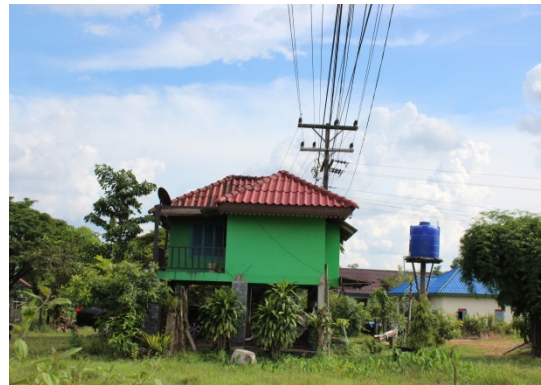
**Photo 6: House rooftop within the operational safety clearance zone of the 22 kV line**

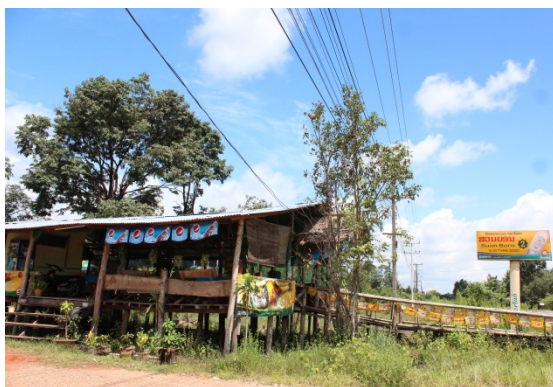
**Photo 7: Suan Born restaurant underneath the 22 kV DL and very close to distribution power lines.**

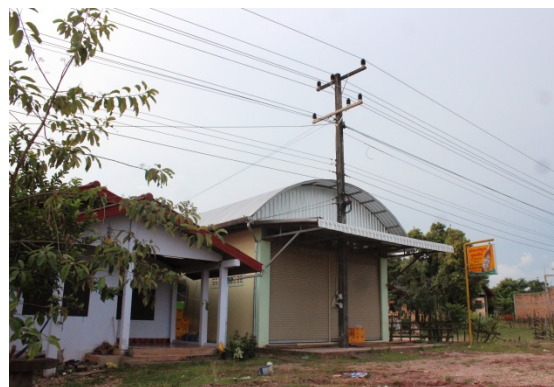
**Photo 8: Extended pole with new 22 kV DL and shop below exceeding the operational safety zone**

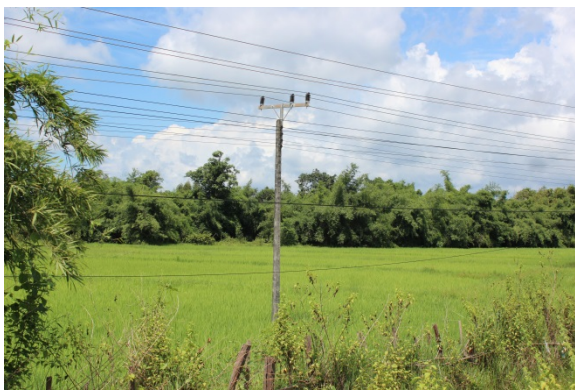
**Photo 5: Existing pole was strengthened to avoid crop disturbance and land use impact.**

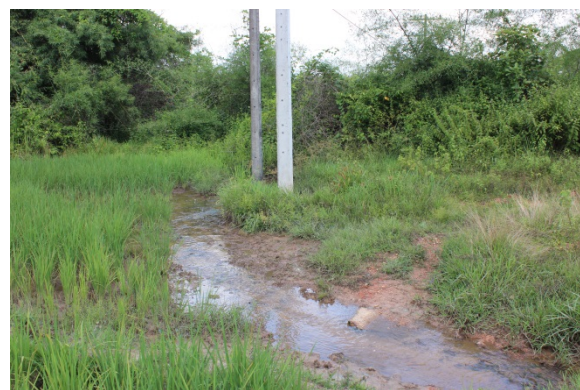
**Photo 6: Co-location of new pole with existing one to minimise disturbance and land use impact**

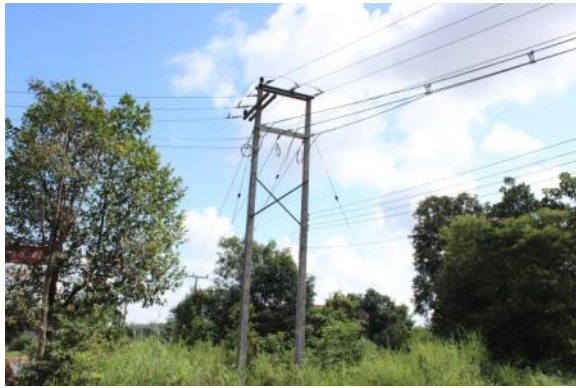
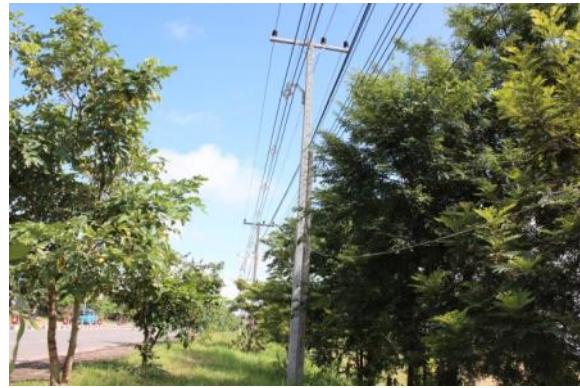
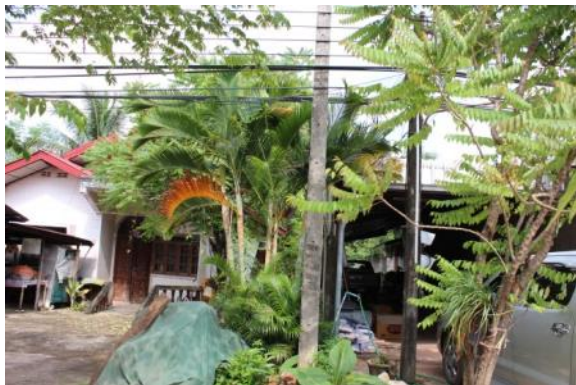
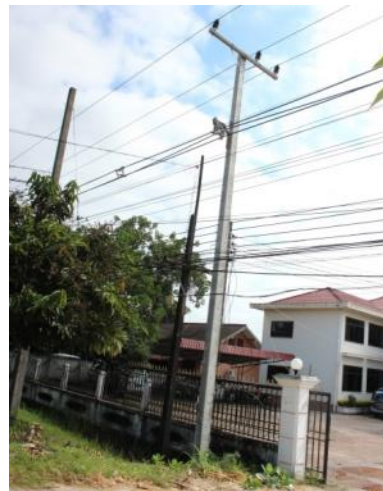
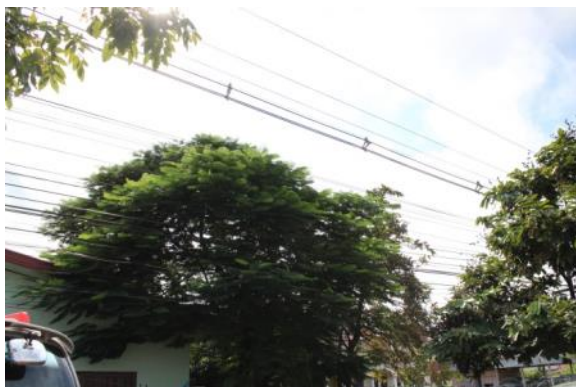
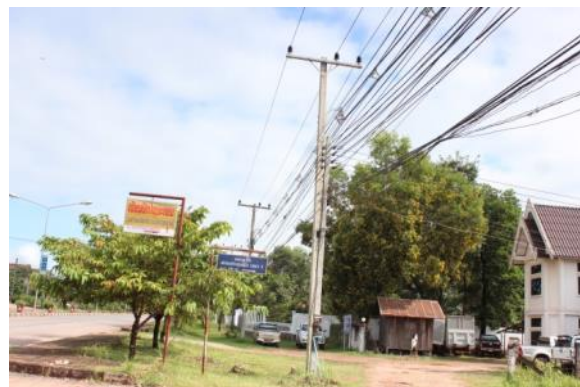
Trees/shrubs potentially within operational safety clearance zone (2 m) of the live 22 kV distribution line conductor

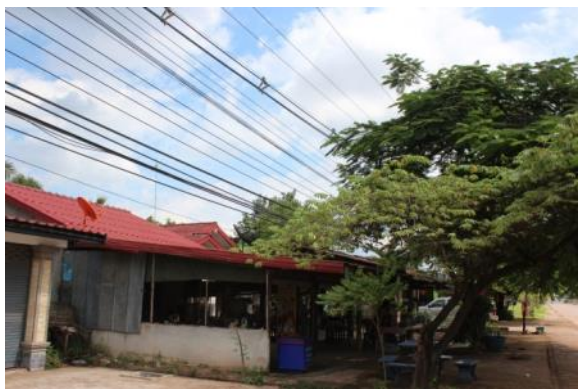
GPS waypoint 675, Ban Thong Yai, Paksan District - Restaurant

Physical residential/commercial structures potentially within 5.5 m (operational safety clearance zone) of the live 22 kV distribution line conductor

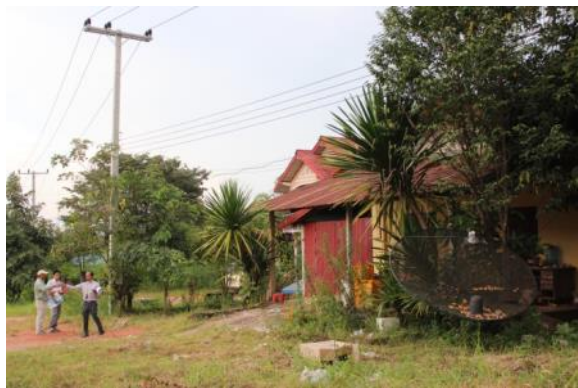
GPS waypoint 630, B. Hongxay, Paksan District – House

630	356801.806930 ; 2036741.26728	New DL ROW	Hongxay	Residential	<ul style="list-style-type: none"> <li>A house is potentially within the operational safety clearance zone.</li> <li>No physical disturbance to adjacent areas observed.</li> </ul>	<ul style="list-style-type: none"> <li>Conduct operational safety risk analysis of the DL ROW.</li> <li>Communicate building height restriction within ROW to property owner.</li> </ul>
641	357121.712535 ; 2037055.95315	New DL ROW	Hongxay	Cultivated land	<ul style="list-style-type: none"> <li>Minor land use impact – small impacted area on the boundary of a rice paddy field, although no physical disturbance to adjacent areas observed.</li> </ul>	<ul style="list-style-type: none"> <li>Avoid further encroachment into rice paddy land.</li> </ul>
642	357156.367033 ; 2037084.91201	New DL ROW	Hongxay	Cultivated land	<ul style="list-style-type: none"> <li>Minor land use impact – small impacted area on the boundary of a rice paddy field, although no physical disturbance to adjacent areas observed.</li> </ul>	<ul style="list-style-type: none"> <li>Avoid further encroachment into rice paddy land.</li> </ul>

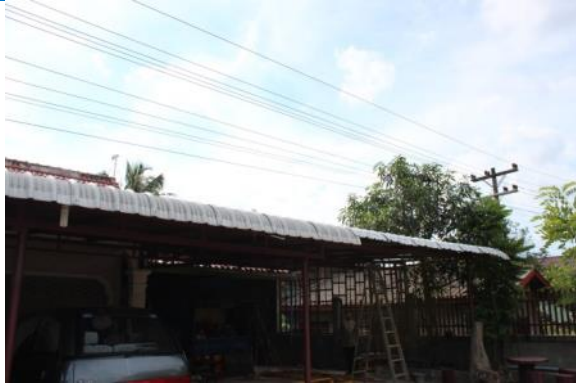
GPS waypoint 732, B. Thong Yai, Paksan District – Shop

Physical residential/commercial structures potentially within 5.5 m (operational safety clearance zone) of the live 22 kV distribution line conductor
