Nam Ngiep 1 Hydropower Project

Environmental Management Monthly Monitoring Report

April 2016

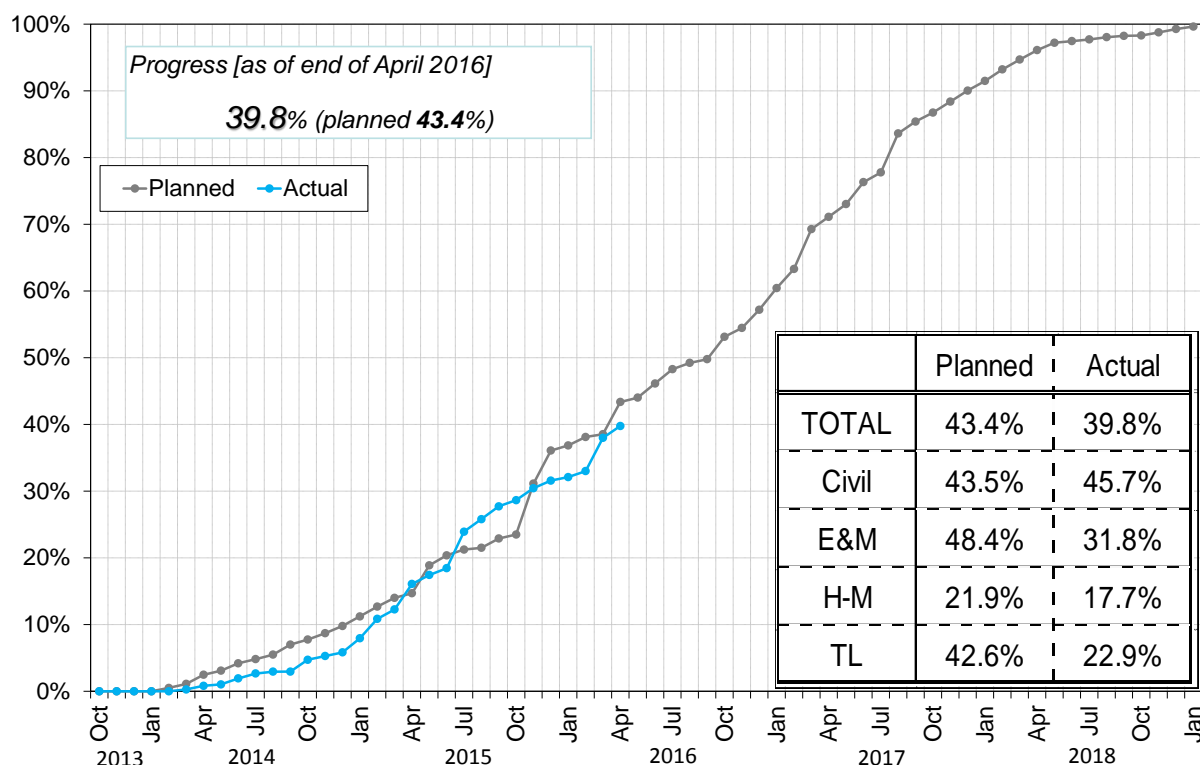
Figure 2-2: Progress Curve (All Construction Works)

¹ The progress to-date is calculated as (Cumulative Amount of Achieved Interim Milestone Payments) / (Total Agreed Price of Construction Contracts) and expressed as a percentage.

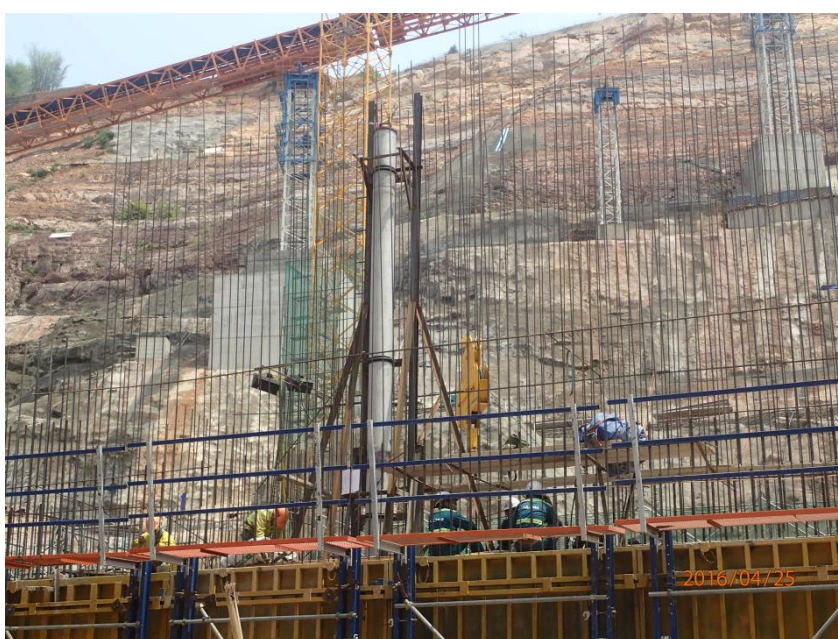
Figure 2-3: Embedded piping installation (Main powerhouse)

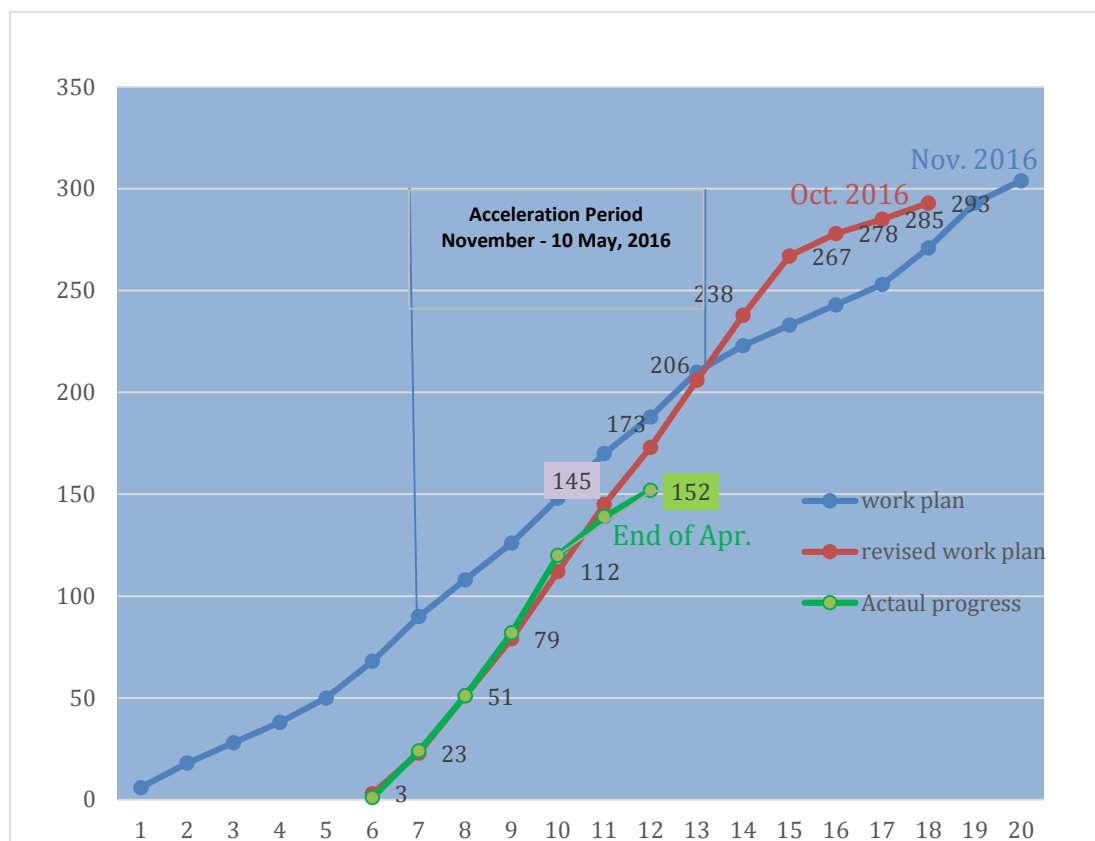
Figure 2-4 Cumulative Work Progress of Tower Installation (Plan and Actual)

In respect of the delay to commencement of most works the Contractor is studying its programme to ensure that sufficient resources are committed as the works progress to ensure that completion is achieved on time (See Figure 2-4 below)

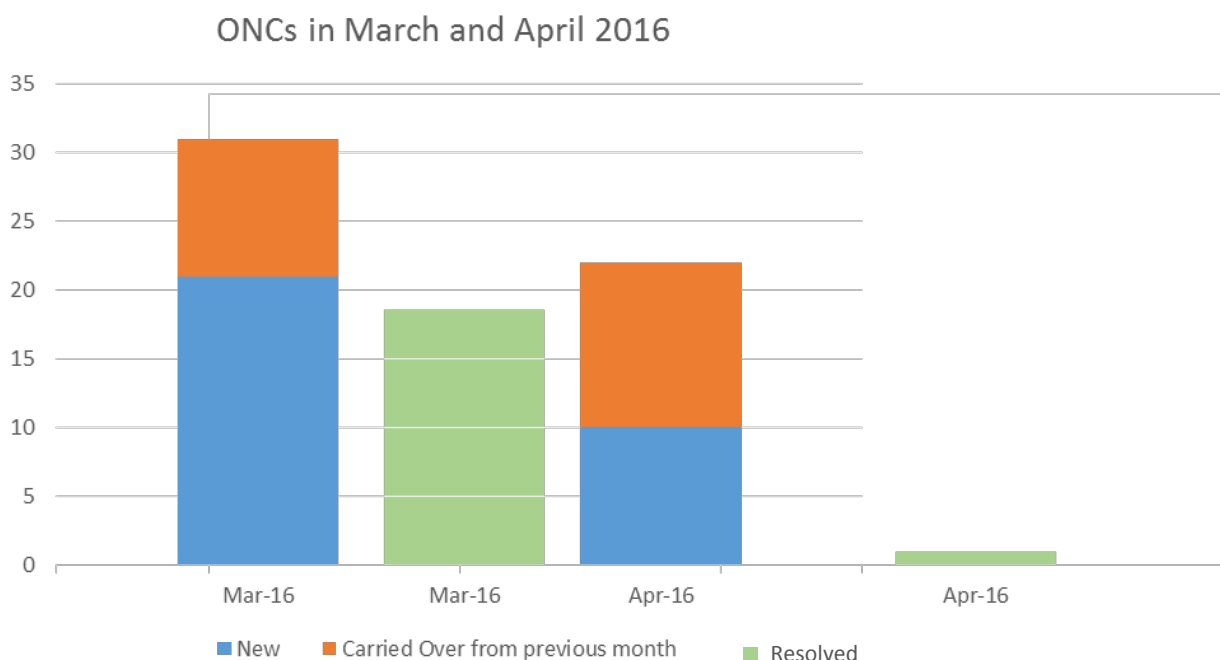
Figure 3-3: ONCs this month compared with previous month

As shown in Table 3-3 and Figure 3-3, the number of new ONCs reduced from 21 in March to 10 in April 2016. With a carry-over from March 2016, a total of 22 ONCs were active. Out of these, only 1 ONCs was resolved, 7 was unresolved exceeding the deadlines and a total of 21 ONCs will be carried over into May 2016. The highest number of issued ONCs was at the SECC Batching Plant (3 ONCs).

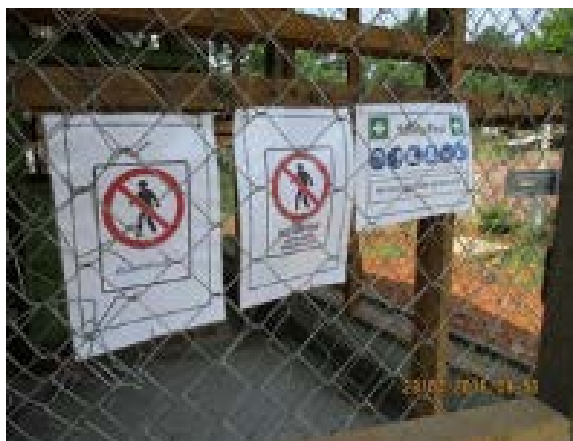
Photograph 3: Safety labels attached to the pressing machine storage area

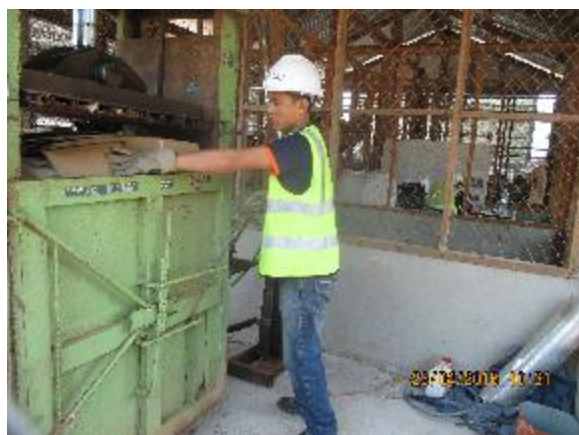
Photograph 4: An operator wears PPE during the machine operation
