## Nam Ngiep 1 Hydropower Project

# Environmental Management Monthly Monitoring Report

April 2018

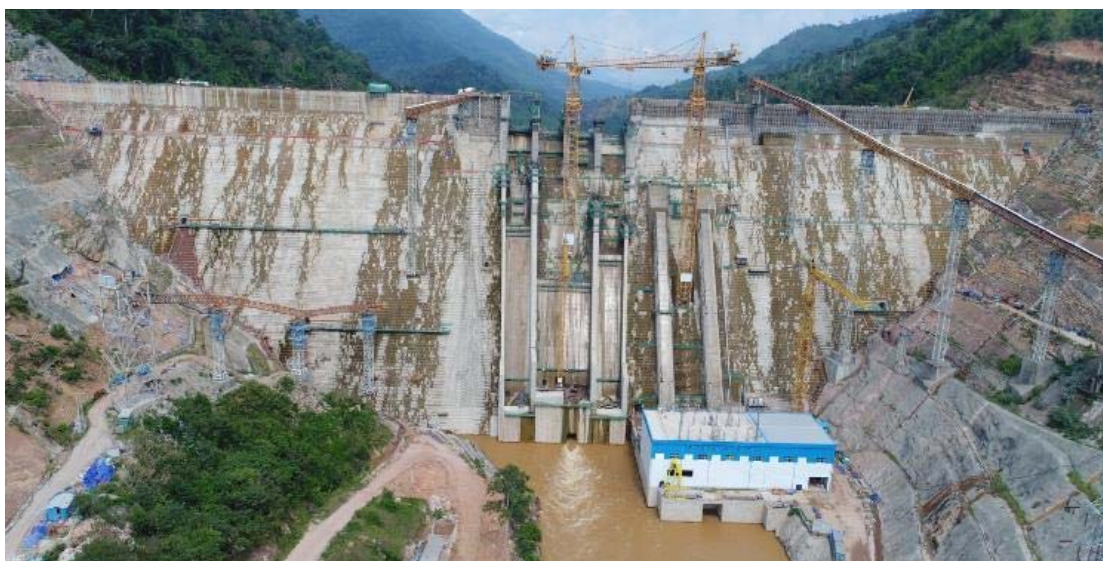
*Figure 2-2: Main Dam and Powerhouse from Overhead Looking Upstream*

After starting the main dam excavation works in October 2014 on the left bank, the works were about one month advanced when diversion of the Nam Ngiep River was achieved at the end of October 2015. However, excavated volumes were 20% greater than expected and part of this additional work is necessary to construct a 'shear key' structure due to the weak layers of rock encountered in the dam foundation. Following the efforts on Site, the additional excavation work was completed at the end of February 2016.

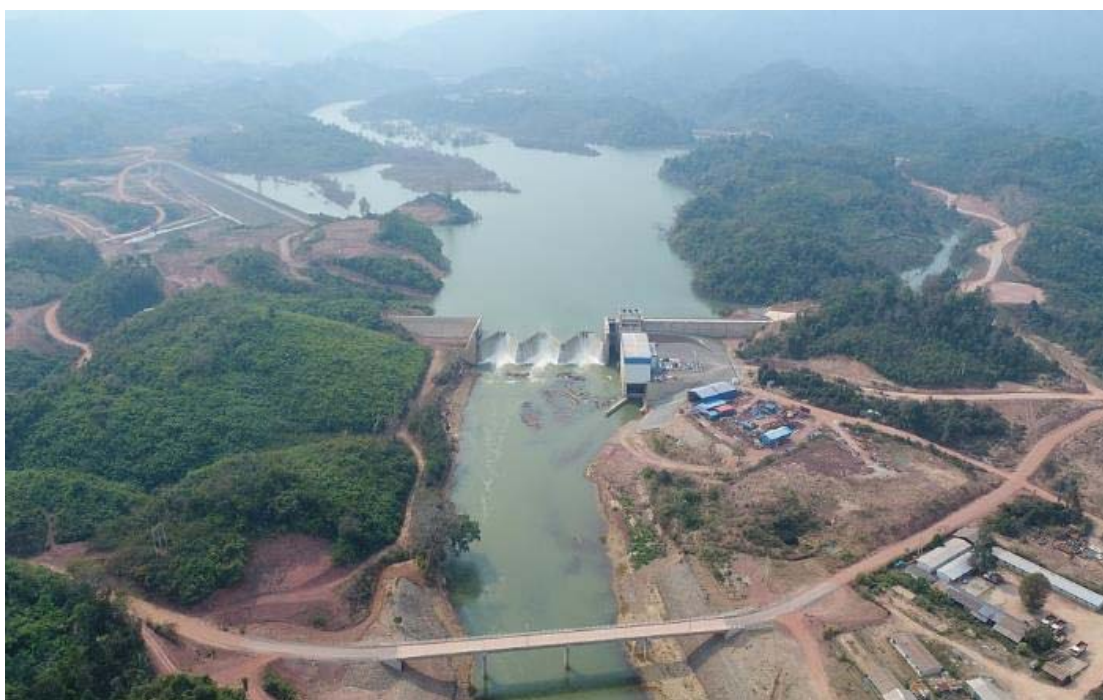
*Figure 2-3: Progress of Re-regulation Dam Powerhouse Works to 31 March 2018*

Structural concrete works were commenced in March 2015, in coordination with installation of the grounding system. The progress of structural concrete works is shown in **Figure 2-3** below
