## Nam Ngiep 1 Hydropower Project

# Environmental Management Monthly Monitoring Report

April 2020

A	5 June 2020	Hendra WINASTU Khamstone SAYSOMPHOU		Khamlar PHONSAVAT	
REV	DATE	AUTHOR	CHECKED	APPROVED	MODIFICATION DETAILS
<u>Accessibility</u>		<b>Document No.</b>  <b>NNP1-C-J0904-RP-064-A</b>			
<input checked="" type="checkbox"/>	Public				
<input type="checkbox"/>	Internal				
<input type="checkbox"/>	Confidential

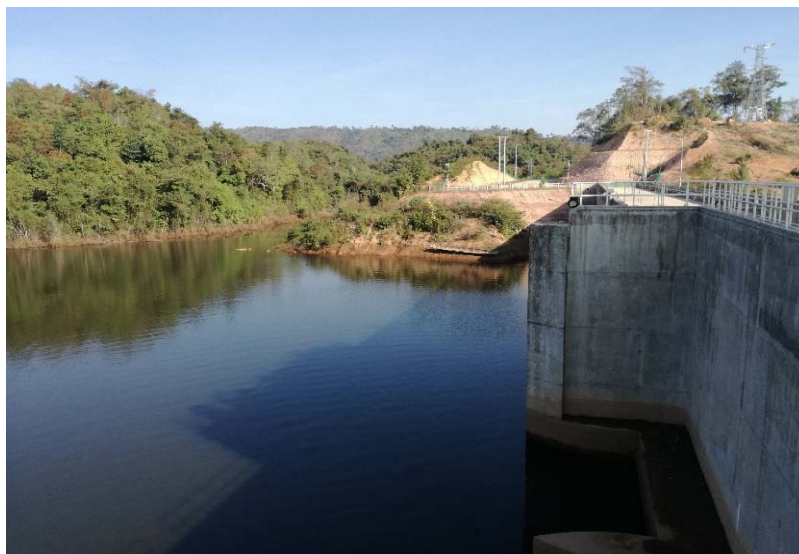
**FIGURE 2-3: COMPLETED RE-REGULATION DAM AND POWERHOUSE AT THE END OF JUNE 2018**

Structural concrete works were commenced in March 2015, in coordination with installation of the grounding system. The progress of overall re-regulating dam and powerhouse works at the left bank section and the right bank and labyrinth weir are shown in **Figure** below. After the completion of the re-regulation dam above, impounding of the reservoir has been carried out having been commenced on 15 May and been completed on 24 May 2017. After Main Dam impounding started, the reservoir storage of the re-regulation dam has been used for the riparian discharge to downstream in accordance with the Concession Agreement.

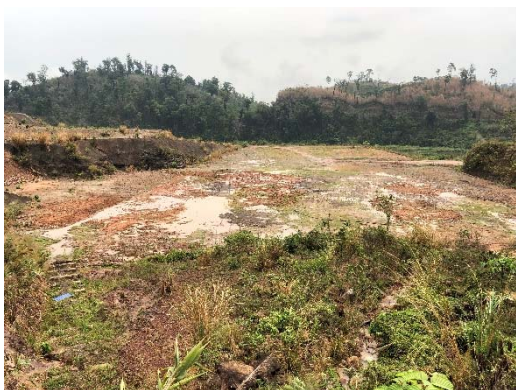
**Figure 2-4 : Re-vegetation of RCC Plant Yard**

Demobilization of plant facilities for both RCC and CVC plants was completed in December 2019. The vegetation improvement for rehabilitation of those areas is ongoing

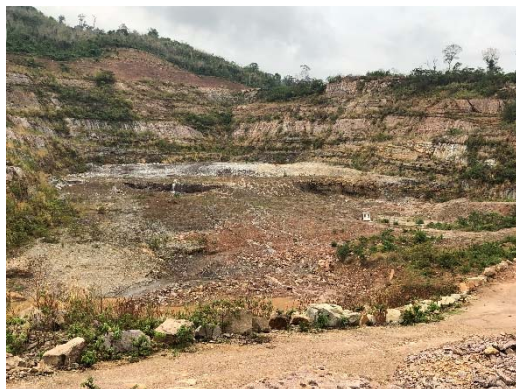
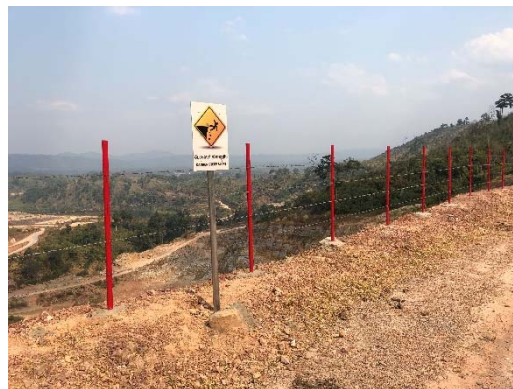
**Figure 2-6: Quarry Area View Showing Re-Vegetation and Safety Fence Installation**

The surface clearing, topsoil and overburden removal works at the extension area were completed in December 2016 and its development works was commenced in January 2017. The final blasting was carried out 27 March 2018. GOL have acknowledged that the quarry operation is complete. After several inspections by GOL and ADB for the Lenders, the quarry site has been improved by such as partial levelling, vegetation at the berms of slopes and large rock installation at top of slopes from an environmental and a safety point of view. Furthermore, a fence around the pond, which is created at the quarry only during the rainy season and is dry during dry season, will be installed to prevent people and animals from entering the pond, subject to ADB approval. A gate near the steel bridge also a barrier to public access. Permanent fence installation around pond as shown in the below picture will not be installed and fence for road safety will be installed at the top of the right bank upper quarry roadside. The levelling of quarry bottom will be implemented from January 2020.

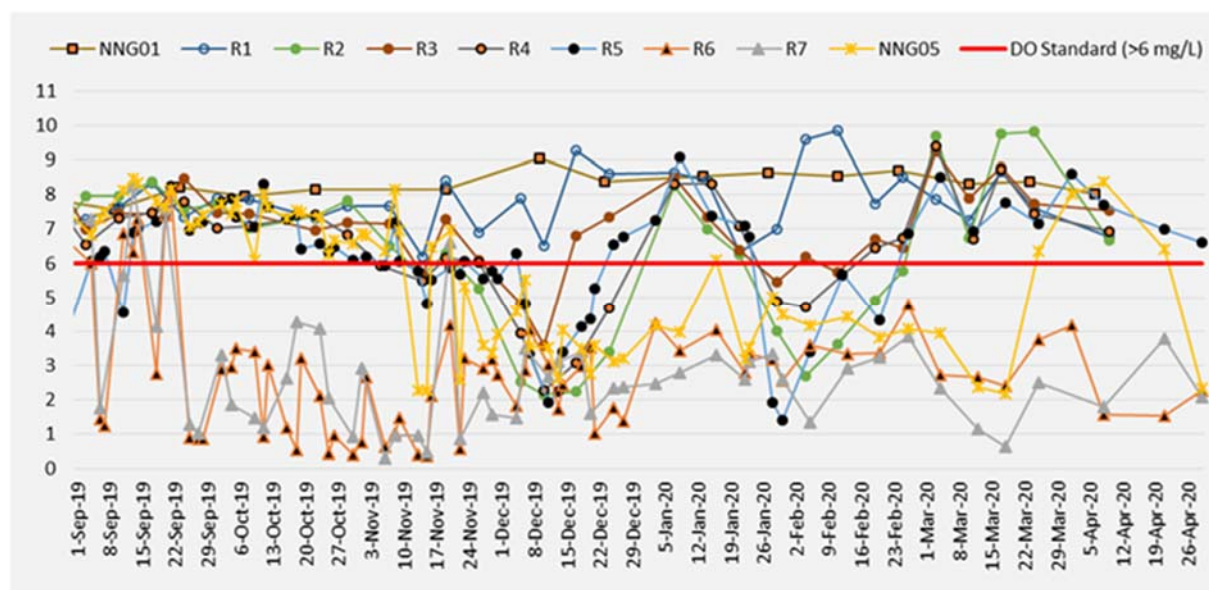
**FIGURE 3-2: CONCENTRATION OF DISSOLVED OXYGEN IN THE UPPER 0.2 M SINCE SEPTEMBER 2019 TO APRIL 2020**

During April 2020, the discharge from the re-regulation dam alternated between discharges from the gate and turbine. All DO concentrations were less than 6 mg/L at the Nam Ngiep Downstream stations (except on 01 and 08 April 2020 due to aeration from gate discharge) and thus are non-compliant with the National Standard. No dead fish were observed in Nam Ngiep downstream during the periods with low DO. NNP1PC is in the process of hiring an international consulting company to assist with the design of additional aeration system to improve the DO level downstream.

The BOD<sub>5</sub> in the downstream stations were between 1.53 mg/L and 2.25 mg/L.

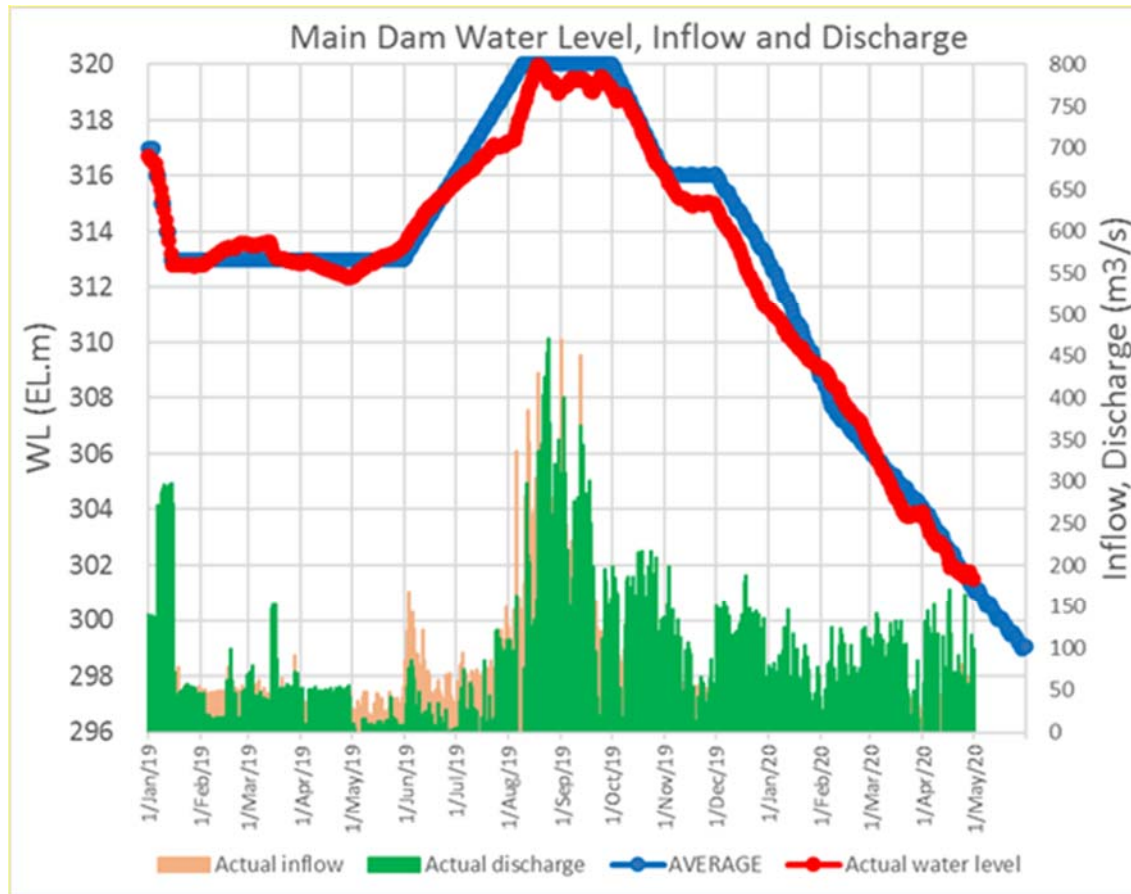
**FIGURE 3-3: WATER LEVEL, INFLOW AND DISCHARGE FOR THE MAIN RESERVOIR**

During April 2020, the mean inflow to the main reservoir was 50 m<sup>3</sup>/s (min 27 m<sup>3</sup>/s and max 114 m<sup>3</sup>/s). During April 2020, the water level in the main reservoir decreased with 2.4 m from El. 303.9 m asl. to El. 301.5 m asl.

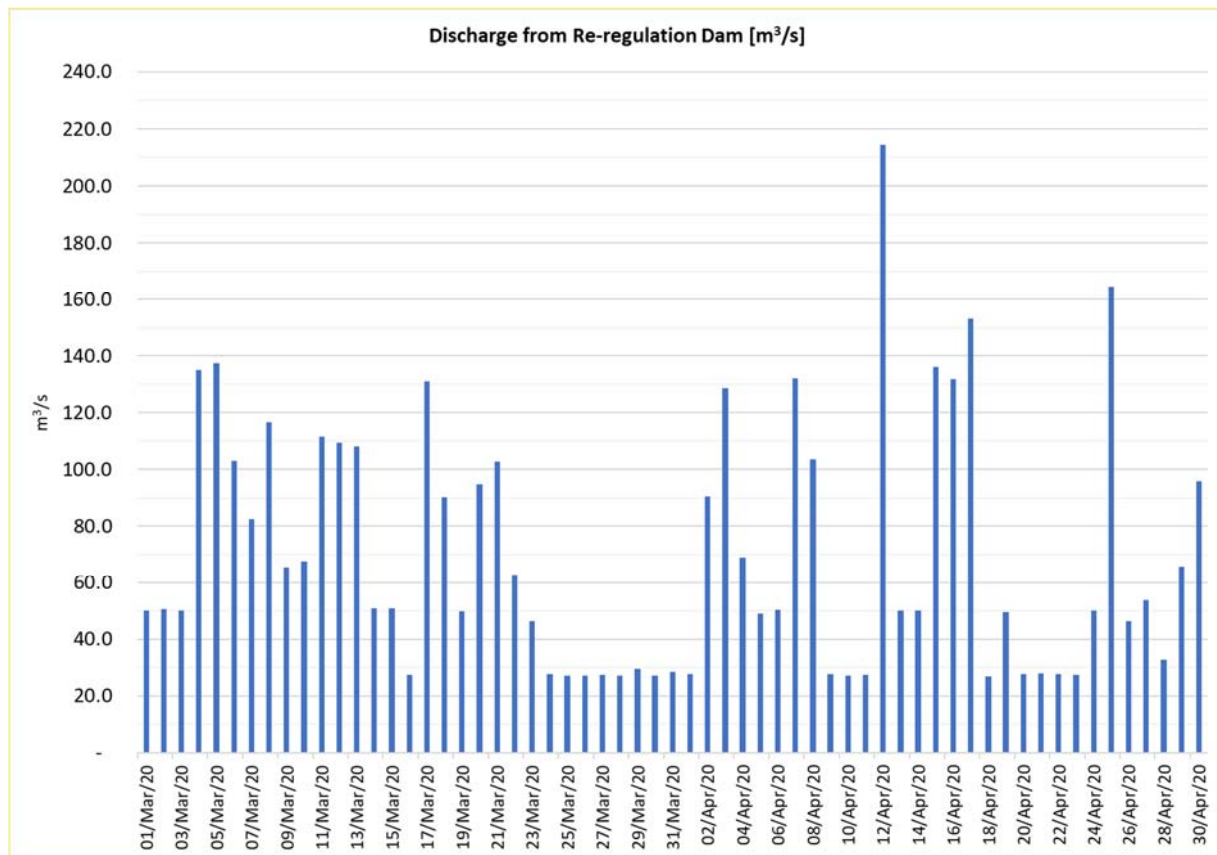
**FIGURE 3-4: DISCHARGE MONITORING AT THE RE-REGULATION DAM IN MARCH 2020 AND APRIL 2020**

The discharge monitoring data for the re-regulation dam during March 2020 and April 2020 is presented in Figure 3-4.

During April 2020, the mean discharge from the re-regulation dam was about 80 m³/s with turbine discharges varying between 50 m³/s and 160 m³/s interrupted by periods with gate discharge of about 28 m³/s. The discharge was kept above the minimum flow requirement of 27 m³/s at all times.
