Nam Ngiep 1 Hydropower Project

Environmental Management Monthly Monitoring Report

August 2016

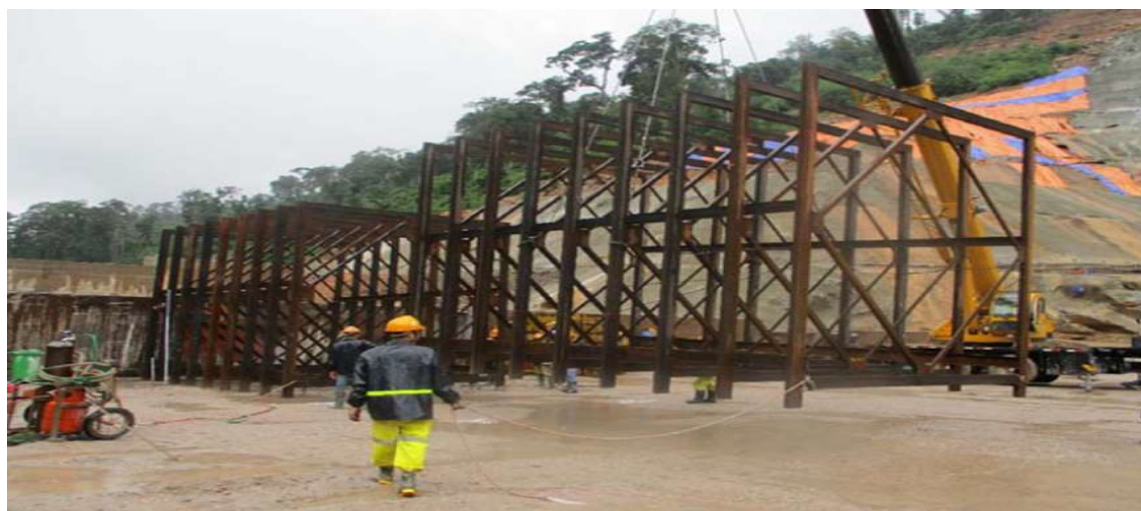
Figure 2-2 Installation of steel frame for Diversion Conduit

After starting the main dam excavation works in October 2014 on the left bank, the works were about one month advanced when diversion of the Nam Ngiep River was achieved at the end of October 2015. However, excavated volumes were 20% greater than expected and part of this additional work is necessary to construct a 'shear key' structure due to the weak layers of rock encountered in the dam foundation. Following the efforts on Site, the additional excavation work was completed at the end of February 2016. The cost of the additional excavation and RCC concrete placement necessitated expenditure of contingency amounts provided exactly for such eventualities. The dental concreting works were commenced in March 2016, and conventional RCC levelling concrete placement for the main dam in the 'shear key' structure up to El. 170.5 m was completed at the beginning of May. Consolidation grouting at the main dam area was commenced on 10 May 2016 and RCC concrete placement for the main dam body was commenced on 21 May 2016. Consolidation grouting covers the whole footprint of the main dam and RCC concrete placement and consolidation grouting are implemented in parallel, section by section. On 19 August 2016, construction of the Diversion Conduit commenced using a temporary steel frame and steel sheets as formwork for the sidewalls as shown in Figure 2-2.

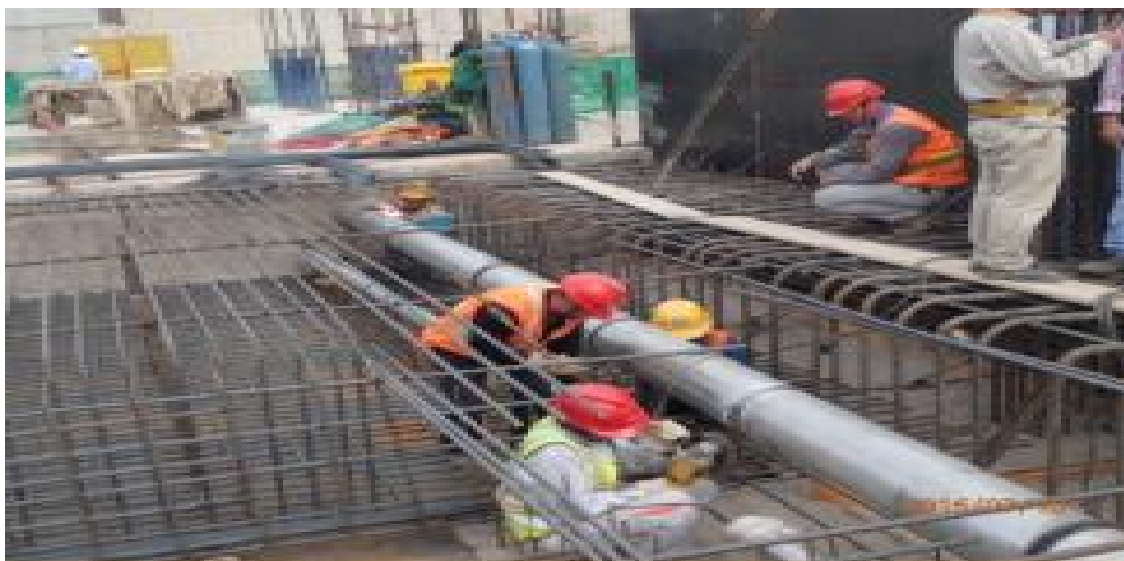
Figure 2-3: Embedded piping installation (Main powerhouse)

June 2014 and the NTP was issued on 03 October 2014. The cumulative work progress of the Electrical and Mechanical Works until the end of August 2016 was 53.0% (compared to planned progress of 53.0%). This delay is due to the change of schedule of delivery of stator material for Unit 1 of the main powerhouse and receipt of runner material of re-regulation powerhouse at the Electrical and Mechanical Works Contractor's factory from April 2016 to August 2016 and from June 2016 to July 2016 respectively. However, the stator of Unit 1 of the main powerhouse and the runner of the re-regulation powerhouse will be shipped from the factory to the Site on schedule by coordination of the manufacturing schedule in the factory. Accordingly, it has no impact on the overall construction schedule. The status of embedded pipe installation is shown in Figure 2-3.

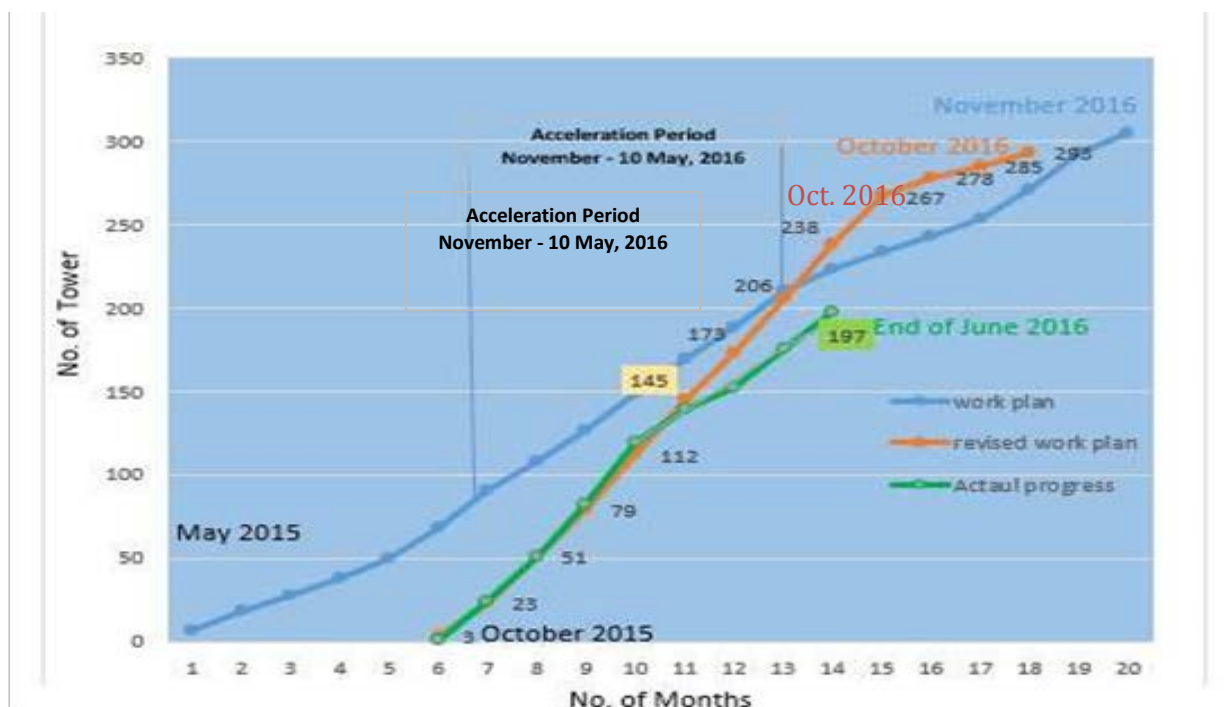
Figure 2-4 Cumulative Work Progress of Tower Installation (Plan and Actual)

In respect of the delay to commencement of most works the Contractor is studying its programme to ensure that sufficient resources are committed as the works progress to ensure that completion is achieved in good time. Onset of daily rains has made access to all areas difficult but the Contractor follows its revised acceleration schedule, after the progress for the construction of tower foundations slowed after April, 2016 (See Figure 2-4 below)

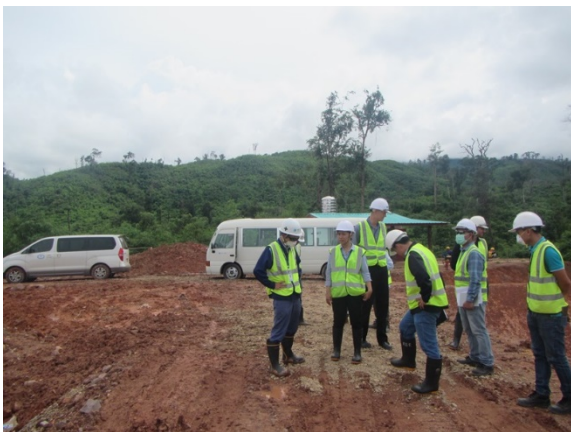
Photograph 1: Final Inspection of the Project Landfill

On 05 August 2016, a joint final inspection of NNP1 Project Solid Waste Landfill construction was undertaken between NNP1PC and the landfill Contractor. A draft Landfill Operation Manual was completed and the responsible staff were trained on the operation of the landfill. Prior to the operation, NNP1PC held a meeting with all the principal Contractors regarding the landfill operation. The landfill operation was officially commenced on 10 August 2016. The landfill will be open on weekdays Monday to Friday from 09:00 to 10:30 am. The NNP1 Project landfill is managed by NNP1PC and an approximate total of 103 m³ of waste was disposed during August 2016 (see Photograph 1 and Photograph 2).

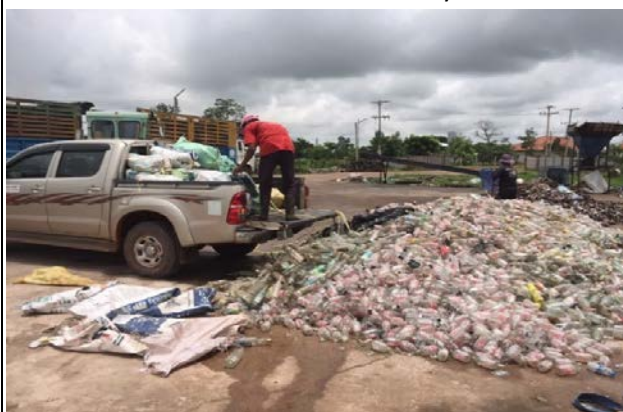
Photograph 3: Recyclable Waste from Recycle Waste Bank Sold to Keo Lao Factory

On 04 August 2016, a total of 415 kg of glass bottles from the Community Recycle Waste Bank at Hat Gniun village was sold to the Keo Lao Factory in Vientiane. In addition, a total of 19 kg of clinical waste from the NNP1 Project site was transported and incinerated at the incinerator located within the Vientiane landfill.

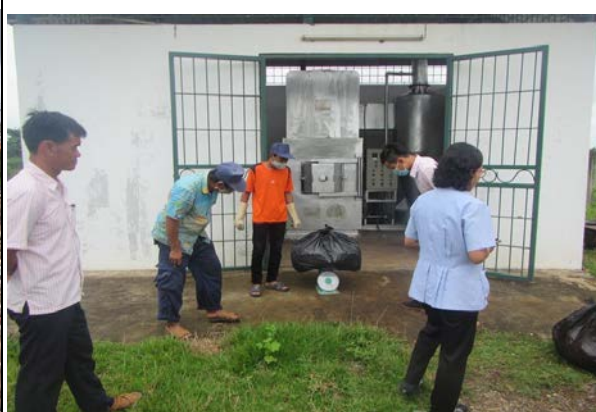
Photograph 4: Clinical Waste was Incinerated at Vientiane Landfill

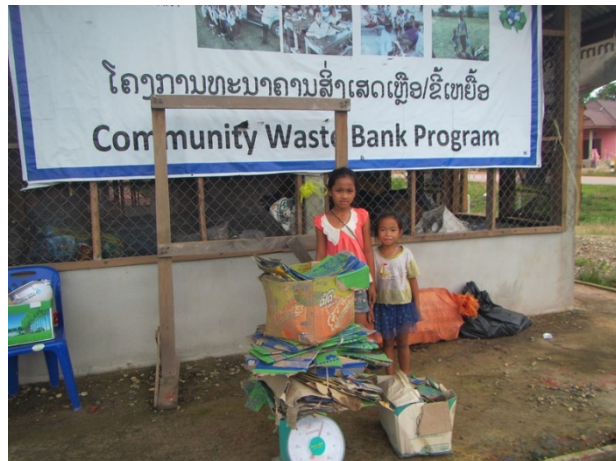
Photograph 5: Recyclable Waste being Sold to the Community Recycle Waste Bank

In August 2016, the purchase of recyclables from villagers and students continued. Some recyclables were transported from contractors' camps to the Recycle Waste Bank at Hat Gniun Village. Recyclables will continue to be stockpiled at the Community Recycle Waste Bank, the Owner's Site Office and Village and the Contractors/subcontractors with the intention of arranging a routine collection by the Khounmixay Processing Factory.

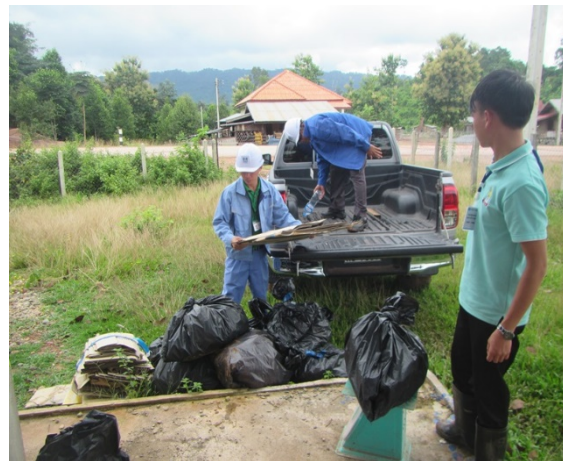
Photograph 6: Recyclables Received from HM Hydro Contractor

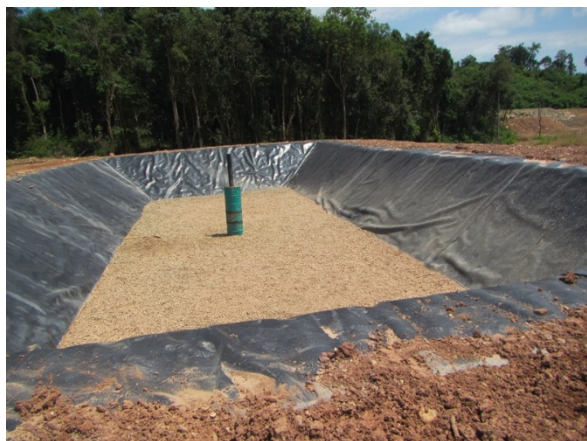
Photograph 9: Permanent Waste Pit No.1

By the end of August 2016, a temporary waste pit, a permanent waste pit and anaerobic treatment ponds were completed at the Houay Soup Solid Waste Landfill. The construction of a wetland pond, fence and site office were ongoing.

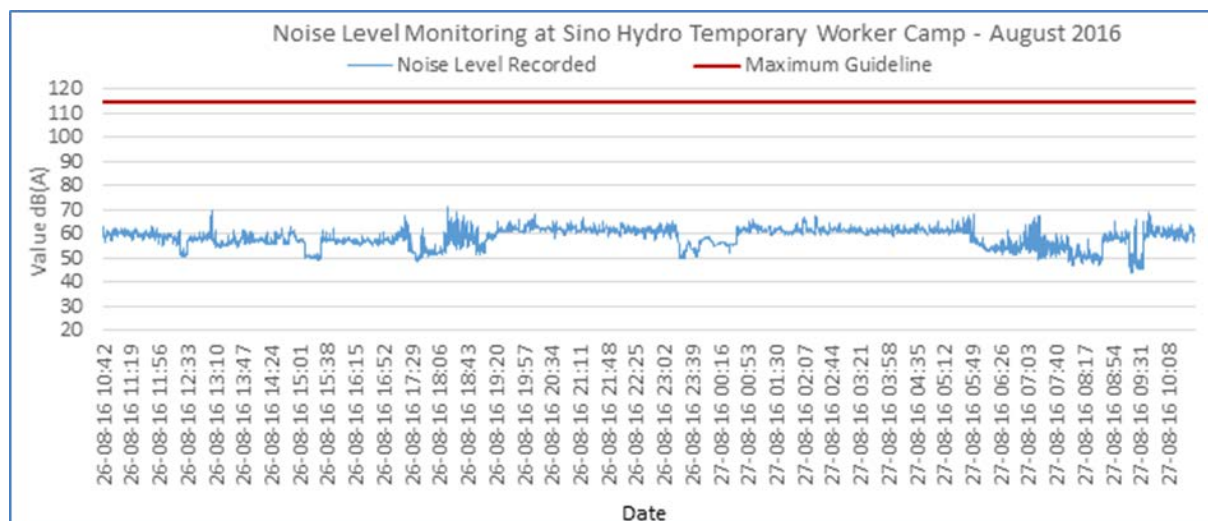
Figure B- 9: Results of Noise Level Monitoring at Sino Hydro Temporary Worker Camp

Noise Level (dB)	26-27/08/2016		27/08/2016
	10:42 – 22:00	22:01 – 06:00	06:01-10:42
Maximum Value Recorded	71	68.5	68.7
Guideline Max	115	115	115
Average Data Recorded	58.22	60.32	55.41
Guideline Averaged	70	50	70
