# Nam Ngiep 1 Hydropower Project

# **Environmental Management Monthly Monitoring Report**

August 2017

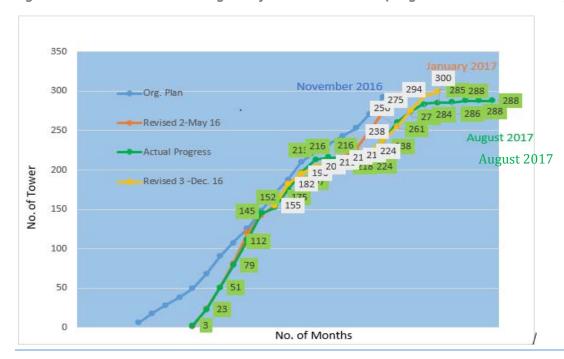
Figure 2-6: Cumulative Work Progress of Tower Foundation (Original Planned and Actual)

The TLW Contract was executed between Loxley-Sri Consortium and NNP1PC on 11 July 2014 and the NTP was issued to the 230 kV TL Contractor on 03 October 2014. The cumulative work progress of the Transmission Line Works until the end of August 2017 was 88.8% (compared to planned progress of 96.0%).

In respect of the delay to commencement of most works the Contractor is studying its programme to ensure that sufficient resources are committed as the works progress to ensure that completion is achieved in good time. Onset of daily rains has made access to all areas difficult but the Contractor follows its revised acceleration schedule, after the progress for the construction of tower foundations slowed after May, 2016 (See Error! Reference source not found.6 below)

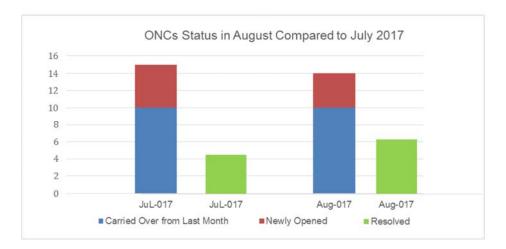
Figure 3-1: Summary of ONC and NCR

Items	ONC	NCR-1	NCR-2	NCR-3
Carried Over from the Last Month (July 2017)	10	3	2	1
Newly Opened in this Month (August 2017)	4	0	0	0
Total in this Month (August 2017)	14	3	2	1
Resolved in this Month (August 2017)	7	1	0	1
Carried over into Next Month (September 2017)	7	2	2	0
Unsolved Exceeding Deadlines	7	2	2	0

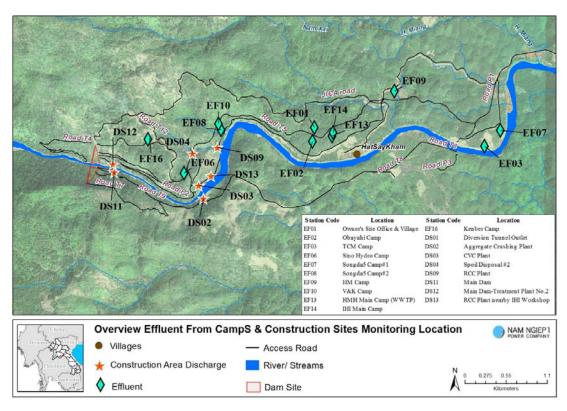
Figure 3-4: Map of Effluent Discharge Monitoring Locations

Since July 2016, the frequency of effluent monitoring has increased from monthly to fortnightly at all the camps, and from fortnightly to weekly at the key construction sites. During August 2017, all camp effluents regardless of the discharge condition were monitored. Results of effluent monitoring from the camps and construction sites are presented in *Error! Reference source not found.*, and the monitoring locations are displayed *Figure 3-4* below.

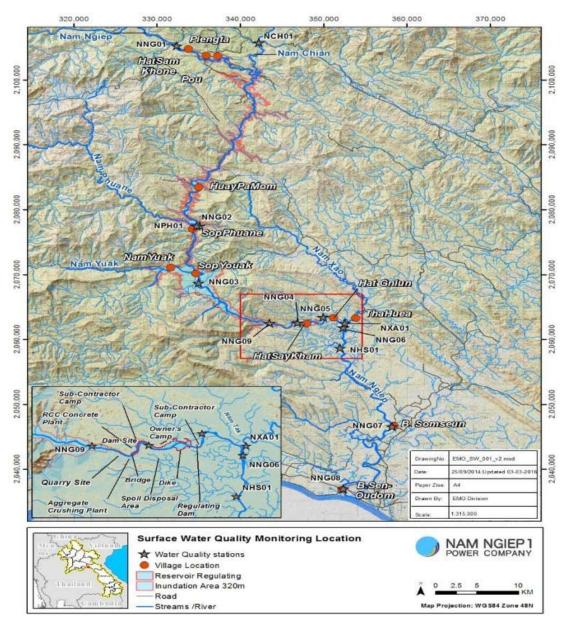
Figure 3-5: Surface Water and Re-Regulation Reservoir Water Quality Monitoring Stations

Surface water samples are collected and analysed twice a month from nine stations in Nam Ngiep and four stations in the main tributaries including the lower Nam Chian, Nam Phouane, Nam Xao and Houay Soup (total thirteen stations). From 24 May 2017, weekly water quality monitoring at the re-regulation reservoir and Nam Ngiep has been undertaken for physical parameters only for four stations namely: i) Nam Ngiep immediately upstream of the main dam (NNG09); ii) re-regulation reservoir upstream of Hatsaykham Village (NNG04/R6); iii) re-regulation reservoir located about 0.3 km upstream of the re-regulation dam (R7) and; iv) Nam Ngiep immediately downstream of the re-regulating dam (NNG05) as shown in *Figure 3-5* below

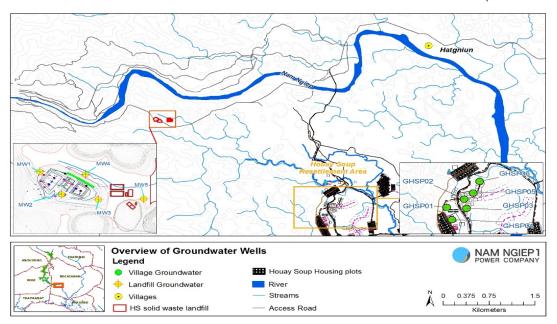
Figure 3-6: Groundwater Quality Monitoring Locations

During August 2017, NNP1PC sampled and analysed the groundwater quality in six boreholes which were built by the Project for resettlers at Houay Soup Resettlement Area (HSRA). It was found that all parameters monitored at these six boreholes complied with the relevant standards as shown below.

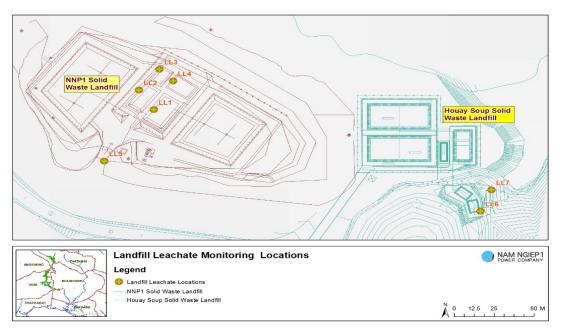
Figure 3-7: Landfill Leachate Monitoring Location

During August 2017, water samples were taken from the NNP1 Project Landfill's final leachate pond (LL4), and from the Houay Soup Landfill's final leachate pond (LL6). The location of landfill leachate monitoring is displayed below. The results indicate compliance with the relevant standards at discharge point from NNP1 Project and Houay Soup Landfills.

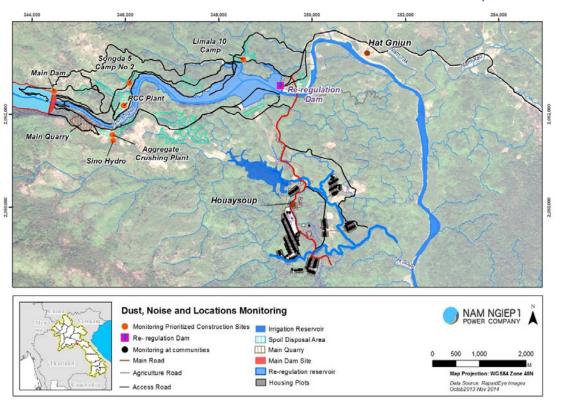
Figure 3-8: Noise and Dust Emission Monitoring Locations

The monitoring points are indicated on the map in *Figure 3-8*. Most of dust measurements complied with the National Standard. However, staff have been advised to wear dust masks while working in the areas at risk. The results are presented in *Annex 2*.

The noise levels recorded at those monitoring stations indicated full compliance with the National Standard for the period of 06:01-22:00. The noise levels during the period of 22:01-06:00 were slightly higher than the Standard at the RCC Plant, Song Da 5 Camp No. 2, and Sino Hydro Temporary Worker Camp [between  $51.50 - 63.31 \, dB(A)$  compared to the Standard of 50 dB(A)], and at Hat Gnuin Village and Houay Soup Resettlement Area [46.42  $- 52.57 \, dB(A)$  compared to the Standard of 45 dB(A)].

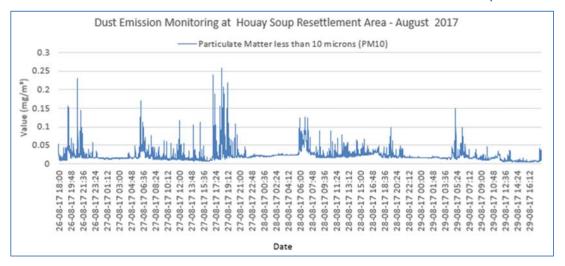
Figure B- 2: Dust Monitoring Results at Houay Soup Resettlement Village in August 2017

Houay Soup Resettlement Area - 24 Hours Average Particulate Matter (PM10) Concentration								
Period         00 to 24 Hours         24 to 48 Hours         48 to 72 Hours								
Start Time	26-Aug-17 18:00	27-Aug-17 18:01	28-Aug-17 18:01					
End Time	27-Aug-17 18:00	28-Aug-17 18:01	29-Aug-17 18:00					
Average Data Record in 24h (mg/m³)	0.020	0.028	0.016					
Guideline Average in 24h (mg/m³)	0.12	0.12	0.12

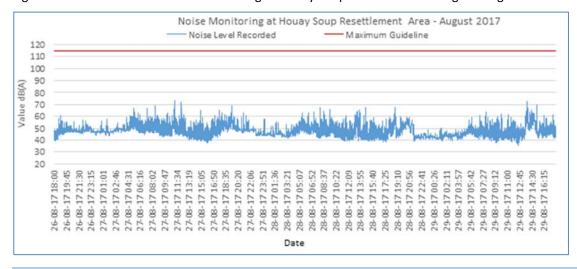
Figure C- 2: Result of Noise Level Monitoring at Houay Soup Resettlement Village in August 2017

Noise Level (dB)	26-27/August/17		27-28/August/17			28-29/August/17			
	18:00-22:00	22:01 - 06:00	06:01 - 18:00	18:00-22:00	22:01 – 06:00	06:01 - 18:00	18:00-22:00	22:01 - 06:00	06:01 - 18:00
Maximum Value Recorded	61.00	66.90	73.40	69.30	62.80	67.70	67.70	59.50	72.80
Guideline Max	115	115	115	115	115	115	115	115	115
Average Data Recorded	47.08	48.97	47.82	51.09	46.42	46.46	49.92	43.77	47.42
Guideline Averaged	55	45	55	55	45	55	55	45	55
