Nam Ngiep 1 Hydropower Project

Environmental Management Monthly Monitoring Report

August 2020

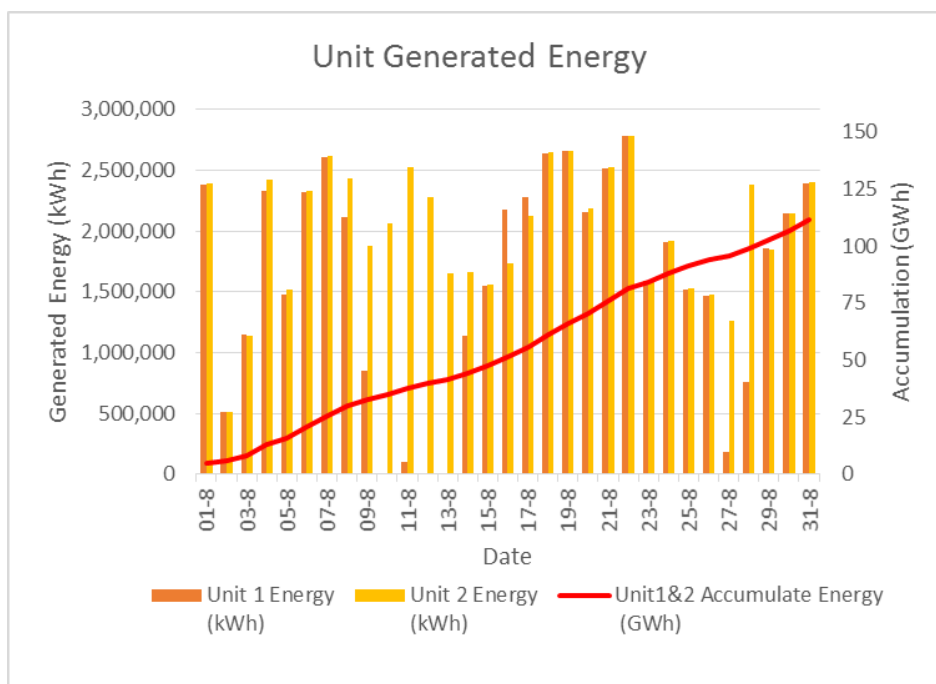
FIGURE 2-1: UNIT GENERATED ENERGY (MAIN POWER STATION)

Figure 2.1 and **Figure 2.2** shows the generation data at the main power station in August 2020. The generation was higher than the previous month.

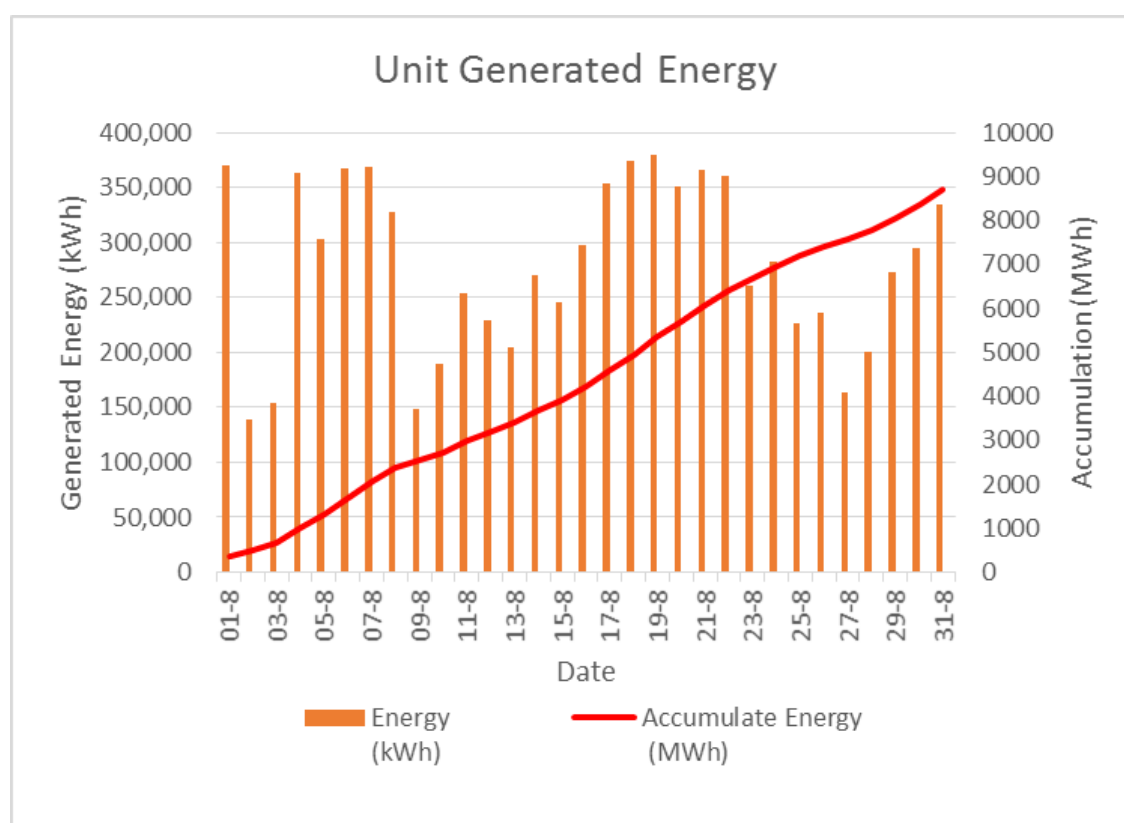
FIGURE 2-3: UNIT GENERATED ENERGY (RE-REGULATION POWER STATION)

Figures 2-3 and **2-4** shows the generation data at the re-regulation power station in August 2020. The generation and operation time are affected by the operations of the main power station according to EGAT PPA. So, the amount of inflow is determined by the operation resulting at the main power station. Notwithstanding, even if the main power station is stopped, the specified 27 m³/sec water from re-regulation power station must be discharged to downstream.

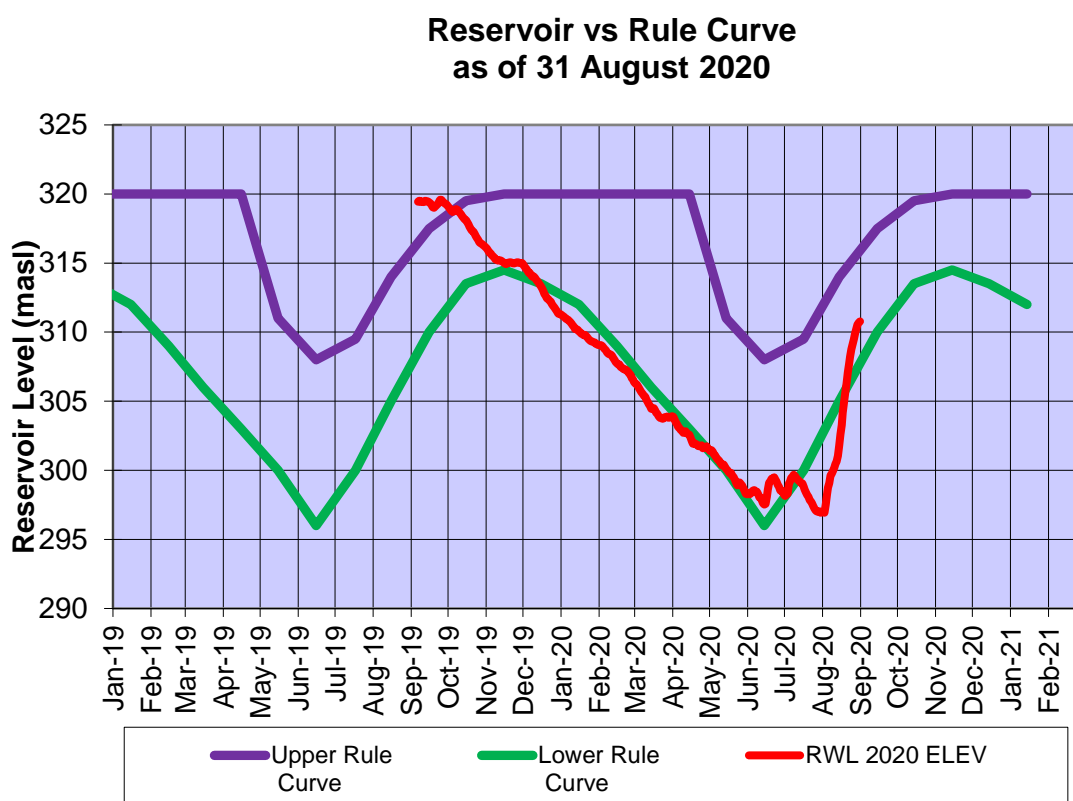
FIGURE 2-5: DAM RESERVOIR LEVEL

Actual dam water level increased from the beginning of August 2020 due to rain.

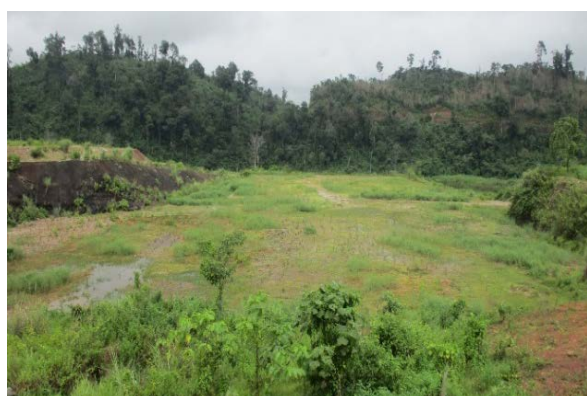
FIGURE 2-8: RE-VEGETATION OF RCC PLANT YARD

Demobilization of plant facilities for both RCC and CVC plants was completed in December 2019. The vegetation improvement for rehabilitation of those areas is ongoing.

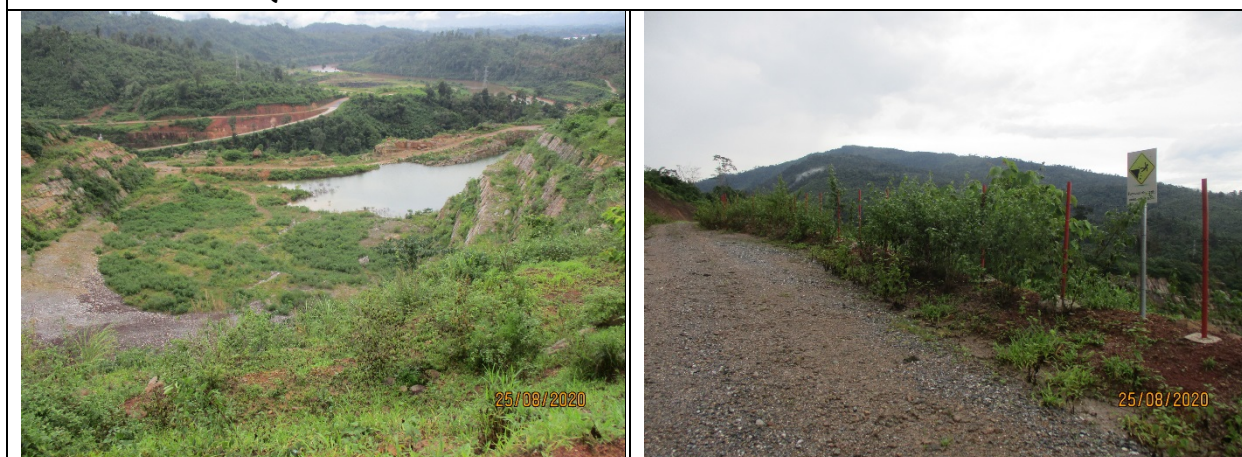
The final blasting was carried out 27 March 2018. GOL have acknowledged that the quarry operation is complete. After several inspections by GOL and ADB for the Lenders, the quarry site has been improved by such as partial levelling, vegetation at the berms of slopes and large rock installation at top of slopes from an environmental and a safety point of view. Fence for safety was installed at top slope at right side. The grading at the quarry bottom and spreading of top soil was completed in January 2020.

FIGURE 2-10: QUARRY AREA VIEW SHOWING RE-VEGETATION AND SAFETY FENCE INSTALLATION

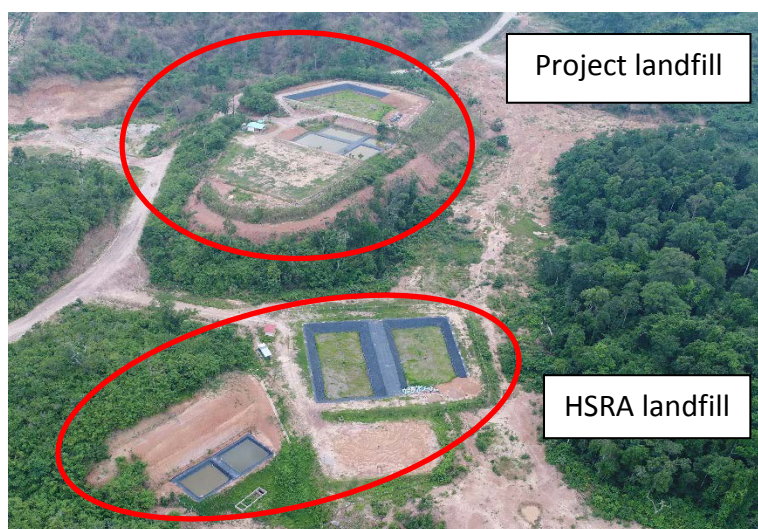
FIGURE 2-11: PHASE 2 OF PROJECT LANDFILL DEVELOPMENT ON 08 JUNE 2017

The operation of both HSRA and Project landfills is ongoing with collection waste materials from Resettlement “Phouhomxay”, neighbour villages and the Owner Site Office and Village.

CURRENT CONDITION OF LANDFILL

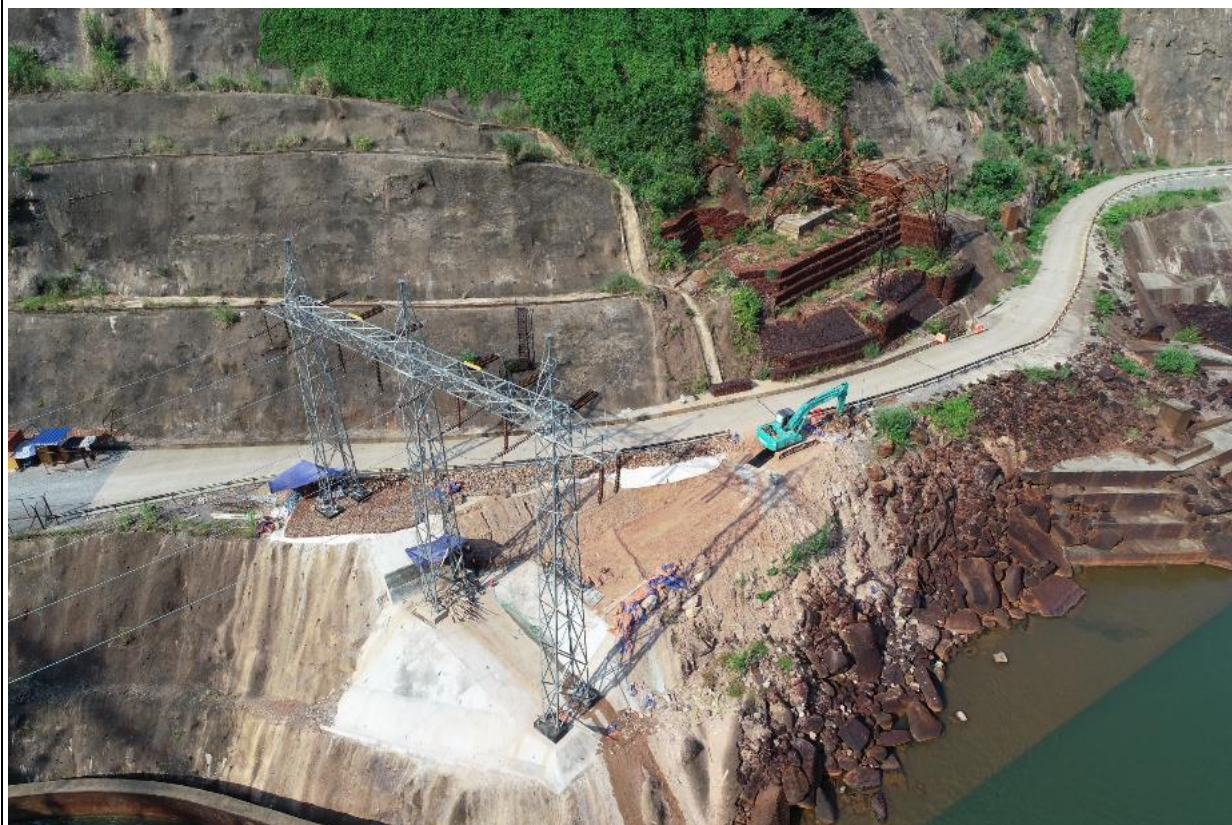
The Tower No.1 was damaged due to the slope failure of approximately 150 m³ volume of material above and behind Tower No.1 that occurred overnight on 17 to 18 of August 2019. Some of the structural steel members of the Tower No.1 were deformed. Tower No.1 did not move significantly but remained an unsafe structure. Movement of the upper part of the steel structure of the tower was observed.

FIGURE 2-13: TOP VIEW OF GANTRY STRUCTURE _SLOPE PROTECTION AROUND FOUNDATION ONGOING

Therefore, a Temporary Tower No.1 was constructed and the transmission line was moved to it from the damaged tower over the period of 06 to 24 September 2019. The construction of the permanent Replacement Tower No.1, disassembly of existing Tower No.1 was contracted in late December 2019. The foundation excavation of legs for new Tower No.1 started in the middle of January 2020 and was completed on February 2020; the damaged Tower No.1 was almost dismantled in January 2020. The installation of gantry structure and new Tower No.1 was completed in the beginning of April 2020. Energization test was completed on 30 April 2020. Remaining works including slope protection around the Tower will be completed by September 2020 because earth work and concrete placement could not be done due to rain. The gabion mattress was installed partly on the top part of the slope.

A contract of bidding for repairing works of 230 Transmission towers or missing part (bolt and nut) is under process.

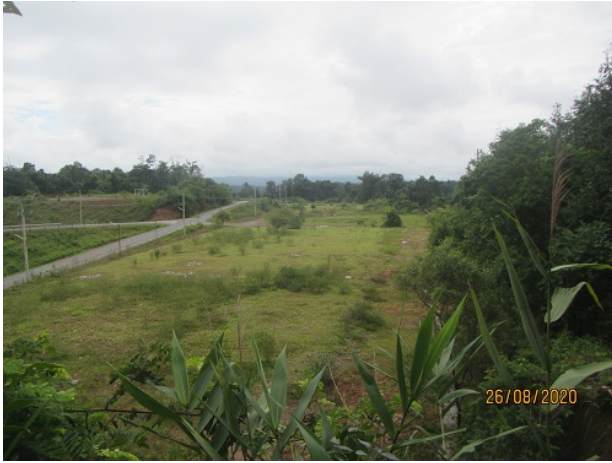
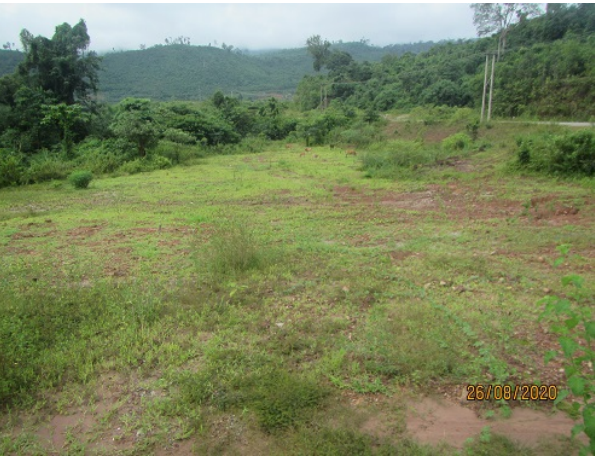
FIGURE 3-1: ADDITIONAL COUNTER MEASURES FOR THE SITE REHABILITATION IN AUGUST 2020

OC Camp Local grass species were additionally planted	V & K CAMP Local grass species were additionally planted

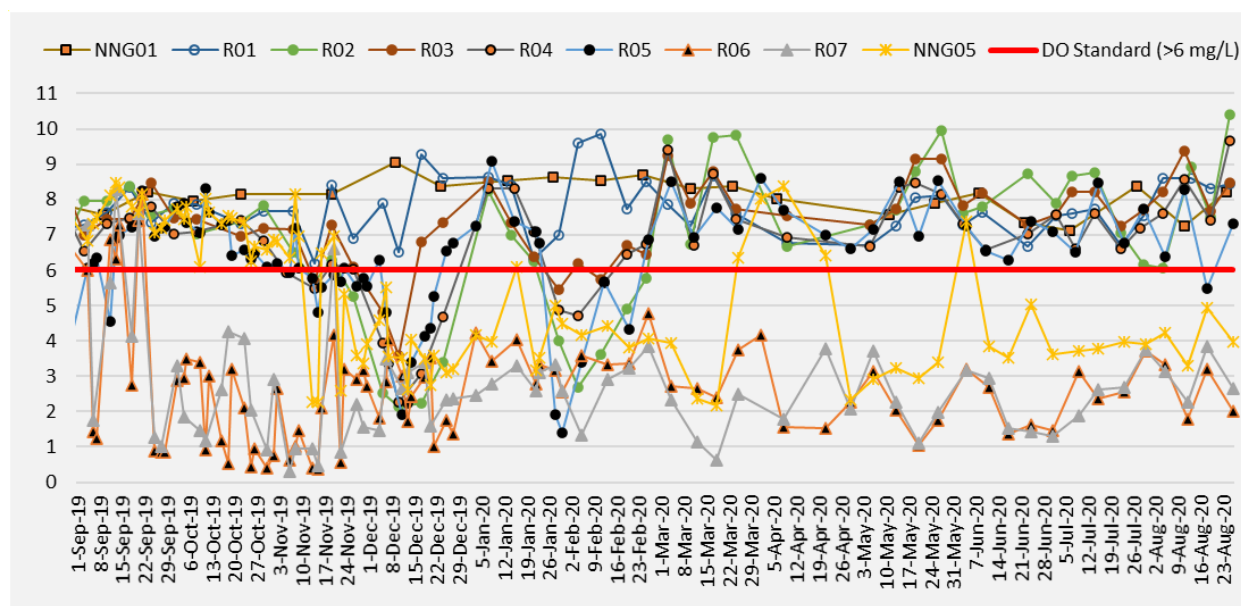
FIGURE 3-3: CONCENTRATION OF DISSOLVED OXYGEN (MG/L) IN THE UPPER 0.2 M SINCE SEPTEMBER 2019 TO AUGUST 2020

During the month, Dissolved Oxygen (DO) levels at the surface of the main reservoir (R01, R02, R03, R04 and R05) were generally between 5 and 10 mg/L. In the re-regulation reservoir (R06 and R07), the DO levels were below 4 mg/L.

The discharge from the re-regulation dam mainly went through the turbines and occasionally went through both the turbines and the gate. The DO levels were less than 6 mg/L at the Nam Ngiep downstream stations and thus are non-compliant with the GoL Standard, except at NNG06 on 18 August 20, NNG07 on 05, 18 and 26 August 2020 and NNG08 on 05, 12, 18 and 26 August 2020. No dead fish was observed in Nam Ngiep downstream during this monitoring period. NNP1PC is in the process of collecting information to assist in the improving DO level downstream.

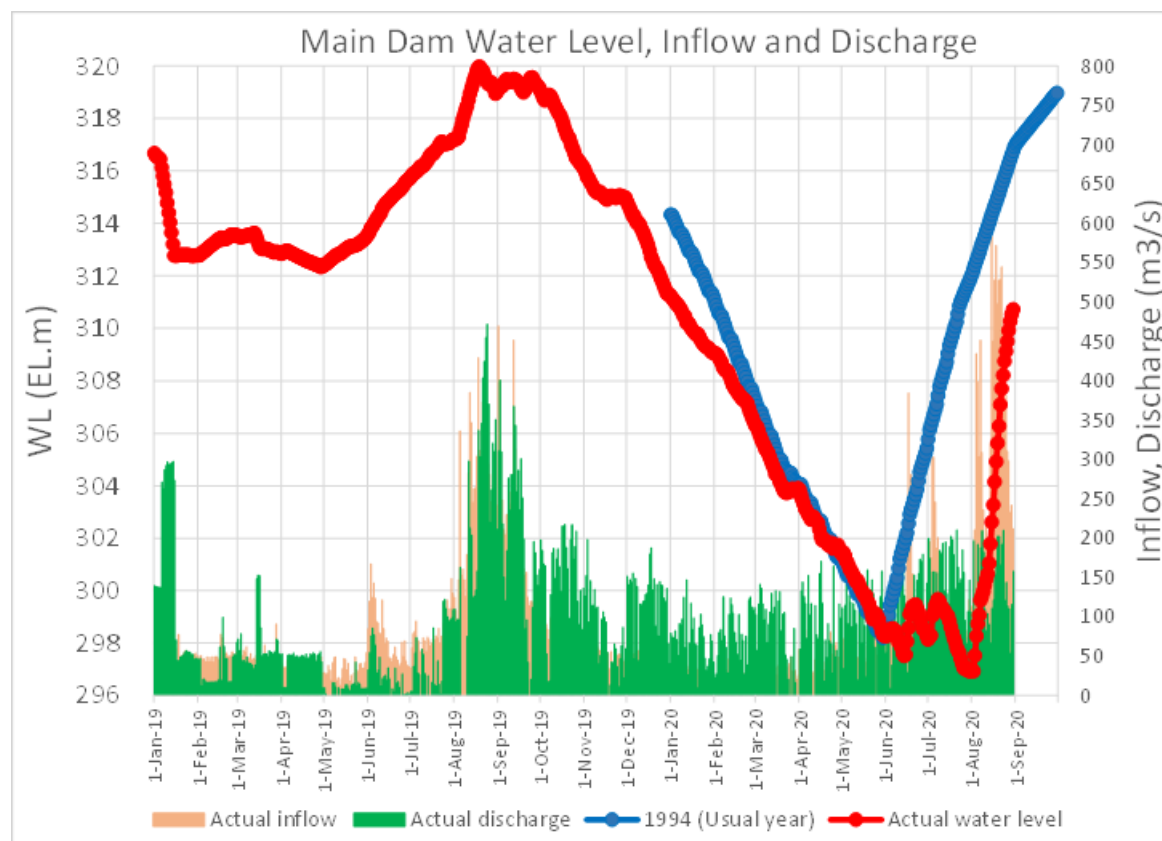
FIGURE 3-4: WATER LEVEL, INFLOW AND DISCHARGE FOR THE MAIN RESERVOIR

In August 2020, the turbine discharges from the main powerhouse varied between 13 and 231 m³/s and usually interrupted by night-time periods with no discharge.

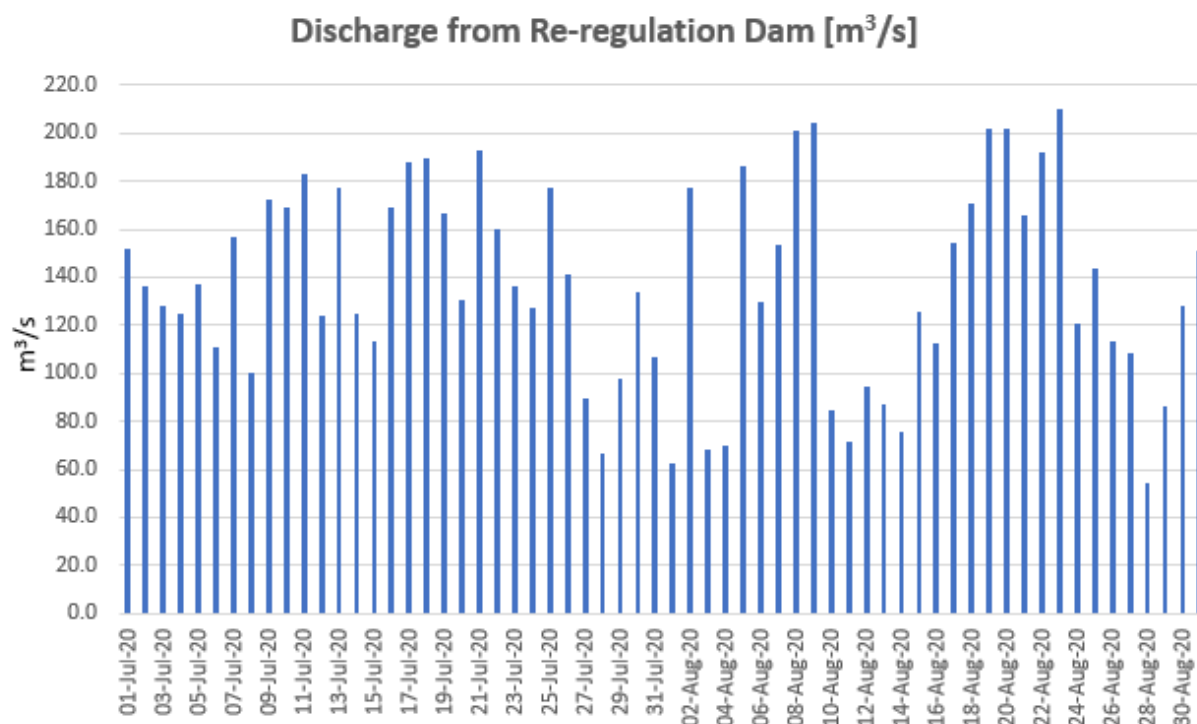
FIGURE 3-5: DISCHARGE MONITORING AT THE RE-REGULATION DAM IN JULY AND AUGUST 2020

The discharge monitoring data for the re-regulation dam during July and August 2020 is presented in *Figure 3-5*.

The changes in the discharge from the re-regulation dam were informed in advance to the RMU and to the heads of the downstream villages, who then announced the changes to the communities over the village speaker systems.
