Nam Ngiep 1 Hydropower Project

Environmental Management Monthly Monitoring Report

February 2017

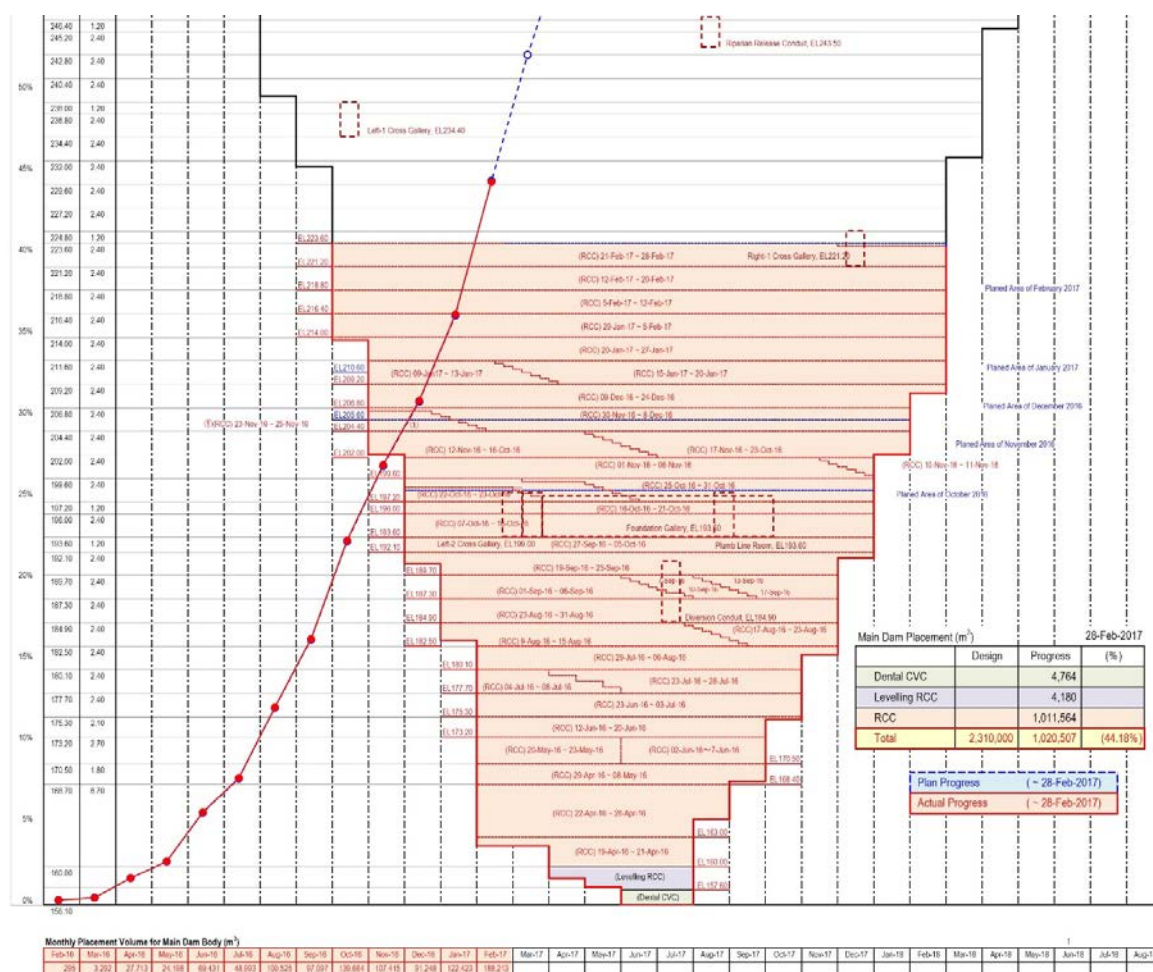
Figure 2-2: Progress of Main Dam RCC Works as of 27 January 2017

The consolidation drilling and grouting for the main dam started in May 2016 and is ongoing. The progress is 77 % by achievement of total drilled length at the end of February 2017 as a proportion of the total expected drilling

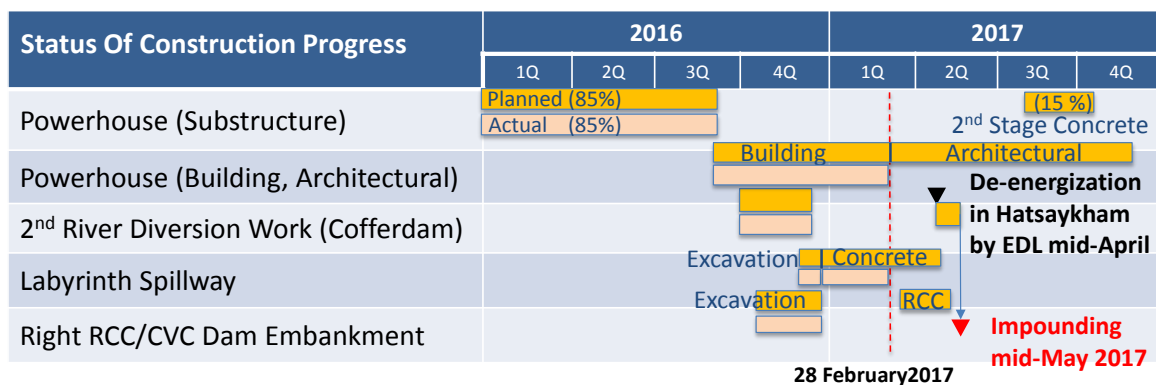
Figure 2-3: Progress of Re-regulation Dam Powerhouse Works to 28 February 2017

The powerhouse concreting has advanced well and secondary concrete embedment for the draft tube liner was completed at the end of April 2016. The left bank structure was re-designed as roller compacted concrete (RCC) and was completed on 18 March 2016. Installation of the re-regulation waterway gate and stop log and re-regulation intake gate and structural concrete works for the retaining wall to support the substation yard were completed in October 2016. Building

superstructure work continued for the powerhouse with the commencement of construction of concrete columns.

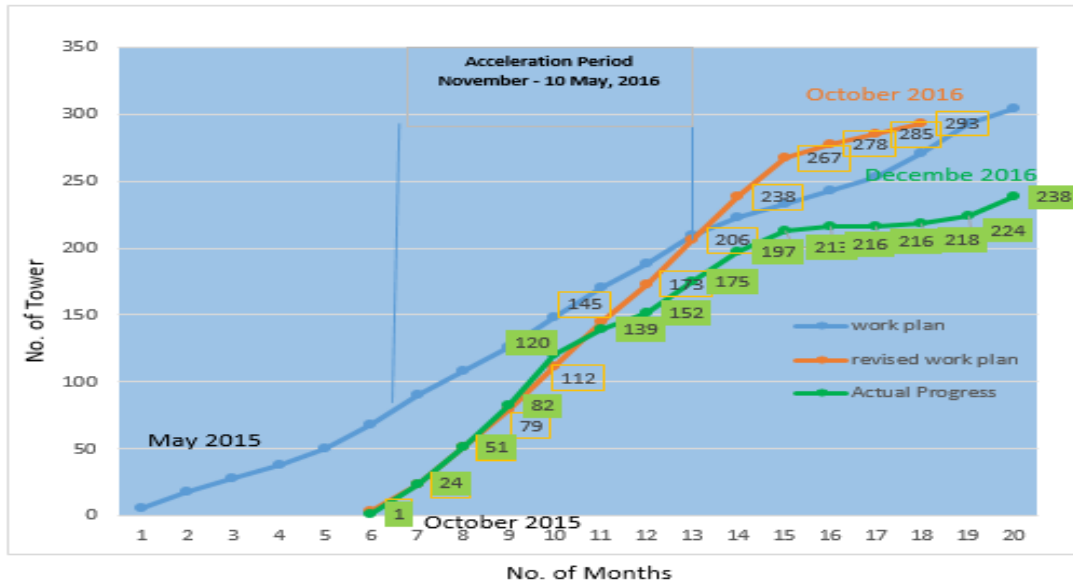
Figure 2-6: Cumulative Work Progress of Tower Foundation (Original Planned and Actual)

In respect of the delay to commencement of most works the Contractor is studying its programme to ensure that sufficient resources are committed as the works progress to ensure that completion is achieved in good time. Onset of daily rains has made access to all areas difficult but the Contractor follows its revised acceleration schedule, after the progress for the construction of tower foundations slowed after April, 2016 (See Figure 2-6 below)

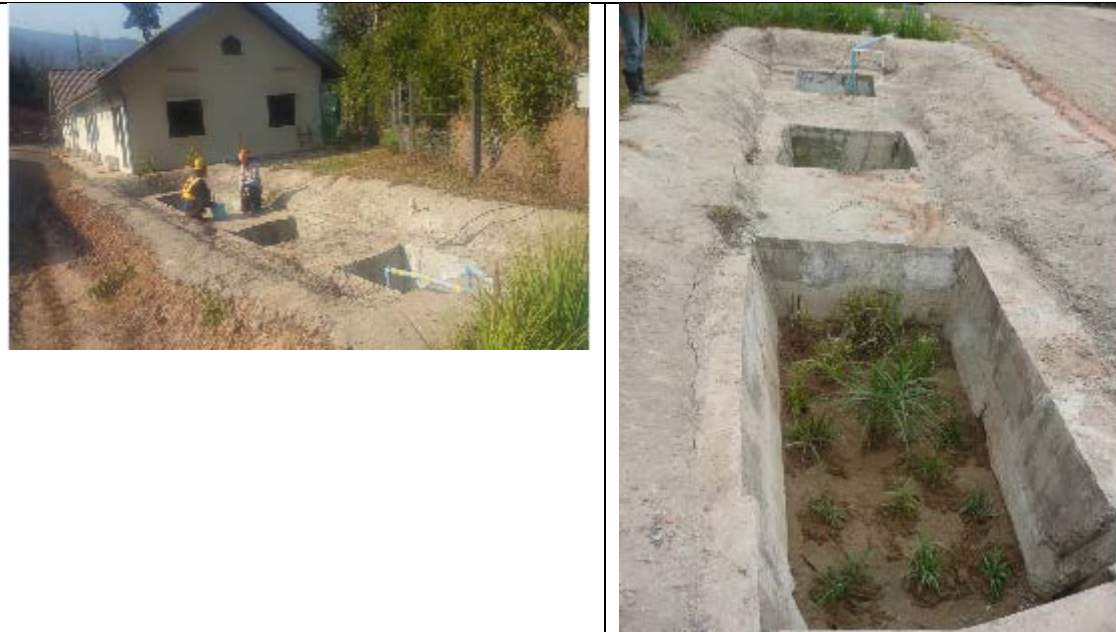
Photograph 1 and Photograph 2 Improvement of the Grey Water Ponds at IHI Camp

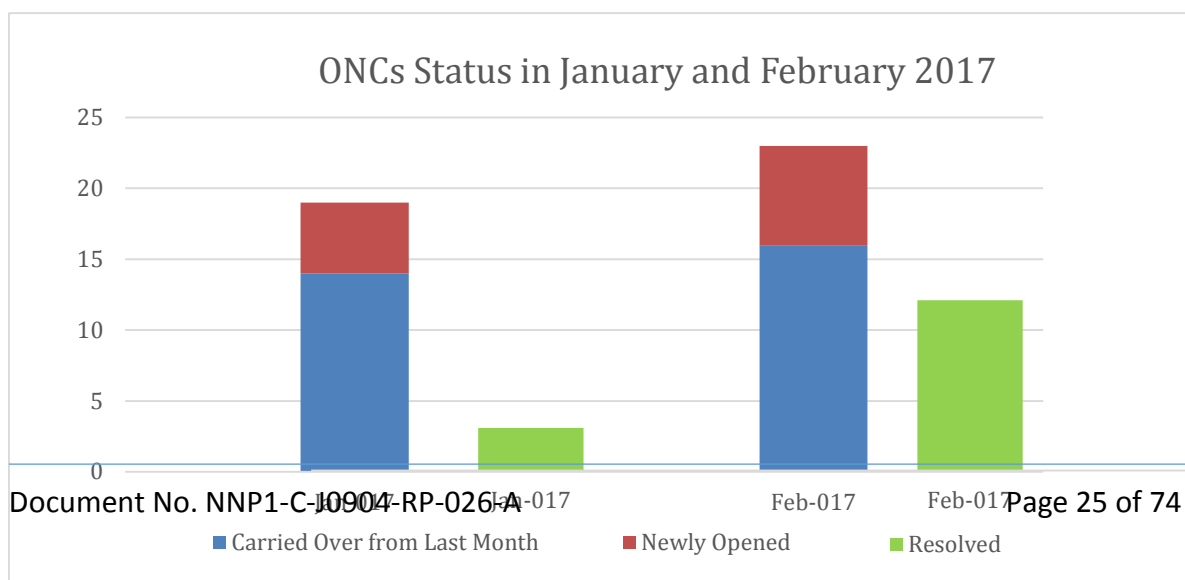
Figure 3-3: Observations of non-compliance (ONCs) in January 2017 Compared with February 2017

- b) Turbid water discharge from the RCC Plant;
- c) Improper Site Decommissioning of the SECC Contractor;
- d) Incomplete construction of Waste Water Treatment Plant at LILAMA 10, and
- e) Stagnant grey water at Song Da 5 Camp No. 2.

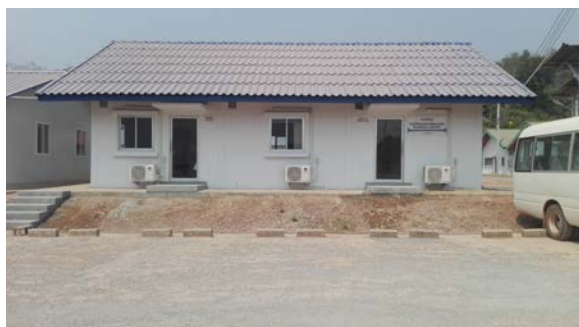
Photograph 3 NNP1 Project Laboratory (external view)

The construction of NNP1 Project laboratory was commenced in the third week of October 2016 at the Owner's Site Office and Village (OSO) and nearly completed by the end of February 2017. The laboratory is expected to be 100% completed in early March 2017 (see Photograph 3 and Photograph 4). Once it is completed, the laboratory equipment will be relocated from the warehouse, installed and operated at the new laboratory. The NNP1 Project laboratory, in collaboration with United Analysis and Engineering Consultant Company Limited (UAE) will conduct performance verification of its analyses for Total Suspended Solids starting from March 2017.

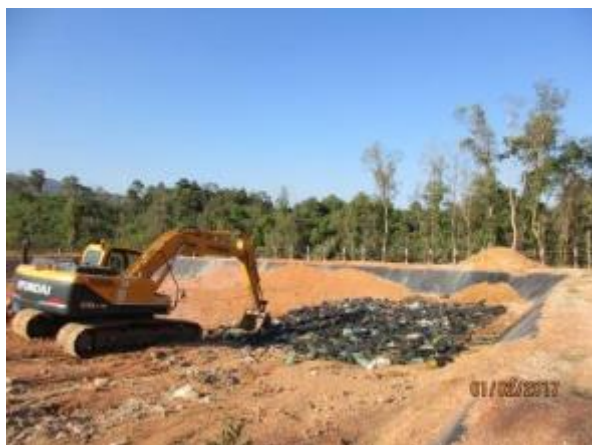
In February 2017, NNP1PC closely supervised the landfill operations including waste disposal, compaction and soil cover activities using a crawler excavator. The solid waste delivered and disposed at the NNP1 Project Landfill was spot-checked and found that the HM Hydro's LILAMA 10 (subcontractor) attempted to dispose of construction waste (large plastic sheets) at the NNP1 Landfill which is not permitted but allowed at the Spoil Disposal Area No.6. This Subcontractor was instructed to collect the construction waste for proper disposal in the designated area of Spoil Disposal Area No.6 (See Photograph 5 and Photograph 6 below). Approximately 136.3 m³ of solid waste was disposed at the NNP1 Project Landfill during February 2017, an increase of 4.6 m³

Photograph 5: Waste compaction and soil cover at the NNP1 Project Landfill

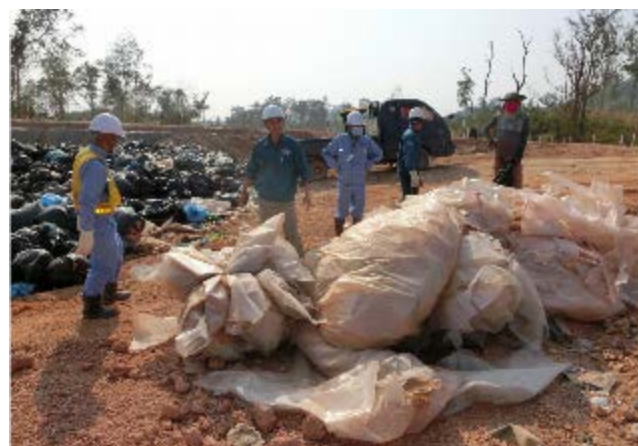
Photograph 6: Contractors Collected Disposed Construction Waste from NNP1 Project Landfill

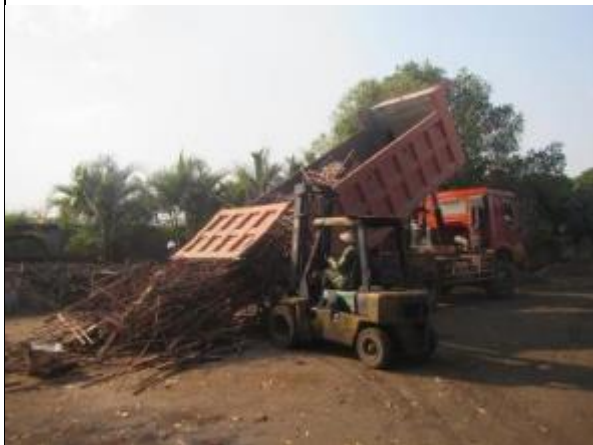
A total of 5,000 kg of scrap metal from a local Contractor - SECC was sold to the local Khoum Mixay Processing Factory in Pakxan District, Bolikhamxay Province and the remaining recycled waste from other Contractors was sold to a local vender at Hat Gniun villagel (See Photograph 7 and Photograph 8 below).

Photograph 7: Scrap metal of SECC Contractor was Sold to Khounmixay Process Factory in Paksan, Bolikhamxay Province

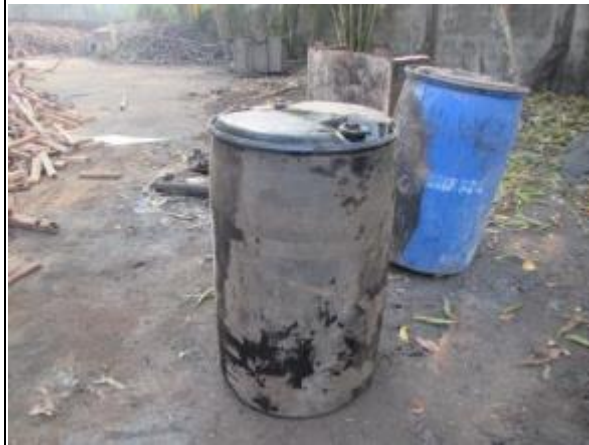
Photograph 8: Some Hazardous Waste of SECC Contractor was Sold to Khounmixay Process Factory in Paksan, Bolikhamxay Province

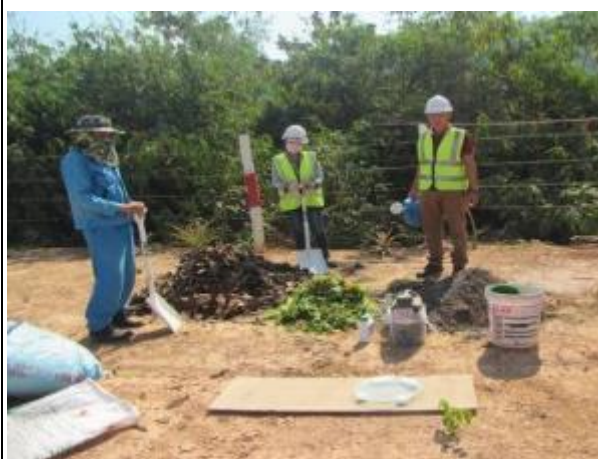
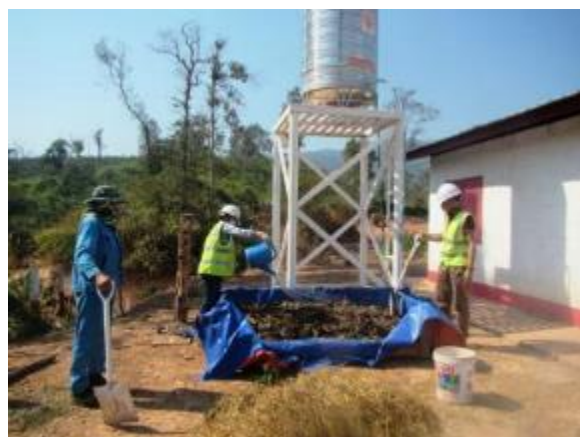
In February 2017, NNP1PC-EMO together with administration staff from OSOV produced a total of 30 kg of compost made from leaves, cow dung, rice husks, molasses, bio-effect (BE), water and discarded vegetables and fruits from the canteens of OSOV, selected Contractors and subcontractors (See Photograph 9 and Photograph 10 below). The compost will be used as organic fertilisers for grasses, plants and flowers in the OSOV.

Photographs 9 and 10: NNP1PC Staff Make Compost at NNP1 Project Landfill

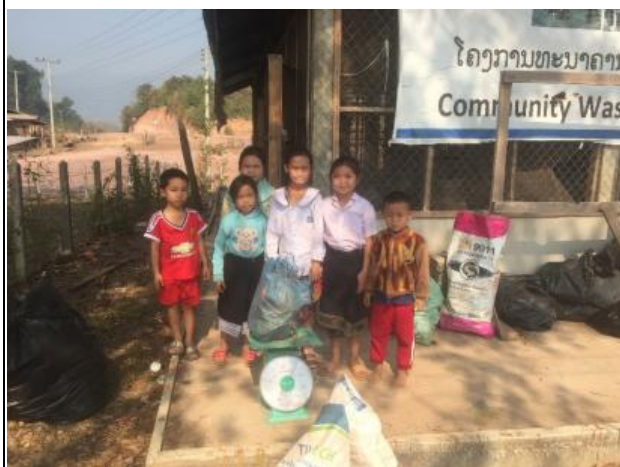
NNP1PC-EMO continued to carry out trial trading of recyclable waste with new residents at Houay Soup Resettlement Area (HSRA) and host village such as Ban Thaheua, Hat Gniun and Hatsaykham Villages. This was also an opportunity to raise their awareness on the waste management which includes waste segregation, reduction and disposal in a temporary waste pit at each household as well as how to manage recyclable waste before selling to the Community Recyclable Waste Bank at Hat Gniun Village (see Photograph 11 and Photograph 12 below):

Photograph 11: Students members Sold Recyclable Waste to Hat Gniun Recyclable Waste bank

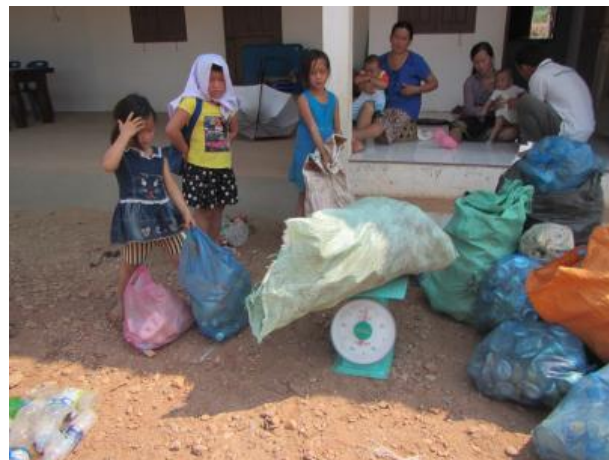
Photograph 12: NNP1PC Bought Recyclable Waste from New Residents at HSRA

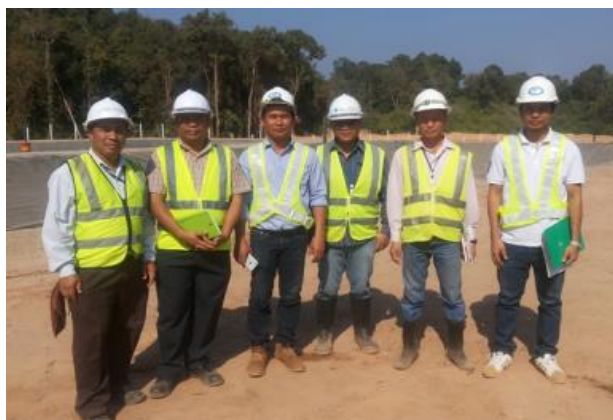
Photograph 73: NNP1PC and a Local Contractor carried out a Final Inspection for 2nd Stage Houay Soup Landfill Construction

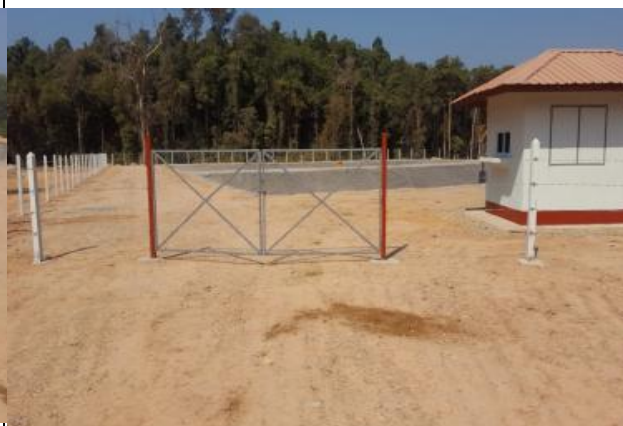
Photograph 84: Completion of the 2nd Stage Houay Soup Landfill Construction

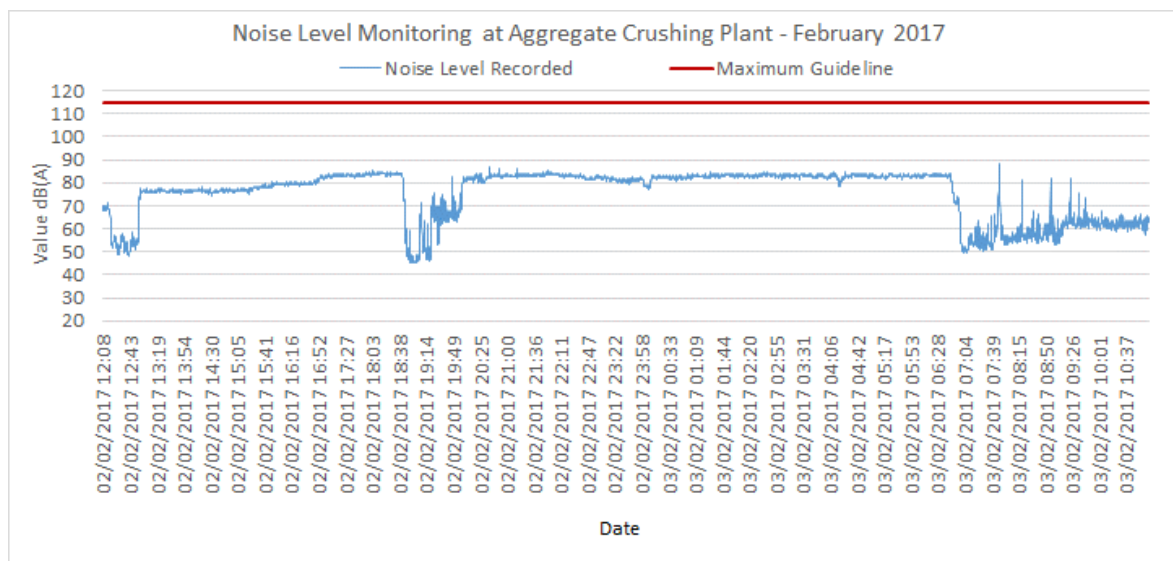
Figure C- 3: Results of Noise Level Monitoring at the Aggregate Crushing Plant in February 2017

The noise levels recorded at the monitoring stations indicated full compliance with the National Standard for the period of 06:01-22:00, except at the Aggregate Crushing Plant and Sino Hydro Temporary Worker Camp. The noise levels during the period of 22:01-06:00 were higher than the Standard at the Aggregate Crushing Plant, RCC Plant, Song Da 5 Camp No. 2, Sino Hydro Camp, Sino Hydro Temporary Worker Camp, Lilama 10 Camp and the Main Dam [between 55.60 – 82.52 dB(A)] compared to the Standard of 50 dB(A)].

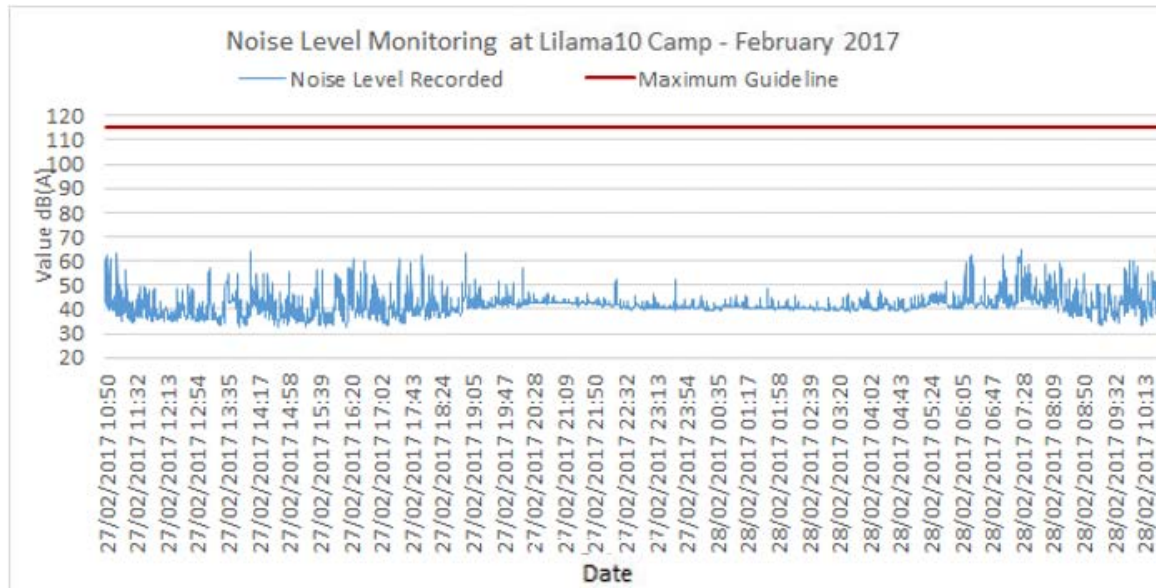
Figure C-10: Results of Noise Level Monitoring at Lilama10 Camp in February 2017
