## Nam Ngiep 1 Hydropower Project

# Environmental Management Monthly Monitoring Report

February 2020

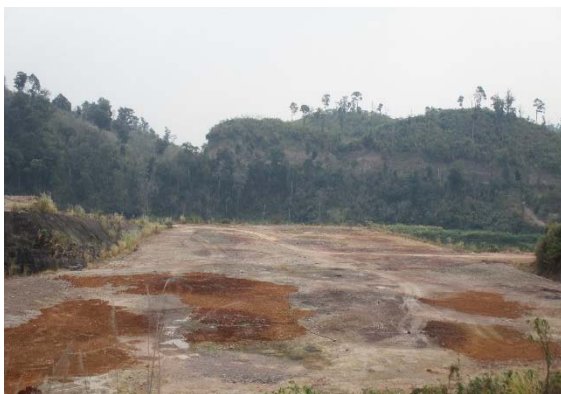
RCC plant yard\_ Vegetation improvement ongoing

Demobilization of plant facilities for both RCC and CVC plants was completed in December 2019. The vegetation improvement for rehabilitation of those areas is ongoing

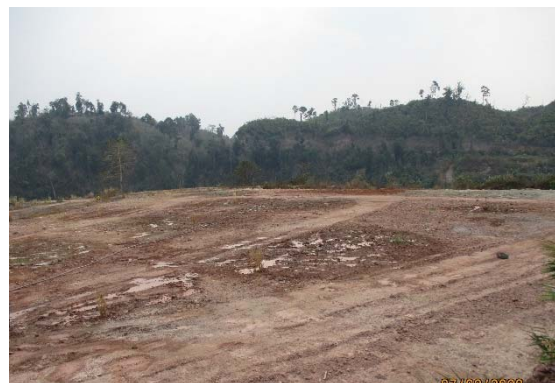
CVC plant yard\_ Vegetation improvement ongoing

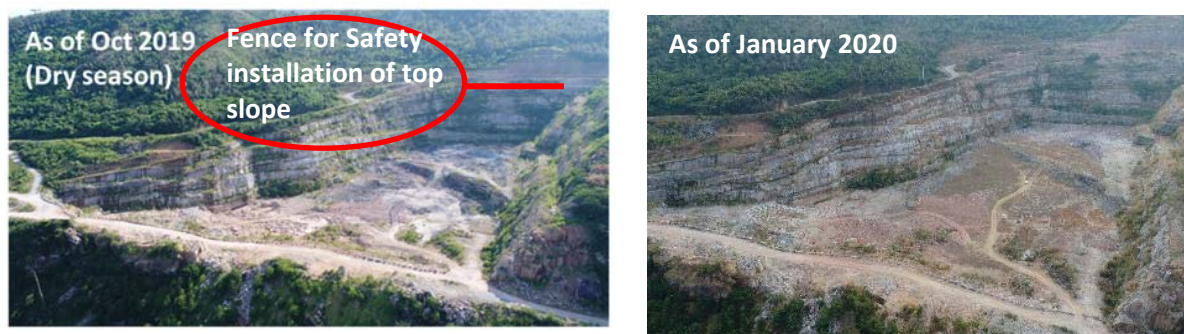
**Figure 2-4: Quarry Area View**

The surface clearing, topsoil and overburden removal works at the extension area were completed in December 2016 and its development works was commenced in January 2017. The final blasting was carried out 27 March 2018. GOL have acknowledged that the quarry operation is complete. After several inspections by GOL and ADB for the Lenders, the quarry site has been improved by such as partial levelling, vegetation at the berms of slopes and large rock installation at top of slopes from an environmental and a safety point of view. Furthermore, a fence around the pond, which is created at the quarry only during the rainy season and is dry during dry season, will be installed to prevent people and animals from entering the pond, subject to ADB approval. A gate near the steel bridge also a barrier to public access. Permanent fence installation around pond as shown in the below picture will not be installed and fence for road safety will be installed at the top of the right bank upper quarry roadside. The levelling of quarry bottom will be implemented from January 2020.

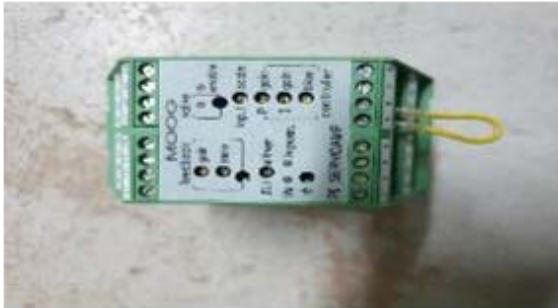
**Figure 4.2-1: Removing of servo amplifier and modifying wiring circuit**

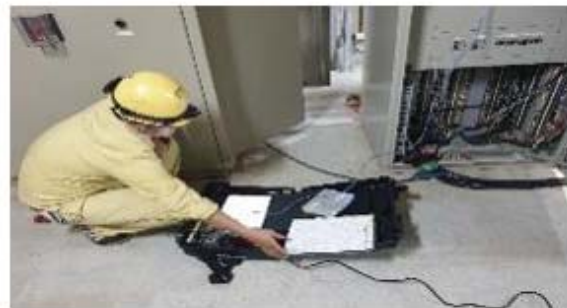
**Figure 4.2-2: Uploading the new logic to the governor system**

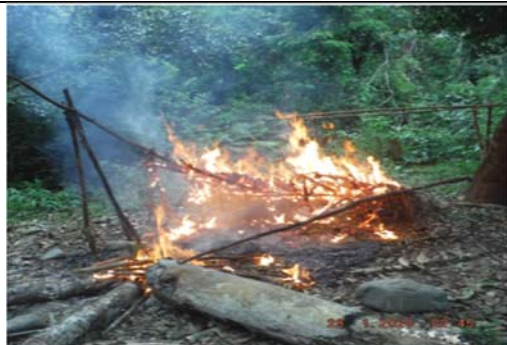
**Figure 3-7: Hunting camp destroyed by patrolling team**

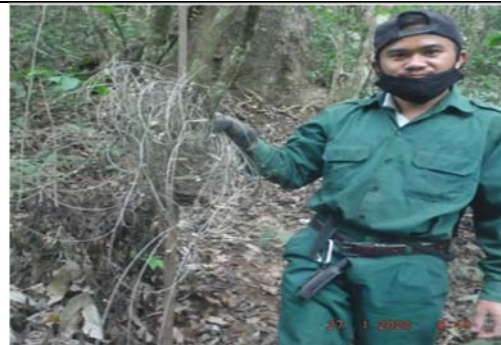
**Figure 3-8: Small wire snares at Nam Kha Gni area**
