Nam Ngiep 1 Hydropower Project

Environmental Management Monthly Monitoring Report

January 2016

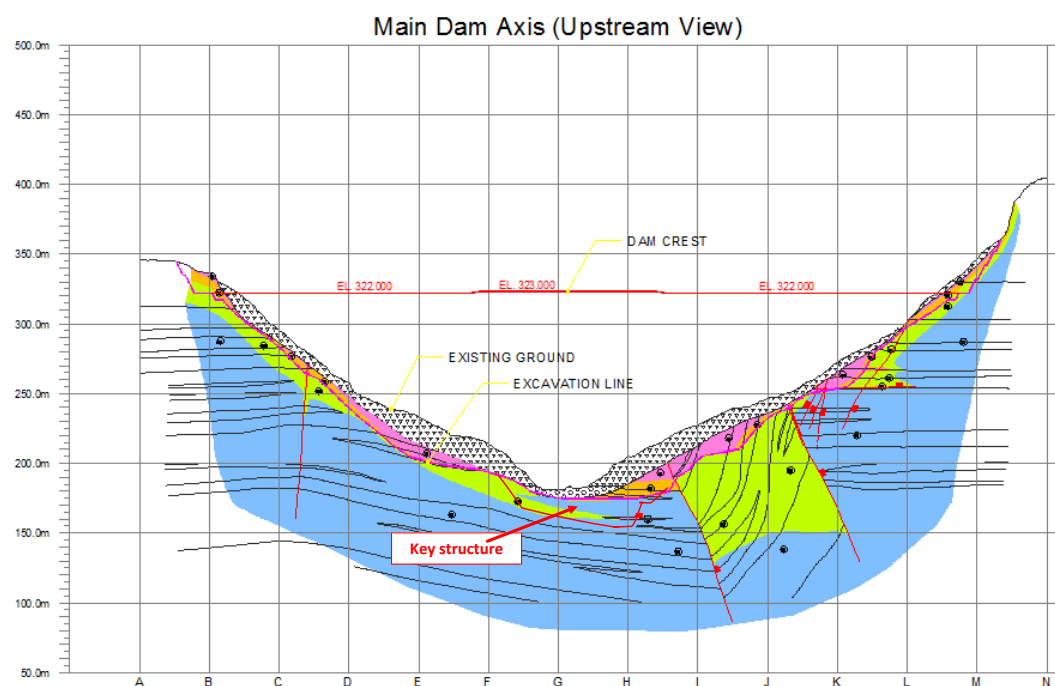
FIG. 4: PROGRESS DRAWING OF THE MAIN DAM EXCAVATION

After starting the main dam excavation works in October 2014 on the left bank, both left and right banks were excavated down to El. 175 m by the end of December 2015. As shown in Fig.4, excavation below this level continues together with the necessary slope protection works, revisiting some areas where damage to the dam foundation was sustained during the wet season.

The dam excavation works were well advanced in the river bed after diversion of the Nam Ngiep was achieved at the end of October 2015. However, excavated volumes are now known to be about 20% greater than expected and part of this is needed to construct a 'key' structure due to the weak layers of rock being encountered in the dam foundation as shown in Fig.4. The additional excavation work was commenced in January 2016.

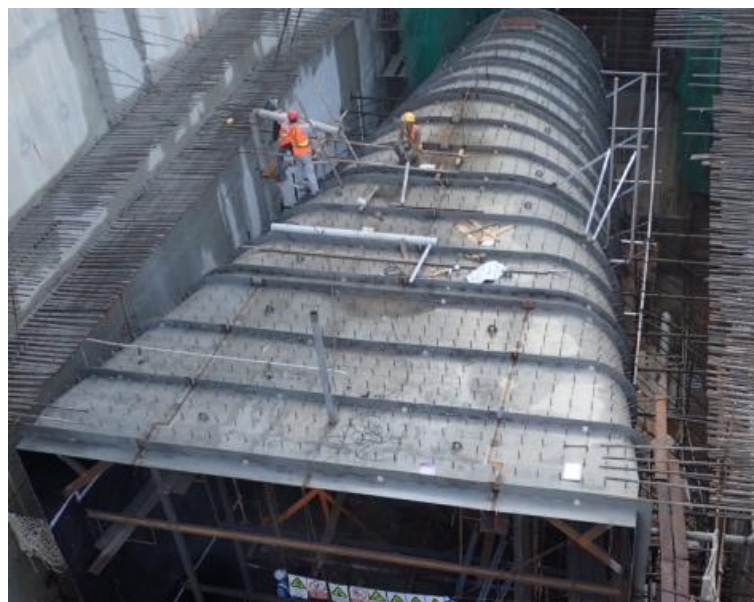
FIG. 5: PROGRESS OF INSTALLATION OF DRAFT TUBE LINER AT THE RE-REGULATION POWERHOUSE

- c) The installation works of the grounding system in the lowest area of the main powerhouse substructure was completed at the end of January 2016;
- d) The installation works of the grounding system in the re-regulation powerhouse was completed below EL. 160 m and its grounding conductor was extended up to EL 166 m on the river side at the outlet area at the end of October 2015 in coordination with the Civil Works Contractor.

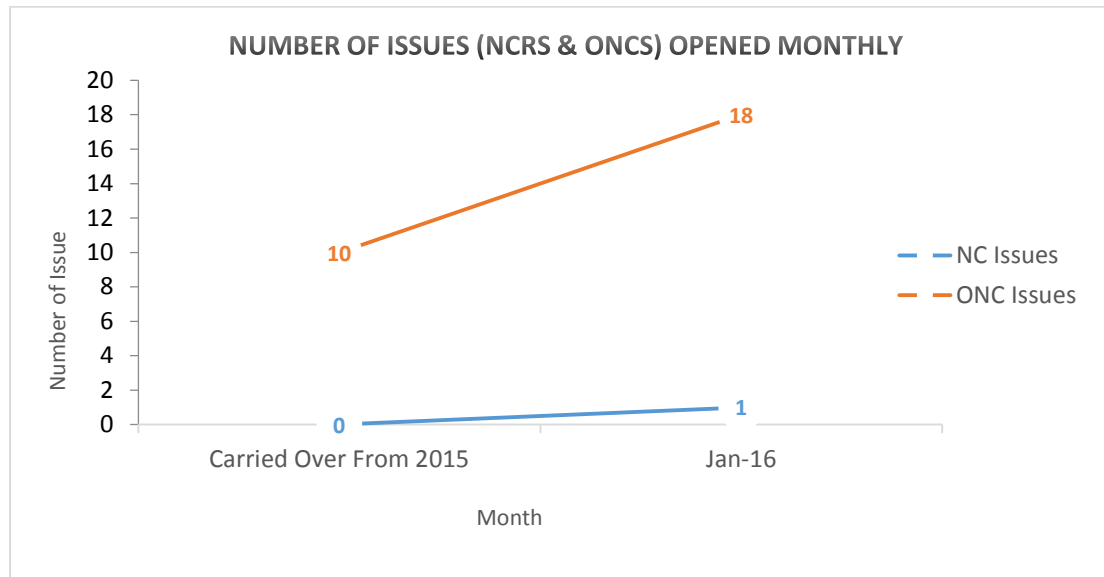
FIG. 8: TRENDS OF ONCs/NCRs IN JANUARY 2016

As shown in Table 3 above, One Non-Compliance Report (NCR) was issued in January as a result of the aggregate crushing plant's slurry disposal offsite at a sediment pond located below Spoil Disposal Area #7. The slurry percolated through the rock/soil profile of the pond and entered into the Nam Ngiep below the Construction Bridge. The implementation of a corrective action plan will be followed up in February 2016.

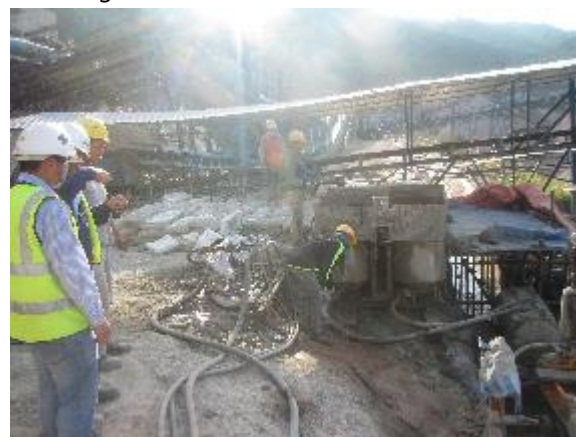
*Photograph 2: Inspection at the Aggregate Crushing Plant*

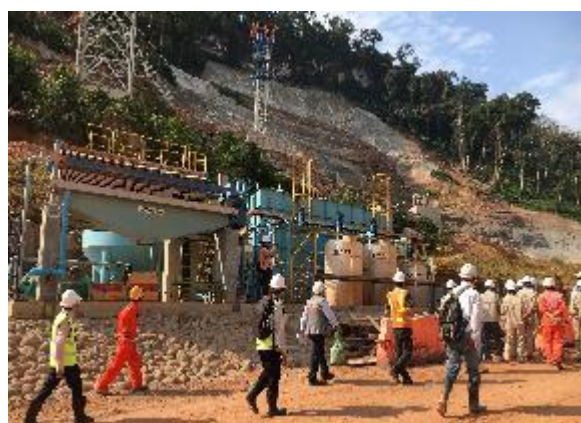
*Photograph 3: A New Turbid Water Treatment System at the Main Dam*

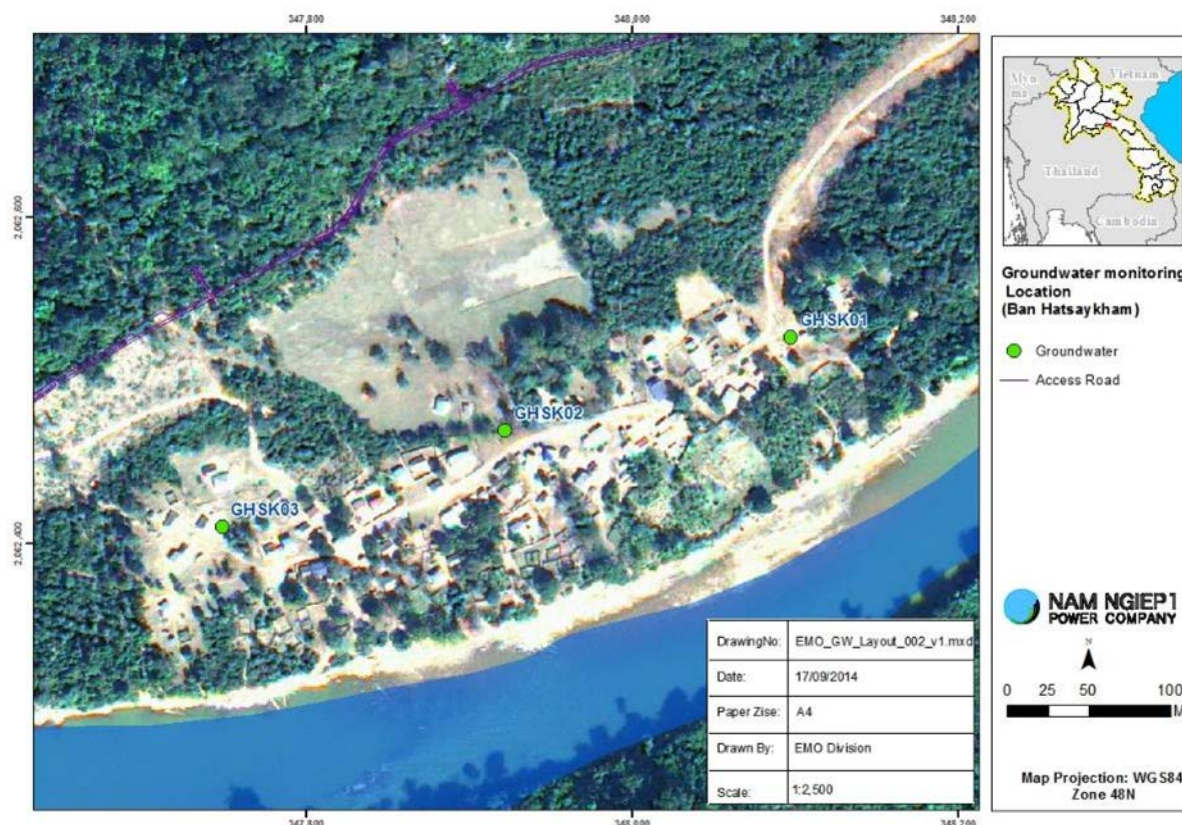
FIG. 10: MAP OF GROUNDWATER SAMPLING SITE AT BAN HATSAYKHAM

In January 2016, groundwater quality was tested in three boreholes at Ban Hatsaykham (Fig.10). The assessment found that the pH levels for one of three boreholes (GHSK02) was 6.37, slightly lower than the National Standard range of between 6.50 and 9.2. The instance of low pH will continue to be monitored. However, the levels of those recorded do not pose risks to health.

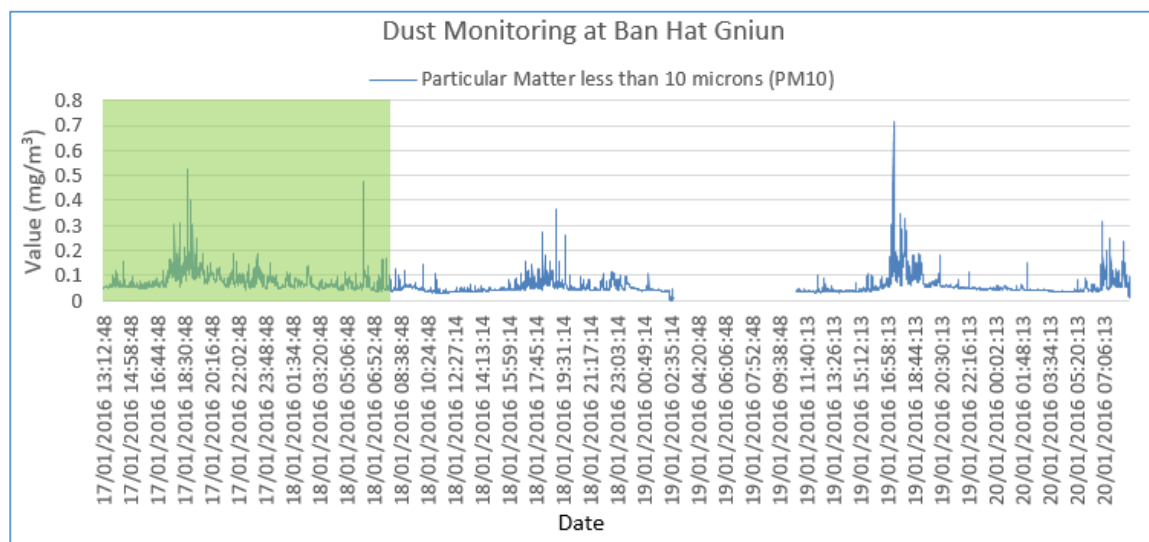
FIG. 13: DUST MONITORING RESULTS AT BAN HAT GNUIN IN JANUARY 2016

Ban Hat Gniun - Average Dust Emission Levels in 24 Hours			
Period	00 to 24 Hours	24 to 48 Hours	48 to 72 Hours
Start Time	17/01/2016 13:12	18/01/2016 13:12	19/01/2016 13:12
End Time	18/01/2016 13:12	19/01/2016 13:12	20/01/2016 08:50
Average Data Recorded in 24h (mg/m ³)	0.071	0.052	0.062
Guideline Average in 24h (mg/m³)	0.12	0.12	0.12

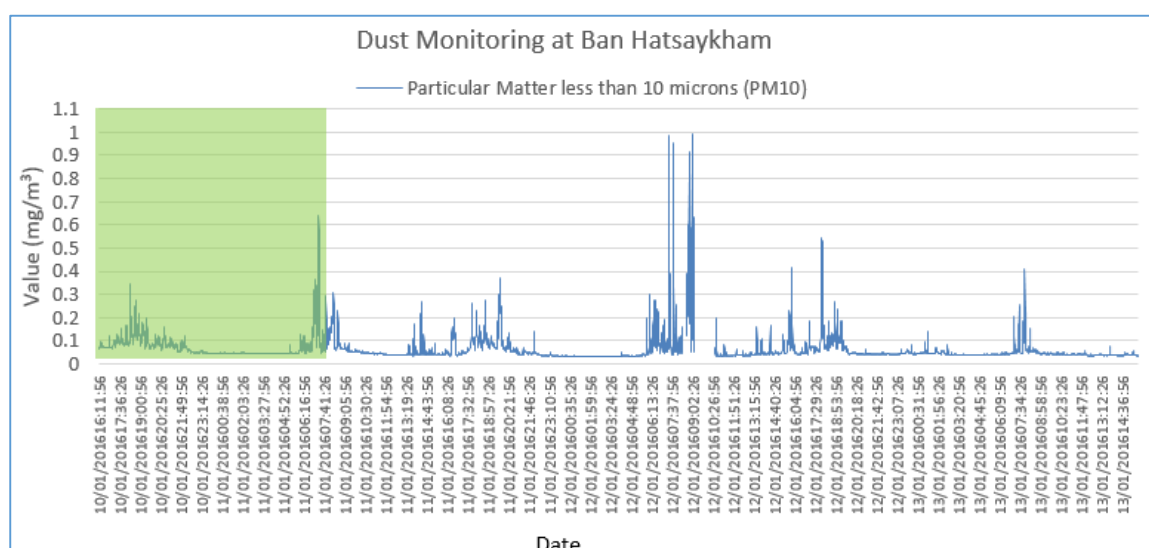
FIG. 14: DUST MONITORING RESULTS AT BAN HATSAYKHAM IN JANUARY 2016

Ban Hatsaykham - Dust Emission Average in 24 Hours			
Period	00 to 24 Hours	24 to 48 Hours	48 to 72 Hours
Start Time	10/01/2016 16:11	11/01/2016 16:11	12/01/2016 16:11
End Time	11/01/2016 16:11	12/01/2016 16:11	13/01/2016 16:11
Average Data Recorded in 24h (mg/m ³)	0.069	0.068	0.052
Guideline Average in 24h (mg/m³)	0.12	0.12	0.12

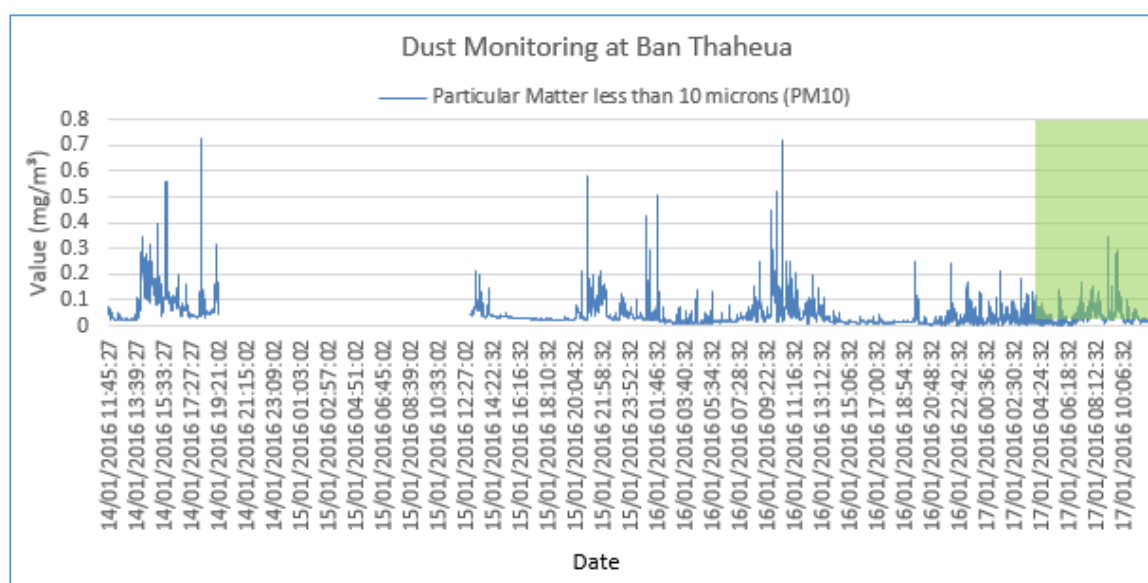
FIG. 15: DUST EMISSION MONITORING RESULTS AT BAN THAHUEA IN JANUARY 2016

Ban Thahuea - Dust Emission Average in 24 Hours			
Period	00 to 24 Hours	24 to 48 Hours	48 to 72 Hours
Start Time	14/01/2016 11:45	15/01/2016 11:45	16/01/2016 11:45
End Time	15/01/2016 11:45	16/01/2016 11:45	17/01/2016 08:59
Average Data Recorded in 24h (mg/m ³)	0.087	0.043	0.029
Guideline Average in 24h (mg/m³)	0.12	0.12	0.12

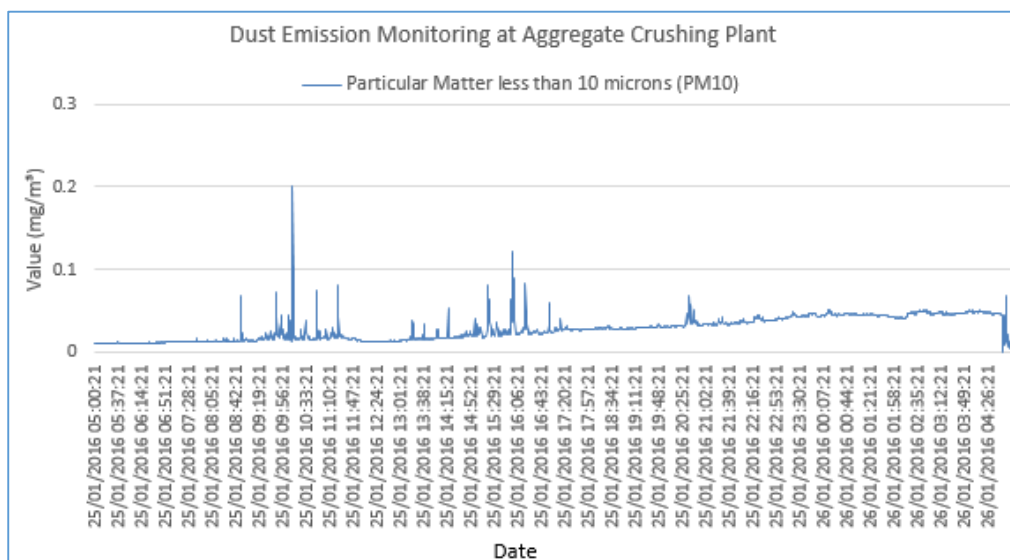
FIG. 16: DUST MONITORING RESULTS AT AGGREGATE CRUSHING PLANT IN JANUARY 2016

- **Aggregate Crushing Plant:** The average dust emission level on the monitored dates complied with the National Environmental Standard (0.12 mg/m³) with an average value of 0.028 mg/m³ (Fig. 16). It maybe resulted from the shower rain and only few crushing machines were operated during the monitoring period. Mitigation measures were also undertaken by the contractor, such as the installation of sprinkler systems to compress the dust generated from the aggregate crushing plant.

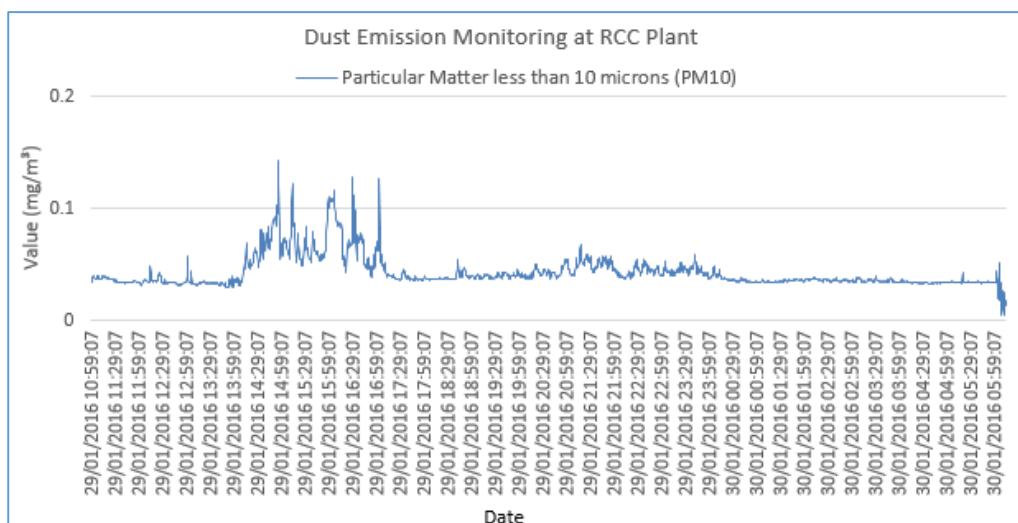
**FIG. 17: DUST MONITORING RESULTS AT RCC PLANT IN JANUARY 2016**

- **RCC Plant:** The average dust emission results at the RCC plant was 0.042 mg/m³ (Fig. 17), thus it is considered to be in compliant with the National Environmental Standard (0.12 mg/m³);

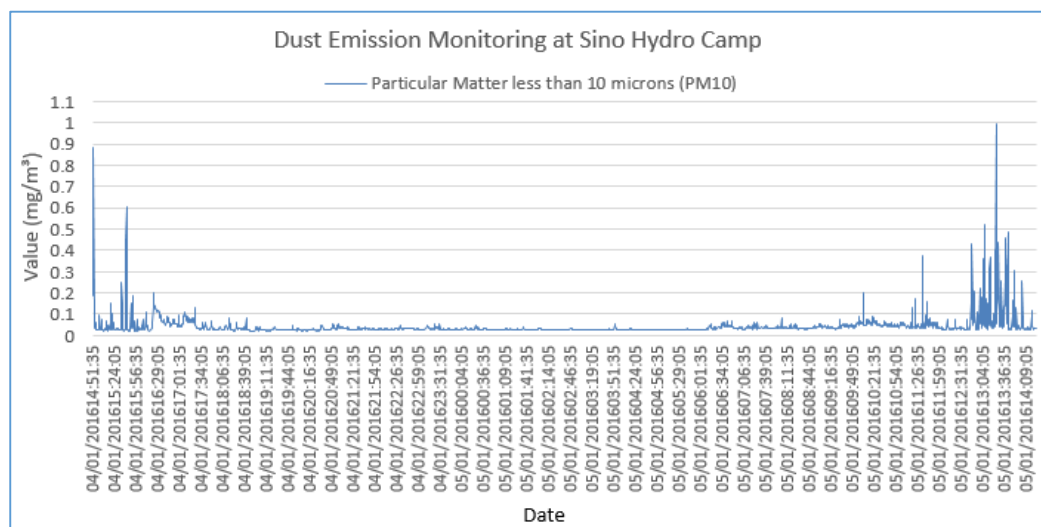
FIG. 19: DUST EMISSION MONITORING RESULTS AT SINO HYDRO CAMP IN JANUARY 2016

- **Sino Hydro Camp:** The average dust emission results was 0.042 mg/m³ (Fig. 19), it is considered complying with the National Environmental Standard (0.12 mg/m³).

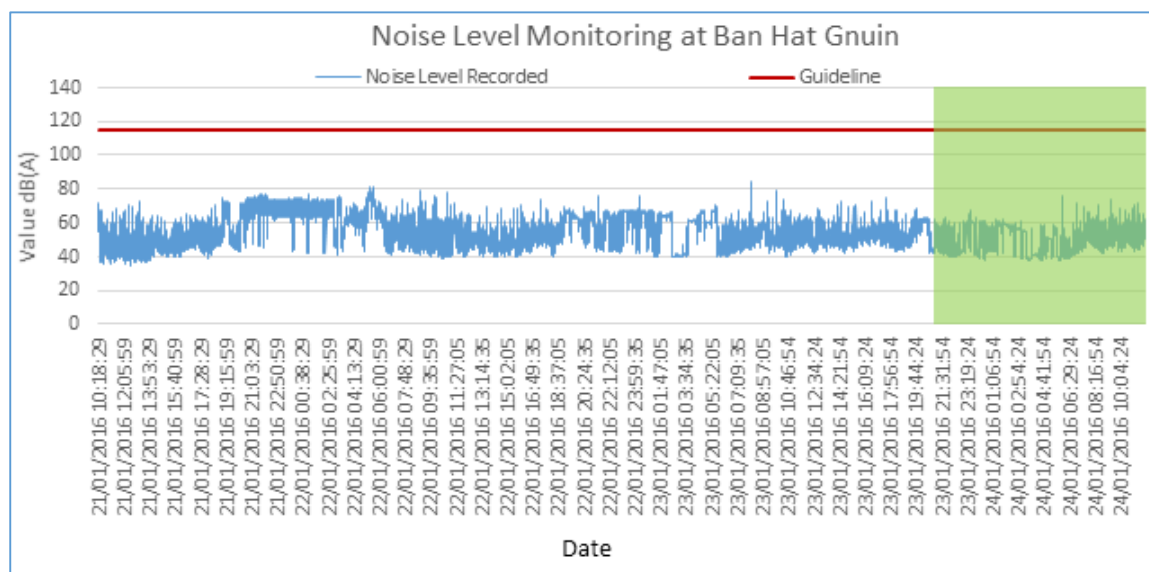
FIG. 20: RESULTS OF NOISE LEVEL MONITORING AT BAN HAT GNUIN IN JANUARY 2016

Noise Level (dB)	21-22/01/2016			22-23/01/2016			23-24/01/2016			24/01/2016
	10:05 – 18:00	18:01 – 22:00	22:01 – 06:00	06:01 – 18:00	18:01 – 22:00	22:01 – 06:00	06:01 – 18:00	18:01 – 22:00	22:01 – 06:00	06:00-11:44
Data Record Max	72.80	77.20	81.70	79.00	76.10	75.50	84.60	68.50	76.30	74.30
Guideline Max	115	115	115	115	115	115	115	115	115	115
Data Record Average	46.62	59.76	66.52	49.66	58.19	58.04	50.51	51.25	49.37	49.72
Guideline Averaged	55	55	45	55	55	45	55	55	45	55

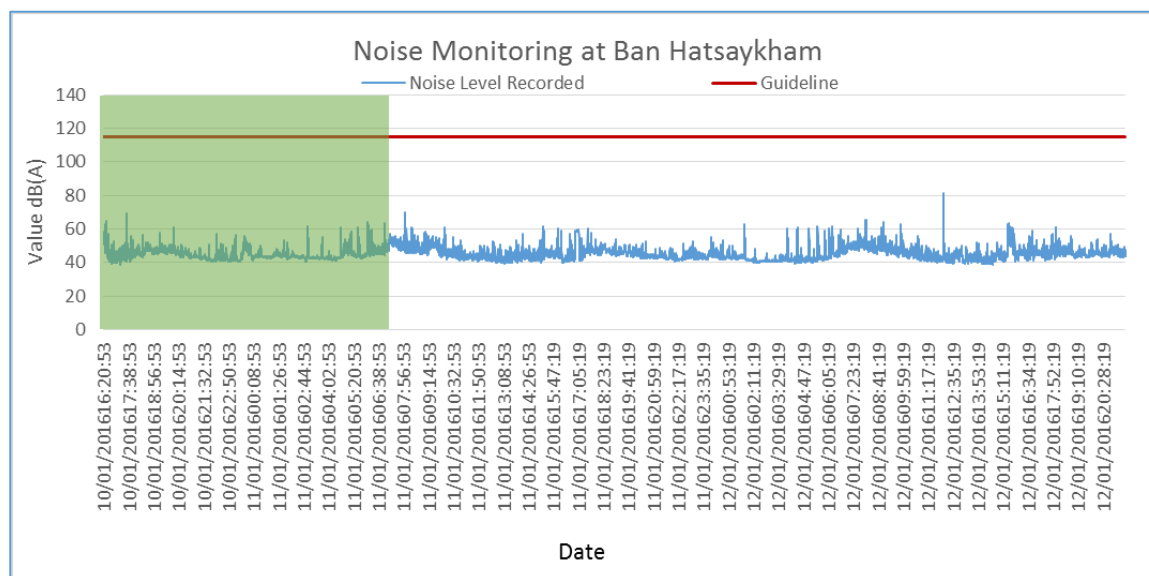
FIG. 21: RESULTS OF NOISE LEVEL MONITORING AT BAN HATSAYKHAM IN JANUARY 2016

Noise Level (dB)	10-11/01/2016			11-12/01/2016			12-13/01/2016			13/01/2016
	16:20-18:00	18:01 – 22:00	22:01 – 06:00	06:01 – 18:00	18:01 – 22:00	22:01 – 06:00	06:01 – 18:00	18:01 – 22:00	22:01 – 06:00	06:01 – 16:20
Data Record Max	69.4	60.7	61.3	69.7	54.1	63	81.6	56.9	61.1	76.4
Guideline Max	115	115	115	115	115	115	115	115	115	115
Data Record Average	45.29	45.49	44.19	46.08	45.28	43.00	45.83	46.05	43.44	45.49
Guideline Averaged	55	55	45	55	55	45	55	55	45	55

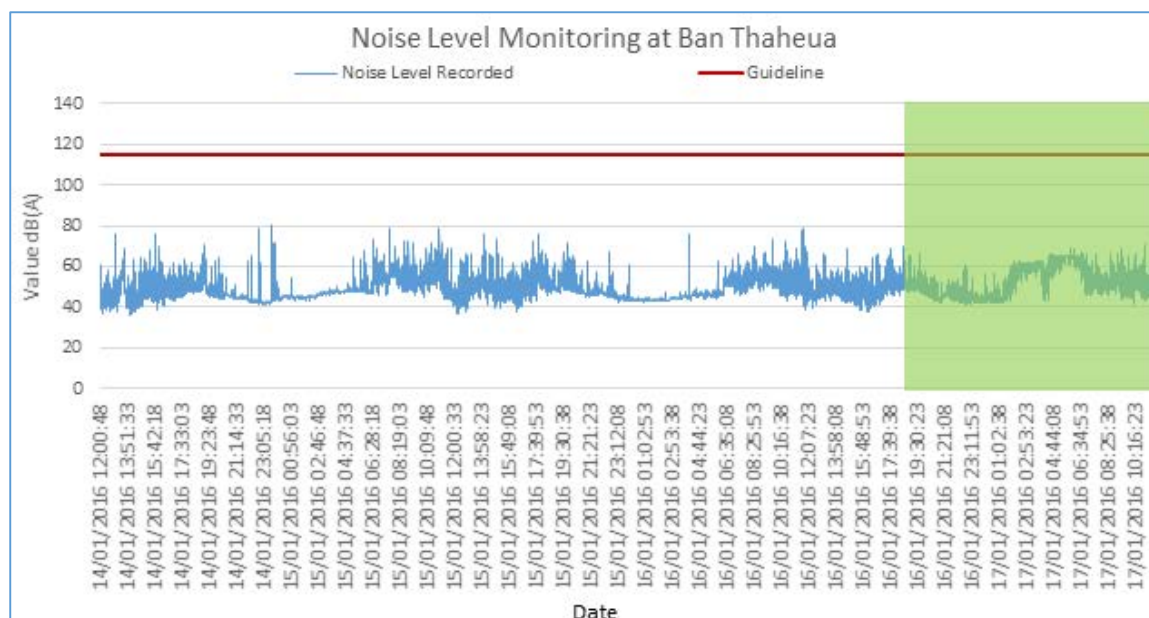
FIG. 22: RESULTS OF NOISE LEVEL MONITORING AT BAN THAHEUA IN JANUARY 2016

Noise Level (dB)	14-15/01/2016			15-16/01/2016			16-17/01/2016			17/01/2016
	12:00-18:00	18:01-22:00	22:01-06:00	06:01-18:00	18:01-22:00	22:01-06:00	06:01-18:00	18:01-22:00	22:01-06:00	06:00-09:10
Data Record Max	75.7	71	80.3	79.2	69.4	75.7	78.6	70.2	69.1	71.8
Guideline Max	115	115	115	115	115	115	115	115	115	115
Data Record Average	47.79	48.05	46.44	51.51	48.71	45.06	50.31	48.38	52.81	50.34
Guideline Averaged	55	55	45	55	55	45	55	55	45	55

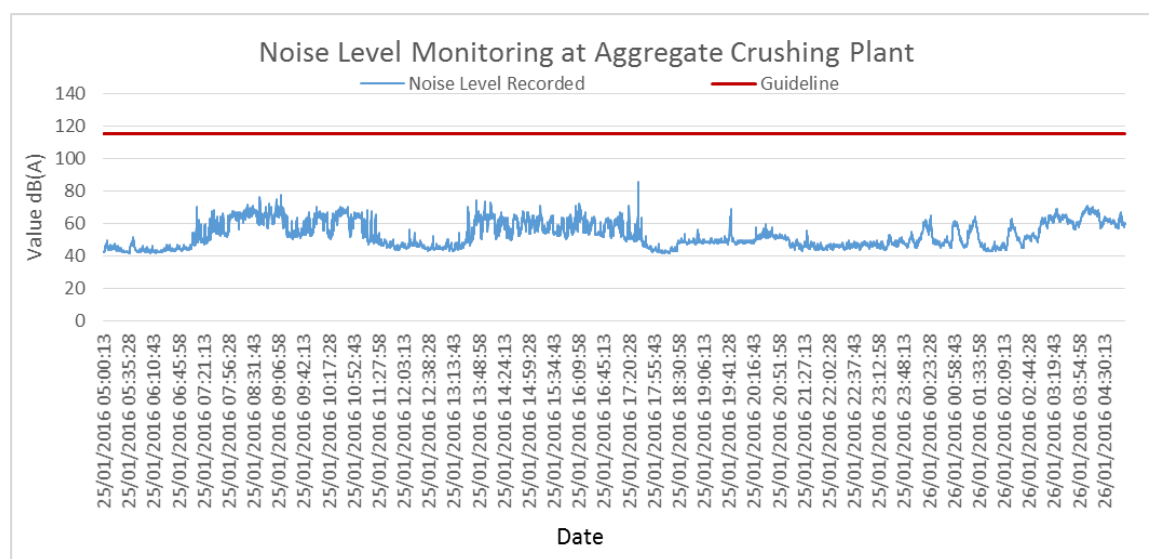
FIG. 23: RESULTS OF NOISE LEVEL MONITORING AT AGGREGATE CRUSHING PLANT IN JANUARY 2016

Noise Level (dB)	25-26/01/2016	
	06:00 – 22:00	22:01 – 06:00
Data Record Max	85.5	70.9
Guideline Max	115	115
Data Record Average	52.64	52.90
Guideline Averaged	70	50

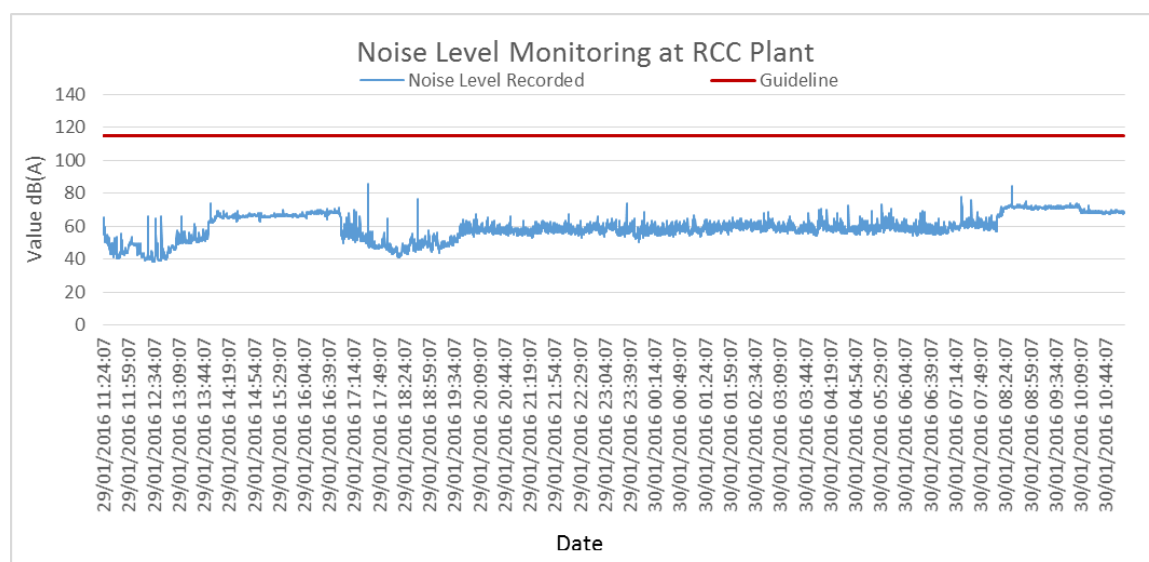
**FIG. 24: RESULTS OF NOISE LEVEL MONITORING AT RCC PLANT IN JANUARY 2016**

Noise Level (dB)	29-30/01/2016		30/01/2016
	11:24 – 22:00	22:01 – 06:00	06:00-11:10
Data Record Max	85.8	73.6	84.3
Guideline Max	115	115	115
Data Record Average	55.93	58.64	65.70
Guideline Averaged	70	50	70

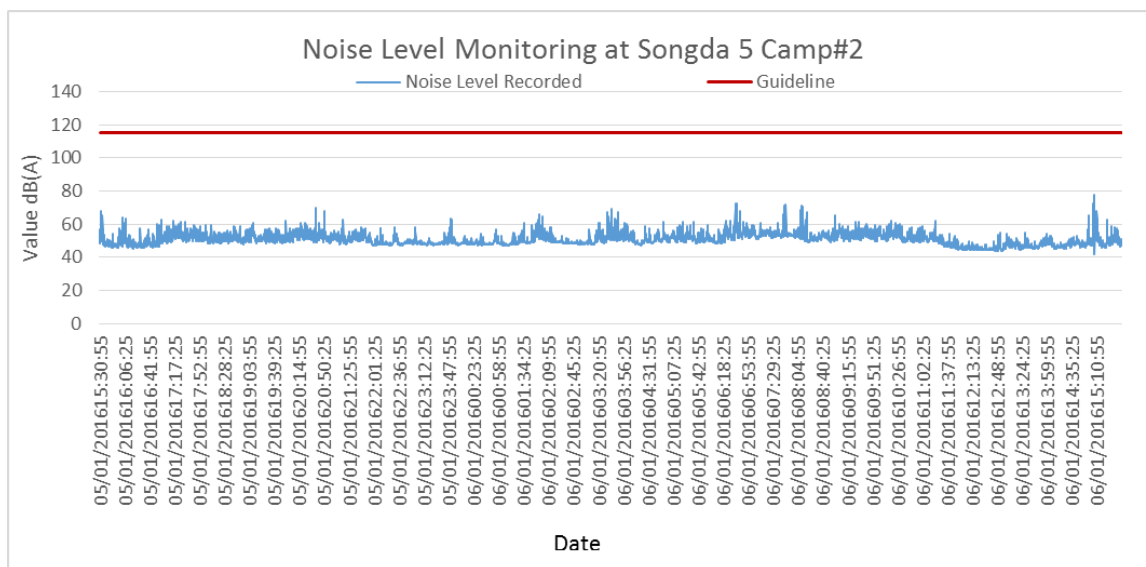
FIG. 25: RESULTS OF NOISE LEVEL MONITORING AT SONGDA CAMP#2 IN JANUARY 2016

Noise Level (dB)	25-26/12/2015		26/12/2015
	17:06 – 22:00	22:01 – 06:00	06:00-15:56
Data Record Max	80.8	62.4	77.3
Guideline Max	115	115	115
Data Record Average	52.03	51.80	51.42
Guideline Averaged	70	50	70

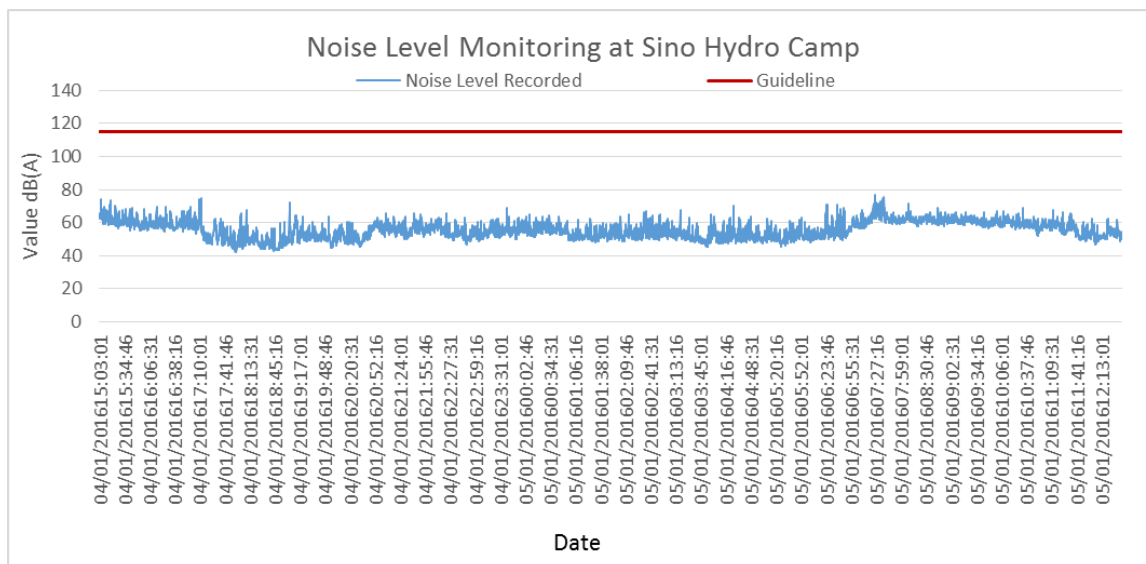
**FIG. 26: RESULTS OF NOISE LEVEL MONITORING AT SINO HYDRO CAMP IN JANUARY 2016**

Noise Level (dB)	29-30/12/2015		30/12/2015
	16:34 – 22:00	22:01 – 06:00	06:00-16:09
Data Record Max	69.3	66.1	73.9
Guideline Max	115	115	115
Data Record Average	54.86	49.69	55.33
Guideline Averaged	70	50	70

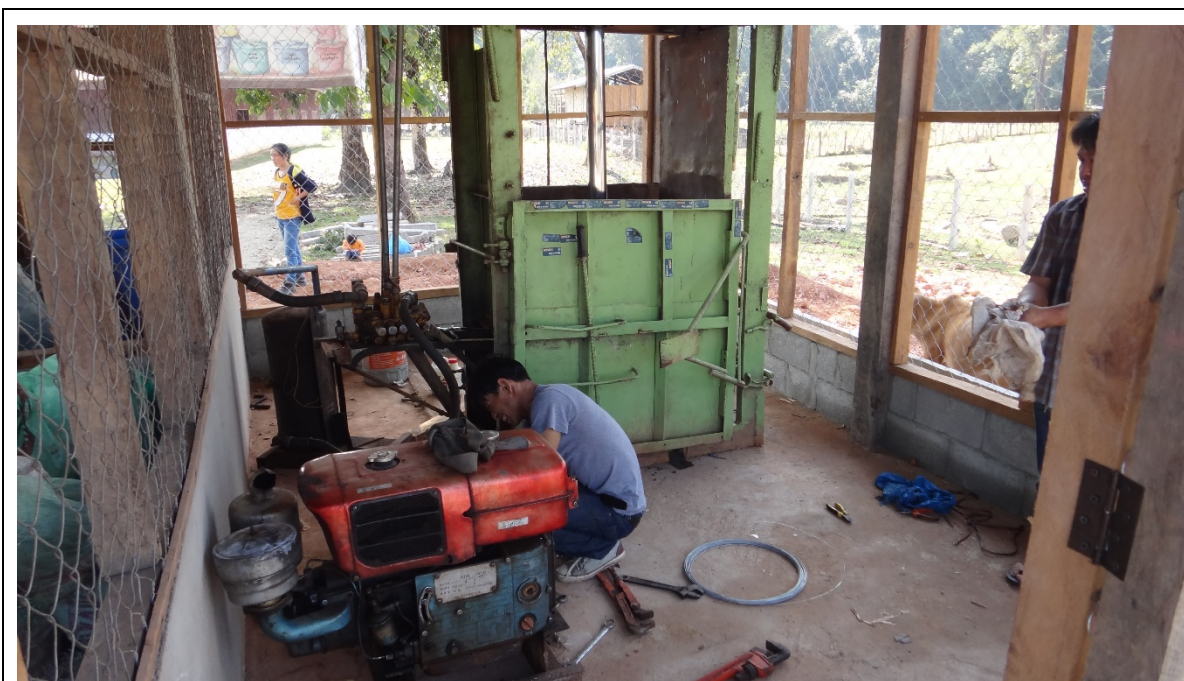
The extension of a storage area for the recycling pressing machine was completed. The machine was installed and instructions were provided for its use. The machine will be used by NNP1PC (Owner's Site Office and Village) and Hat Gniun village to press plastics and cans to improve values of their sale price. The machine will be operational when all safety measures have been approved by NNP1PC TD. It was also agreed that the pressing machine will operate only on Saturday and Sunday for a trial period of 6 months and will be relocated to the Owner's Site Office and Village until a permanent location is identified (see below photo).

Photograph 5: Installing a Recyclable Pressing Machine

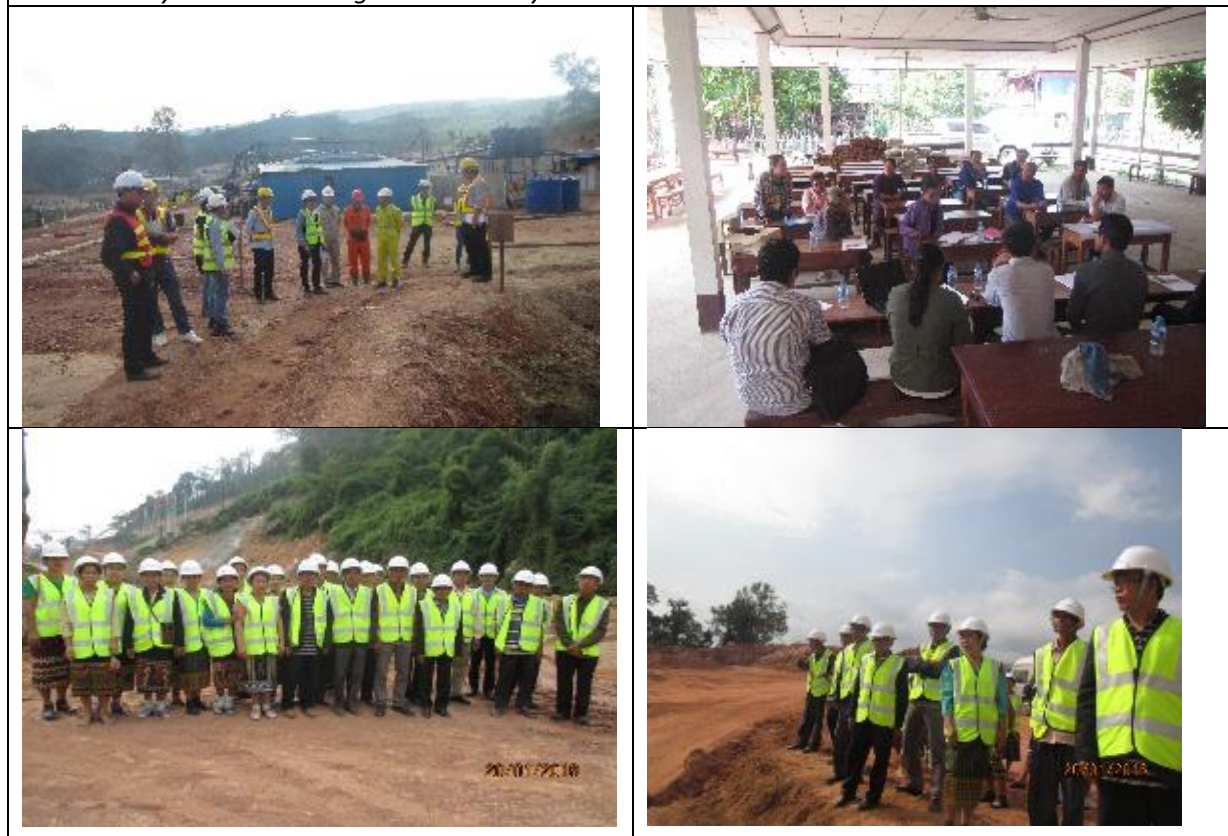
Photograph 6-9: Sites Inspection and the down stream village(Ban Xom Xeun) Visit by the EMU Bolikhamxay Province During 12-14 January 2016

- Turbid water from the aggregate crushing plant yard and bridge construction;
- Untreated water at the sediment pond of the RT camp, SongDA camp#2 and V&K camp;
- Temporary waste pits at the spoil area number 6;
- Drainage system at the workshop area for the bridge construction work;
- Potential turbid water of NamNgiep river to the XomXeun village (downstream village).

During the consultation with the downstream villagers at Ban XomXeun, NNP1PC acknowledged the villagers's concerns on the water quality of Nam Ngiep during October to November 2015. It clarified that the turbid water was mainly caused by upstream activities of the NNP1 project area according to the surface water quality monitoring results during this period. After the EMO's information presentation, the Technical Department of NNP1PC invited the villagers to visit the site on 20 January 2016 to enhance their understanding on the current construction activities in the main dam (see above photos).
