## Nam Ngiep 1 Hydropower Project

# Environmental Management Monthly Monitoring Report

January 2018

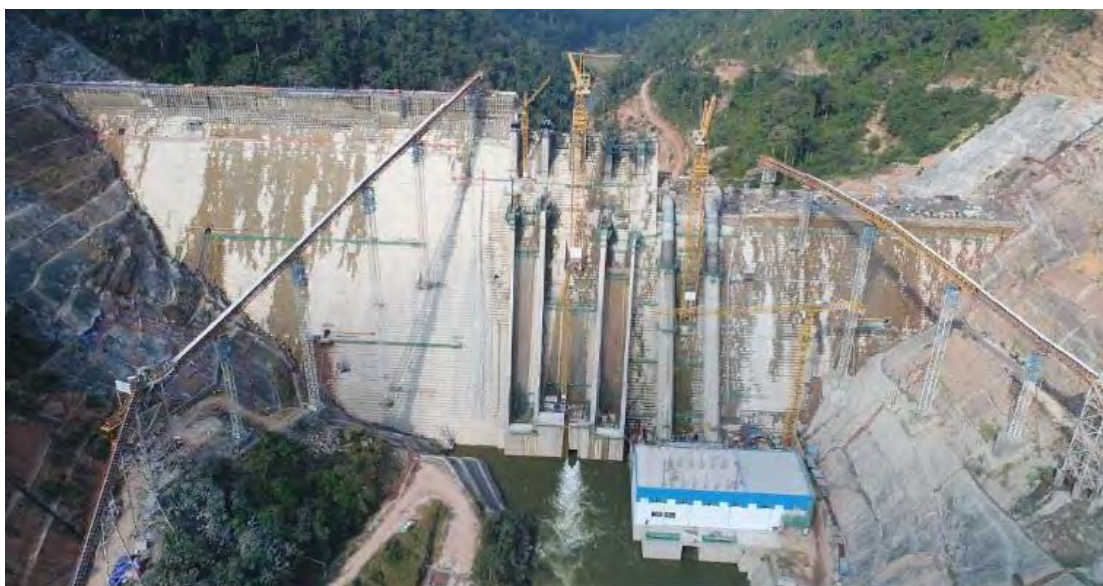
*Figure 2-2: Main Dam and Powerhouse from Overhead Looking Upstream*

After starting the main dam excavation works in October 2014 on the left bank, the works were about one month advanced when diversion of the Nam Ngiep River was achieved at the end of October 2015. However, excavated volumes were 20% greater than expected and part of this additional work is necessary to construct a 'shear key' structure due to the weak layers of rock encountered in the dam foundation. Following the efforts on Site, the additional excavation work was completed at the end of February 2016.

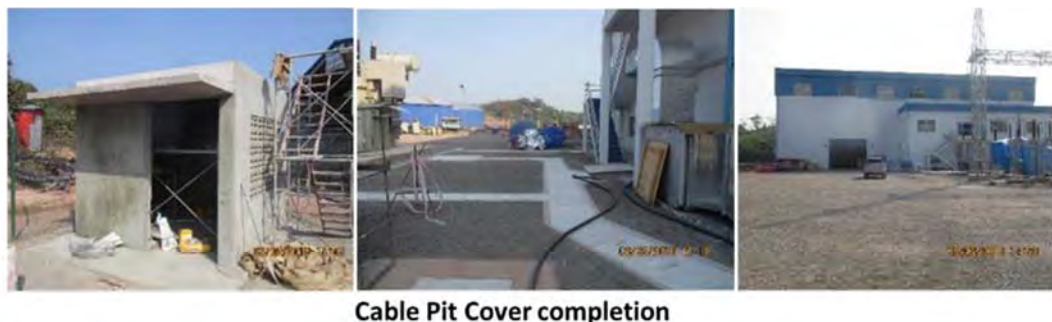
*Figure 2-3: Progress of Re-regulation Dam Powerhouse Works to 30 November 2017*

Structural concrete works were commenced in March 2015, in coordination with installation of the grounding system. The progress of structural concrete works is shown in **Figure 2-3** below

The powerhouse concreting has advanced well and secondary concrete embedment for the draft tube liner was completed at the end of April 2016. The left bank structure was re-designed as roller compacted concrete (RCC) and was completed on 18 March 2016. Installation of the re-regulation waterway gate and stop log and re-regulation intake gate and structural concrete works for the retaining wall to support the substation yard were

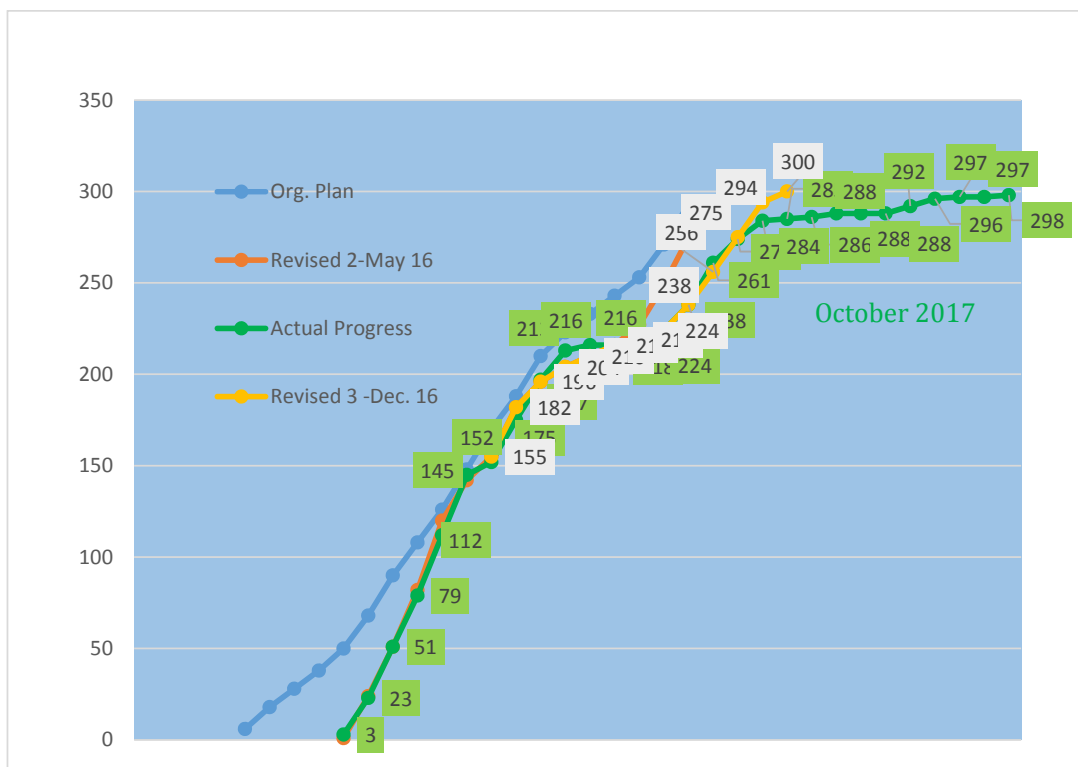
*Figure 2-6: Cumulative Work Progress of Tower Foundation (Original Planned and Actual)*

In respect of the delay to commencement of most works the Contractor is studying its programme to ensure that sufficient resources are committed as the works progress to ensure that completion is achieved in good time. Onset of daily rains has made access to all areas difficult but the Contractor follows its revised acceleration schedule, after the progress for the construction of tower foundations slowed after May, 2016 (See **Figure 2-6** below)

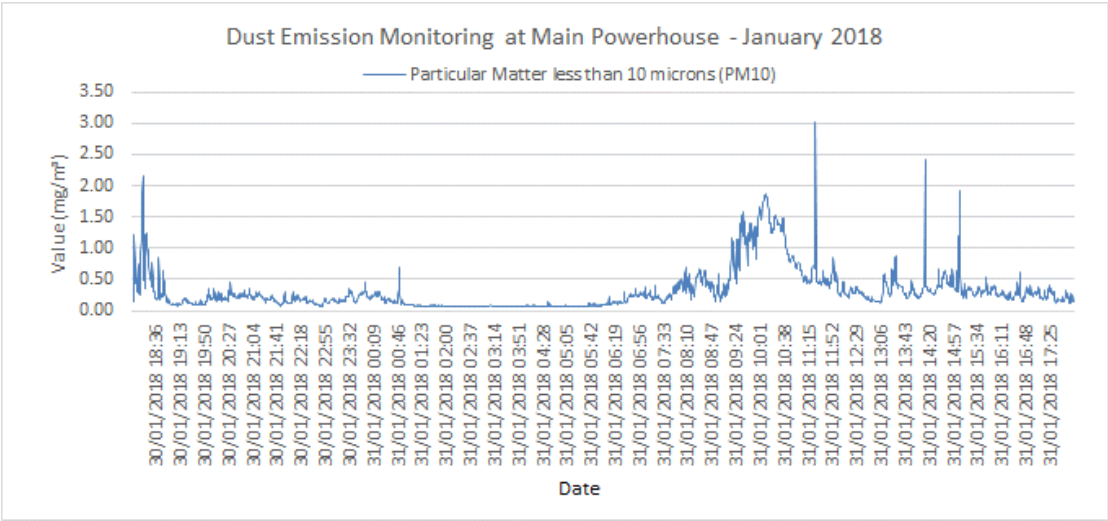
Figure B- 9: Dust Monitoring Results at the Main Powerhouse in January 2018

The monitoring points are indicated on the map in **Figure 1-9**. The results indicate compliance with the National Standard at all monitored stations, except at the Main Powerhouse. All staff were advised to wear dust masks while working in the area. The results are presented in **Annex 2**.

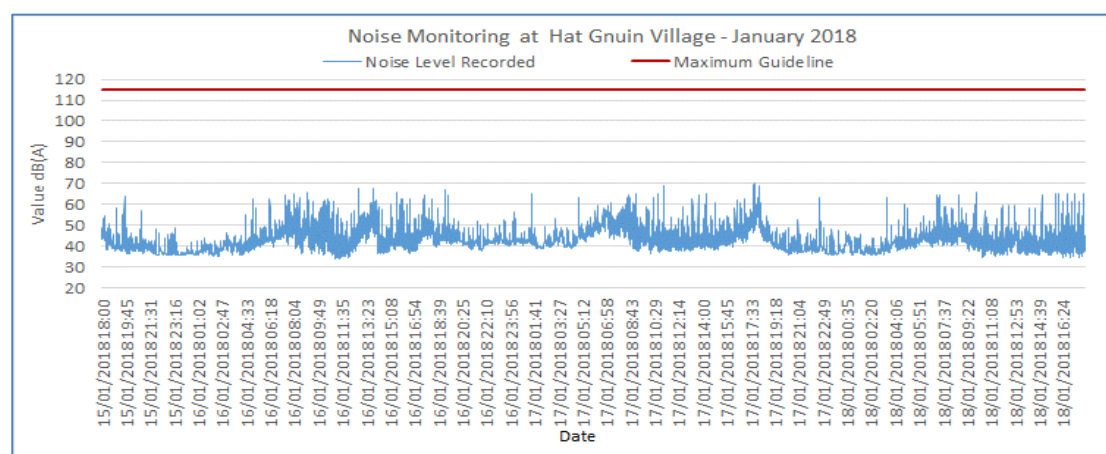
**Figure C- 1: Result of Noise Level Monitoring at Ban Hat Gniun in January 2018**

The results at all stations (except Hat Gniun Village and Main Powerhouse) indicated compliance with National Standard for the period of 06:01-22:00. The noise levels during 06:01-18:00 were higher than the Standard at the Main Powerhouse.

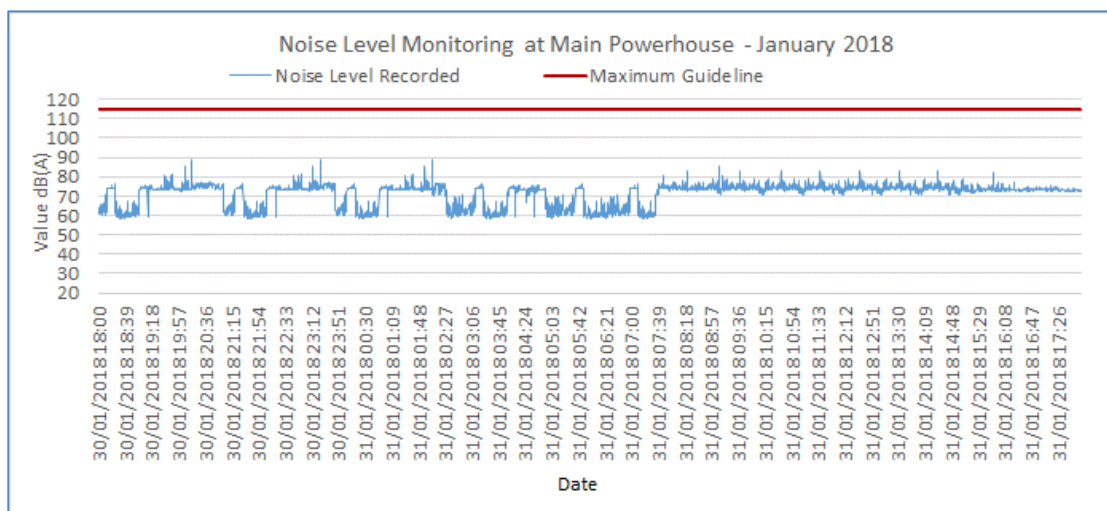
**Figure C- 9: Results of Noise Level Monitoring at Main Powerhouse in January 2018**

Noise Level (dB)	30-31/January/18		31/January/18
	18:00 – 22:00	22:01 – 06:00	06:01-18:00
Data Record Max	89	89	85.5
<b>Guideline Max</b>	<b>115</b>	<b>115</b>	<b>115</b>
Data Record Average	69.49	69.29	72.45
<b>Guideline Averaged</b>	<b>70</b>	<b>70</b>	<b>70</b>
