NAM NGIEP 1
POWER COMPANY

Nam Ngiep 1 Hydropower Project

Environmental Management Monthly Monitoring Report

July 2016

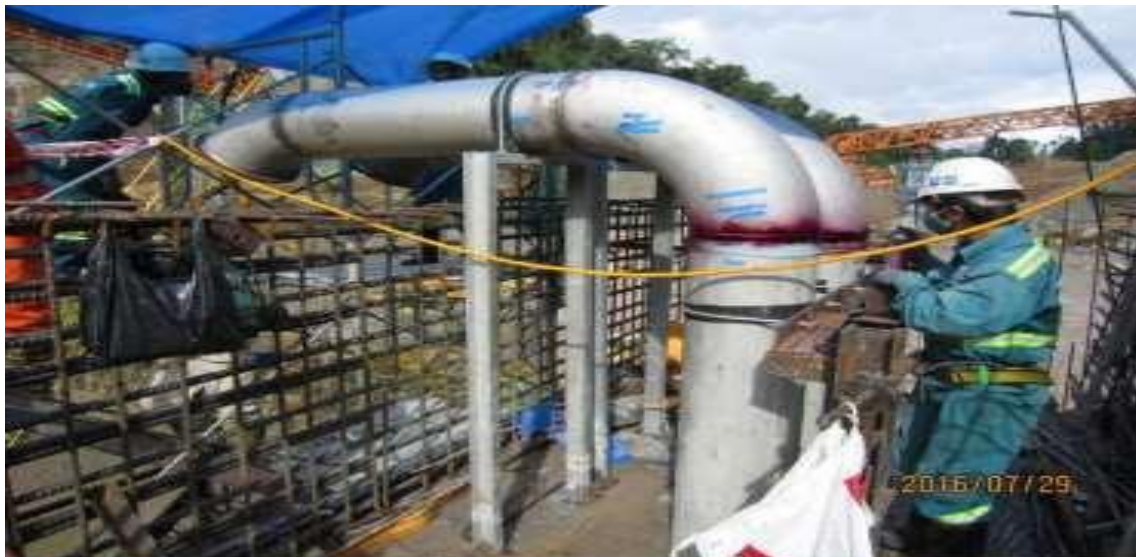
Figure 2-2: Embedded piping installation (Main powerhouse)

- b) Figure 2-2.
- c) The grounding works for the main powerhouse and re-regulation power house are under way in coordination with concrete casting work.

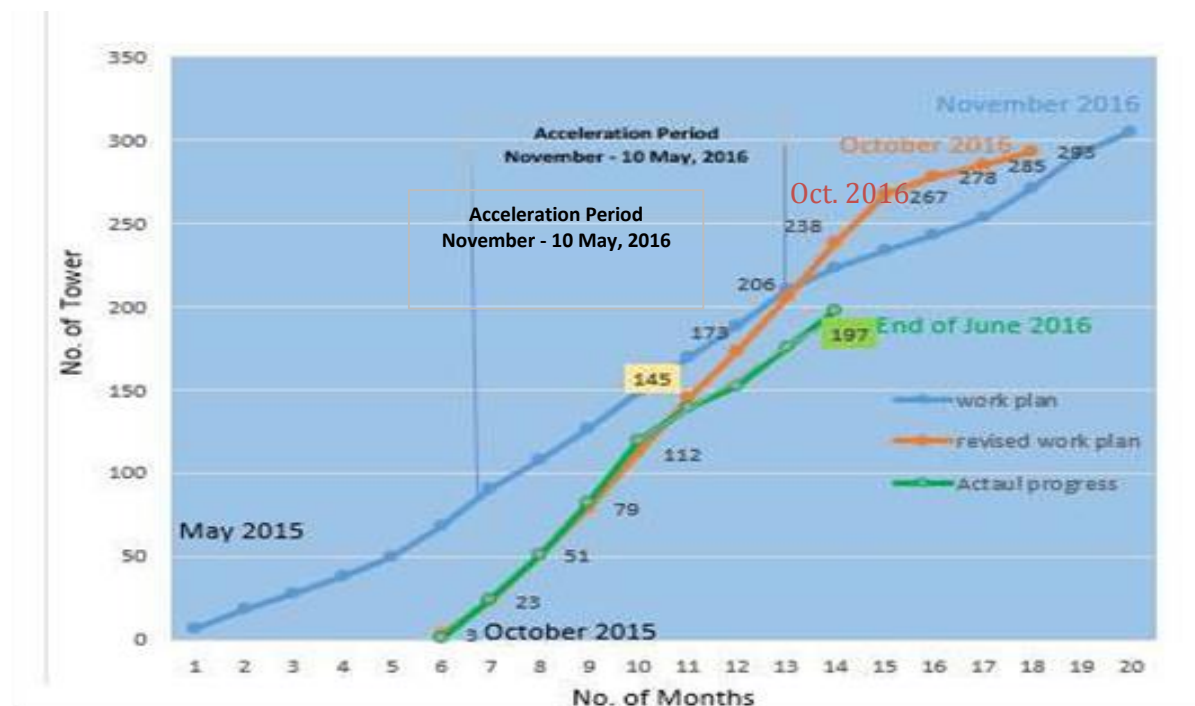
Figure 2-3 Cumulative Work Progress of Tower Installation (Plan and Actual)

- The construction progress by the end of June 2016 is completion of 197 out of an expected total of 293 tower foundations, tower erection of 117 towers and the checking and tightening of bolts and nuts for 98 towers. The progress in July 2016 is on the revised schedule (refer to the Figure 2-2).

In respect of the delay to commencement of most works the Contractor is studying its programme to ensure that sufficient resources are committed as the works progress to ensure that completion is achieved in good time. Onset of daily rains has made access to all areas difficult but the Contractor follows its revised acceleration schedule, after the progress for the construction of tower foundations slowed after April, 2016 (See Figure 2-3 below)

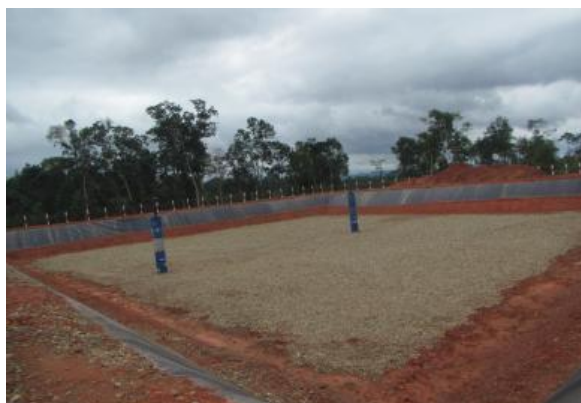
Photograph 1: Construction of the NNP1 landfill waste pit

The construction of the NNP1 Project landfill was substantially completed in July 2016 with some minor activities to be completed such as improving the landfill road surface with sub-base course, concrete lining of the open ditch and removing waste from temporary pits to the new waste pit. The total volume of all waste removed from the temporary pits to the new pit was approximately 800 m³ including soil layers that could not be separated (see Photograph 1 and Photograph 2).
