NAM NGIEP 1
POWER COMPANY

Nam Ngiep 1 Hydropower Project

Environmental Management Monthly Monitoring Report

July 2018

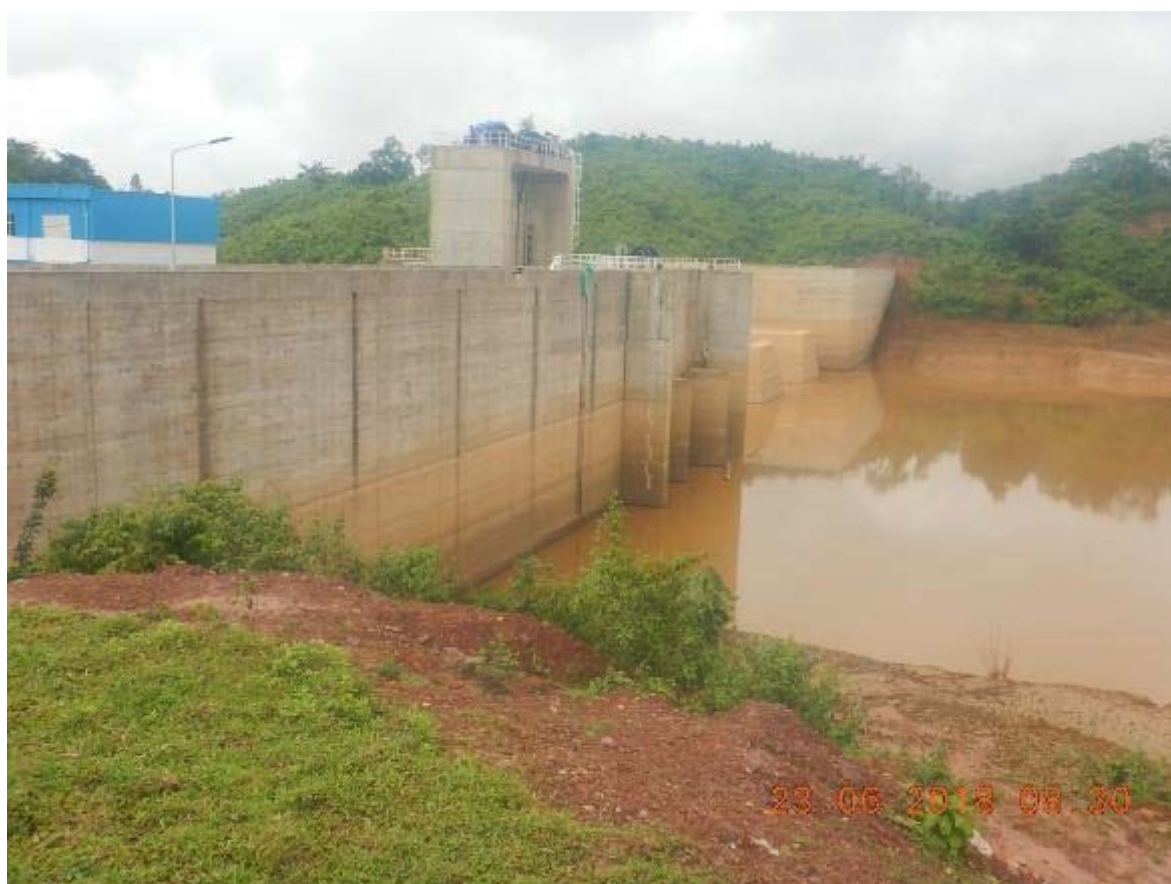
Figure 2-3: Completed Re-regulation Dam and Powerhouse at the End of June 2018

Structural concrete works were commenced in March 2015, in coordination with installation of the grounding system. The progress of structural concrete works is shown in **Figure 2-3** below

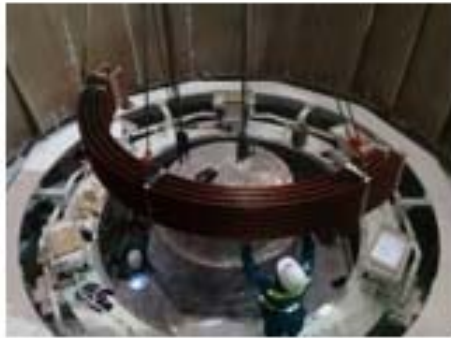
Figure 4.2-7: Lowering and Installing Lower Cooling Coil for Unit 2

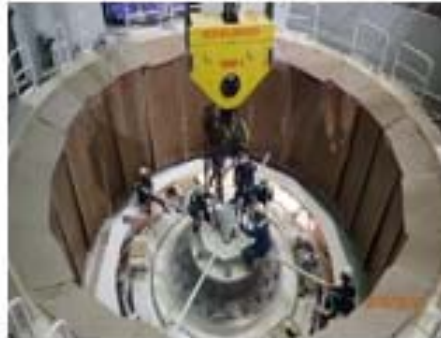
Figure 4.2-8: Run-out Check for Coupling Main Shaft and Lower Shaft for Unit 2

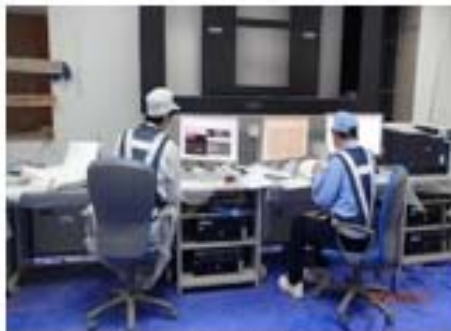
Figure 4.2-9: Commissioning Tests of SCADA System Interface to Remote Control Panels

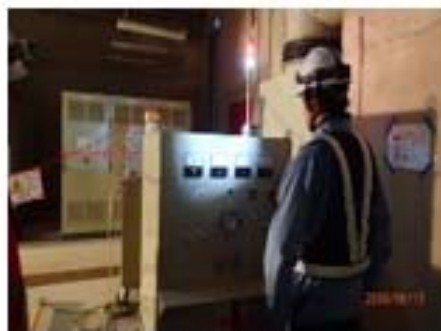
Figure 4.2-10: Dielectric Strength Test for 16.5 kV Disconnecting Switch for Unit 1 & 2

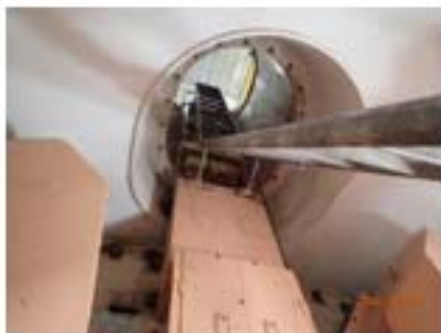
Figure 4.2-11: Installation of Generator Main Lead along Access Shaft

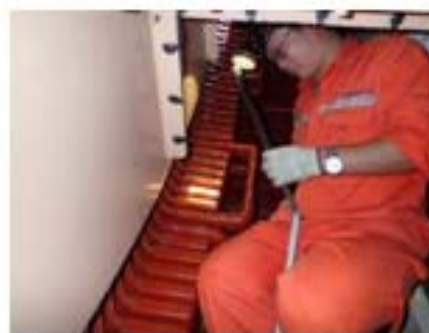
Figure 4.2-12: Inspection of Generator Air Gap between Rotor and Stator
