## Nam Ngiep 1 Hydropower Project

# Environmental Management Monthly Monitoring Report

July 2020

A	15 August 2020	Hendra WINASTU Khamtone SAYSONPHOU	Wanidaporn RODE	Khamlar PHONSAVAT	Final
REV	DATE	AUTHOR	CHECKED	APPROVED	MODIFICATION DETAILS
<u>Accessibility</u>		<b>Document No.</b>  <b>NNP1-C-J0904-RP-067-A</b>			
<input checked="" type="checkbox"/>	Public				
<input type="checkbox"/>	Internal				
<input type="checkbox"/>	Confidential

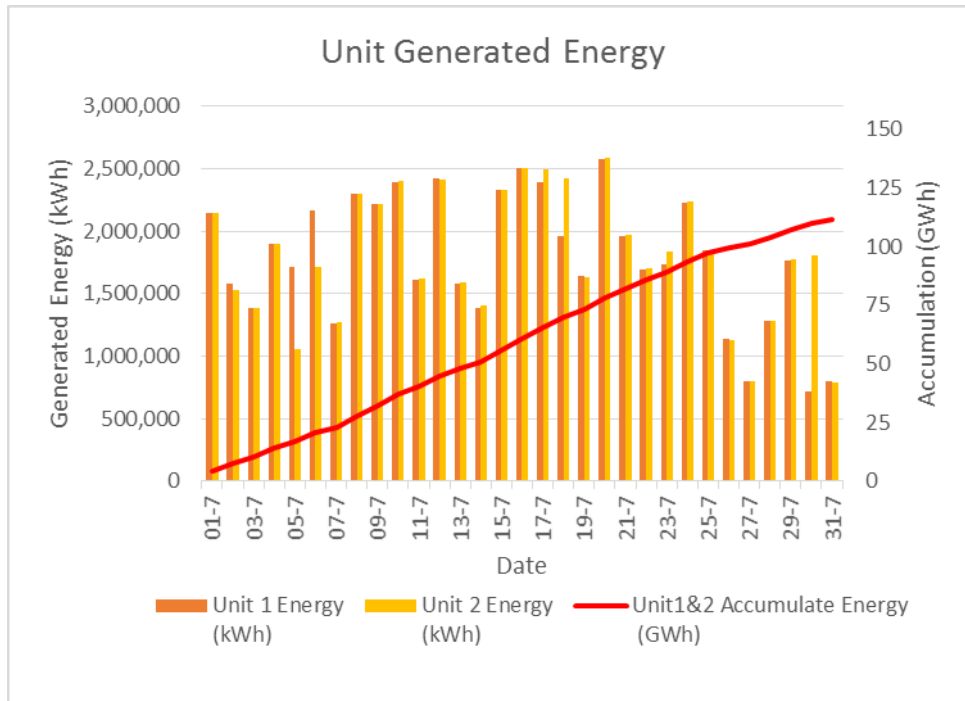
**FIGURE 2-1: UNIT GENERATED ENERGY (MAIN POWER STATION)**

**Figure 2.1** and **Figure 2.2** shows the generation data at the main power station in July 2020. The generation was higher than the previous month.

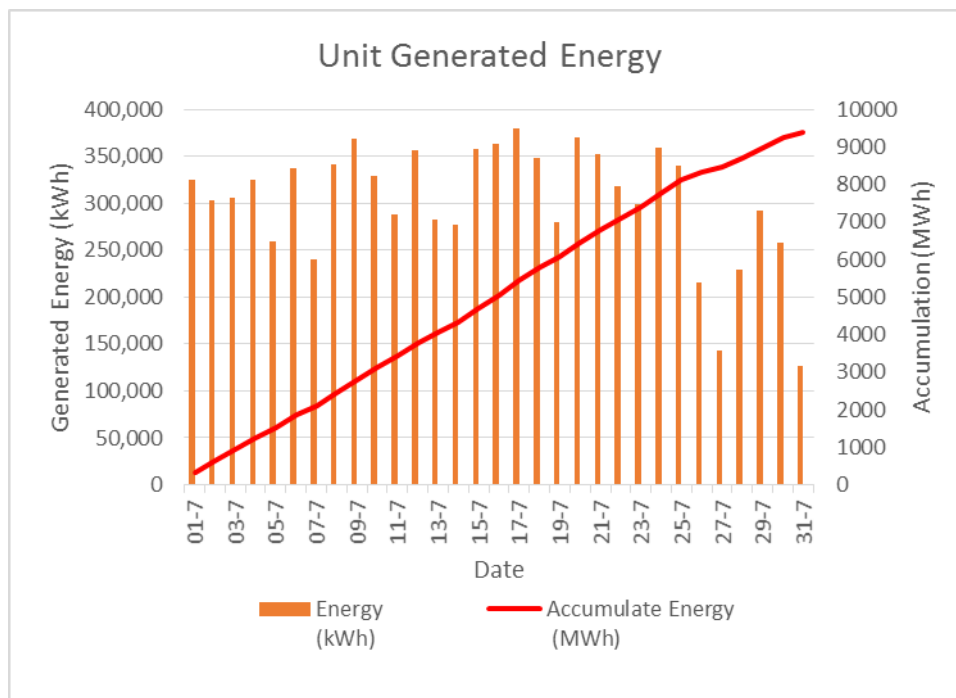
**FIGURE 2-3: UNIT GENERATED ENERGY (RE-REGULATION POWER STATION)**

**Figures 2-3** and **2-4** shows the generation data at the re-regulation power station in July 2020. The generation and operation time are affected by the operations of the main power station according to EGAT PPA. So, the amount of inflow is determined by the operation resulting at the main power station. Notwithstanding, even if the main power station is stopped, the specified 27 m<sup>3</sup>/sec water from re-regulation power station must be discharged to downstream.

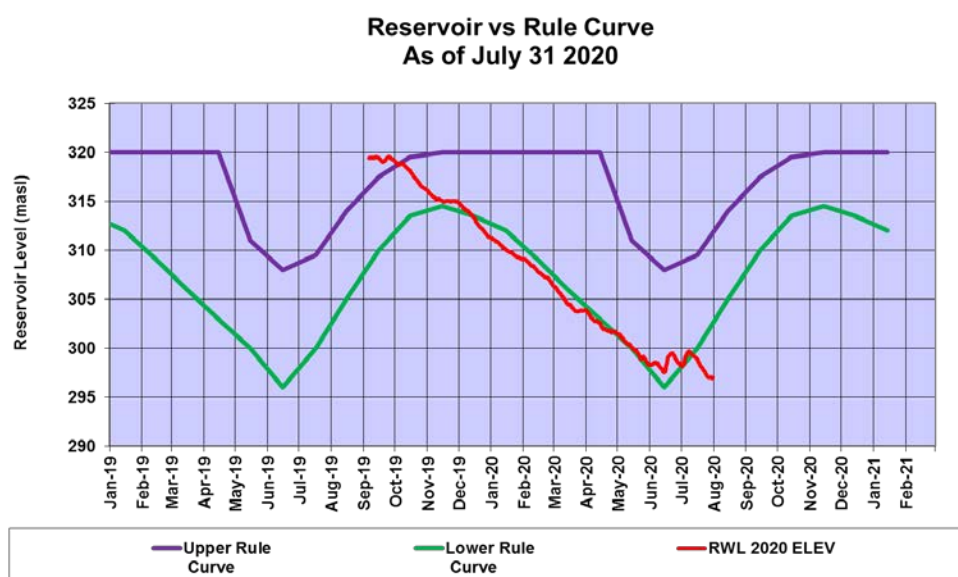
**FIGURE 2-5: DAM RESERVOIR LEVEL**

Actual dam water level decreased from the middle of July 2020 due to small amount of rain.

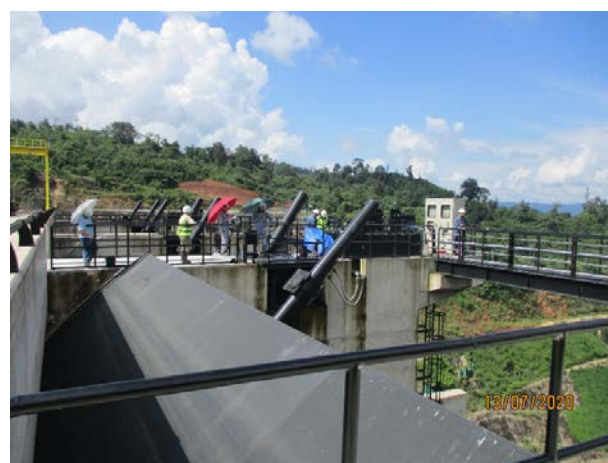
**FIGURE 2-6: SPILLWAY GATE OPERATION WITH EGAT –PPA TEAM**

1. Annual inspection test of Main Dam Spillway gates with EGAT PPA team to confirm an operation condition was conducted on 13 July 2020.
2. Carry out a monthly operation test for main facilities such as spillway gate, Gantry of intake gate at Main Dam, gantry of draft gate at Main Power house.
3. Carry out Main Dam, Re-regulation Dam facilities monitoring by weekly basis

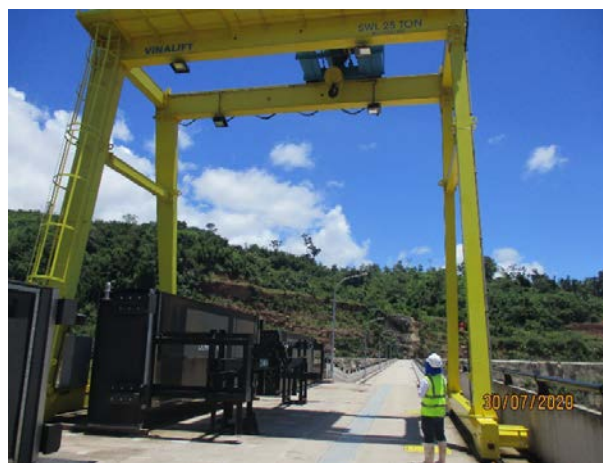
**FIGURE 2-7: OPERATION TEST OF GANTRY CRANE OF INTAKE GATE OF MAIN DAM**

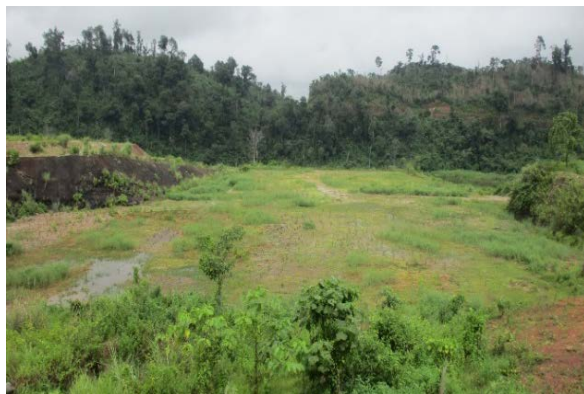
**FIGURE 2-10: RE-VEGETATION OF RCC PLANT YARD**

Demobilization of plant facilities for both RCC and CVC plants was completed in December 2019. The vegetation improvement for rehabilitation of those areas is ongoing.

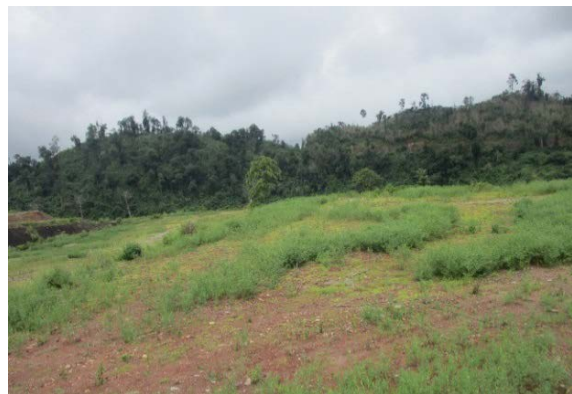
**FIGURE 2-11: RE-VEGETATION OF CVC PLANT YARD**

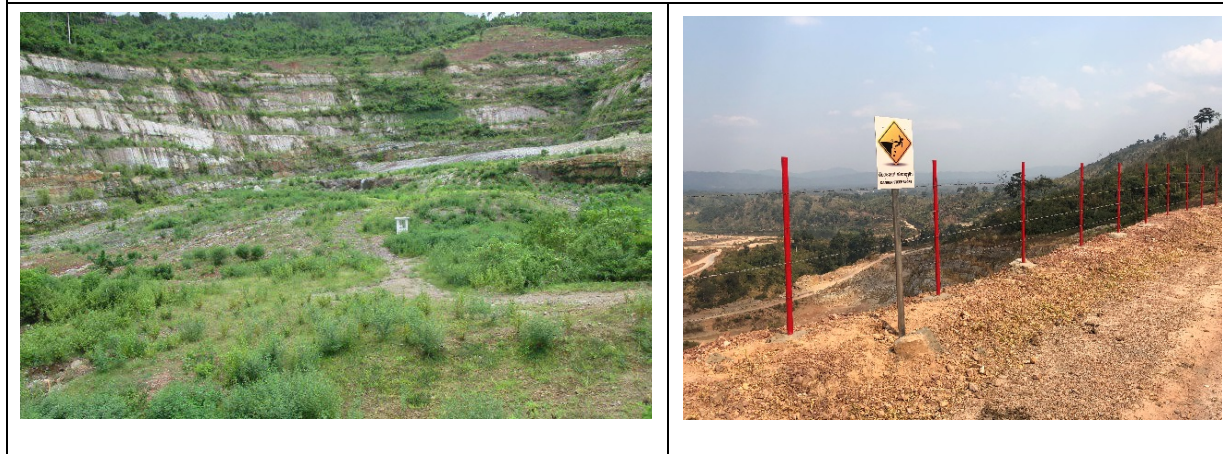
**FIGURE 2-12: QUARRY AREA VIEW SHOWING RE-VEGETATION AND SAFETY FENCE INSTALLATION**

The final blasting was carried out 27 March 2018. GOL have acknowledged that the quarry operation is complete. After several inspections by GOL and ADB for the Lenders, the quarry site has been improved by such as partial levelling, vegetation at the berms of slopes and large rock installation at top of slopes from an environmental and a safety point of view. Fence for safety was installed at top slope at right side. The grading at the quarry bottom and spreading of top soil was completed in January 2020.

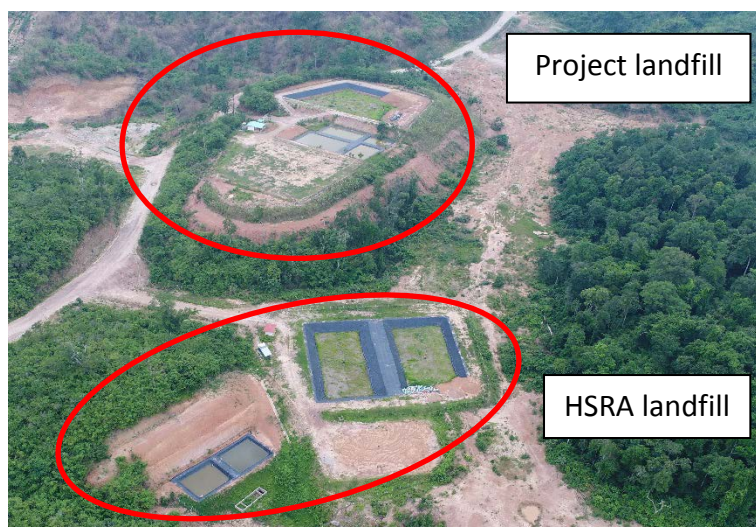
**FIGURE 2-13: PHASE 2 OF PROJECT LANDFILL DEVELOPMENT ON 08 JUNE 2017**

#### CURRENT CONDITION OF LANDFILL

The operation of both HSRA and Project landfills is ongoing with collection waste materials from Resettlement “Phouhomxay”, neighbour villages and the Owner Site Office and Village.

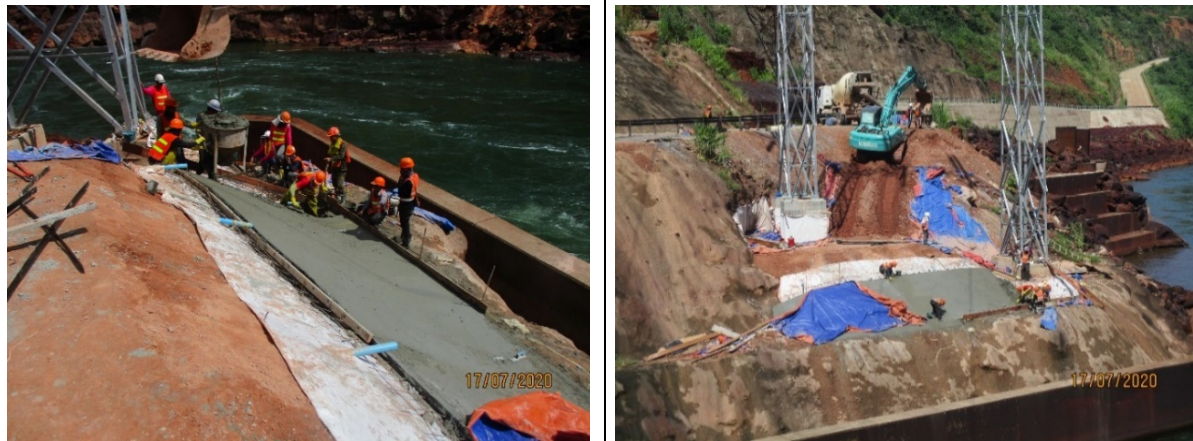
The Tower No.1 was damaged due to the slope failure of approximately 150 m<sup>3</sup> volume of material above and behind Tower No.1 that occurred overnight on 17 to 18 of August 2019. Some of the structural steel members of the Tower No.1 were deformed. Tower No.1 did not move significantly but remained an unsafe structure. Movement of the upper part of the steel structure of the tower was observed.

**FIGURE 2-15: TOP VIEW OF GANTRY STRUCTURE \_ SLOPE PROTECTION AROUND FOUNDATION ONGOING**

Therefore, a Temporary Tower No.1 was constructed and the transmission line was moved to it from the damaged tower over the period 06 to 24 September 2019. The construction of the permanent Replacement Tower No.1, disassembly of existing Tower No.1 was contracted in late December 2019. The foundation excavation of legs for new Tower No.1 started in the middle of January 2020 and was completed on February 2020; the damaged Tower No.1 was almost dismantled in January 2020. The installation of gantry structure and new Tower No.1 was completed in the beginning of April 2020. Energization test was completed on 30 April 2020. Remaining works including slope protection around the Tower will be completed by August 2020 because earth work and concrete placement could not be done due to rain.

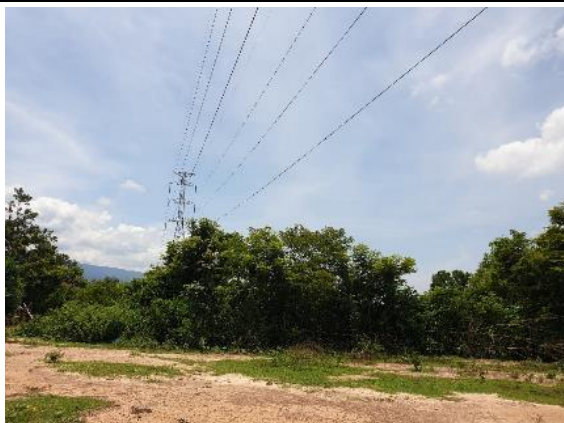
**FIGURE 2-17: CUTTING HIGH TREES UNDER TRANSMISSION LINES**

1. Checking of Access road condition,
2. Cutting high trees and cleaning vines climbing on towers, and
3. Fixing and replacement of stolen bolts, nuts and some part members.

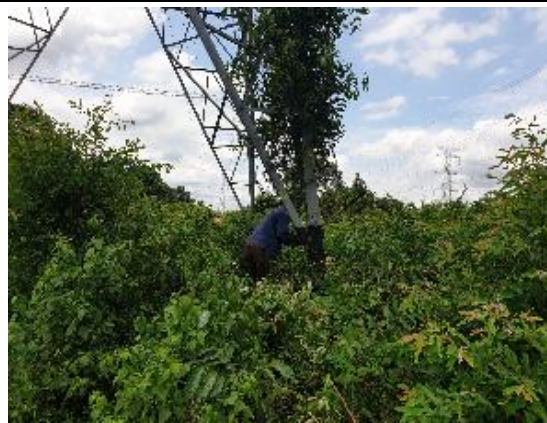
**FIGURE 2-18: CLEANING VINES CLIMBING ON TOWERS**

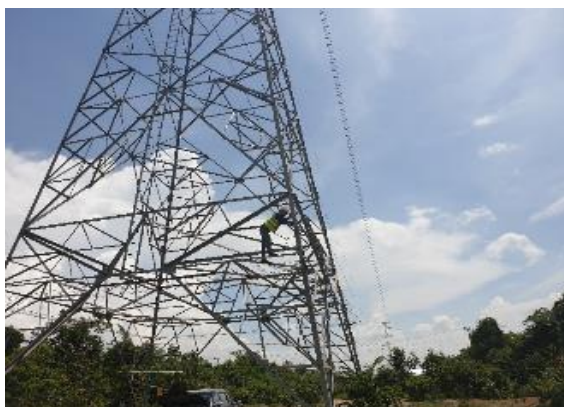
**FIGURE 2-19: FIXING AND REPLACEMENT OF STOLEN PARTS (BOLT\_NUT)**

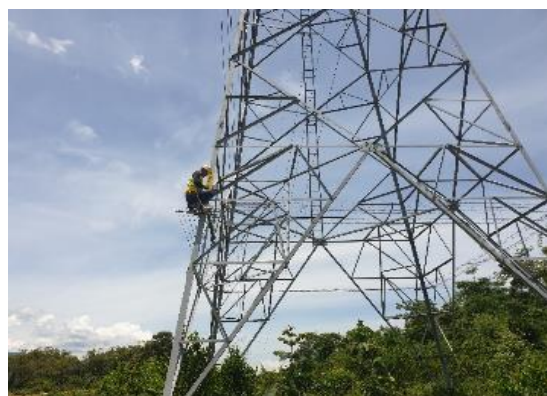
**FIGURE 2-20: FIXING AND REPLACEMENT OF STOLEN PART MEMBERS**

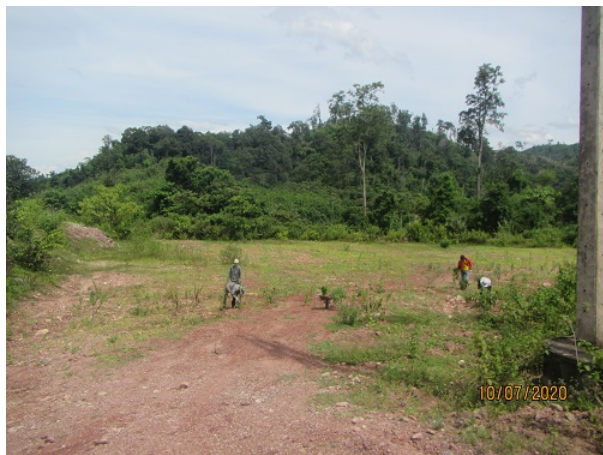
<b>V&amp;K camp</b> Local grass species were additionally planted

At 03 sites (spoil disposal area no.8, V&K camp and the main quarry) out of 08 revegetated sites, where the green cover is less than 70%, the Civil Works Contractor planted additional local grass species. Appropriate counter measures will continue to be implemented on the remaining 05 sites (ZHEFU camp, Spoil No.2, RCC plant, CVC plant and Song Da5 magazine) to ensure the green cover of at least 70% by the end of wet season 2020.

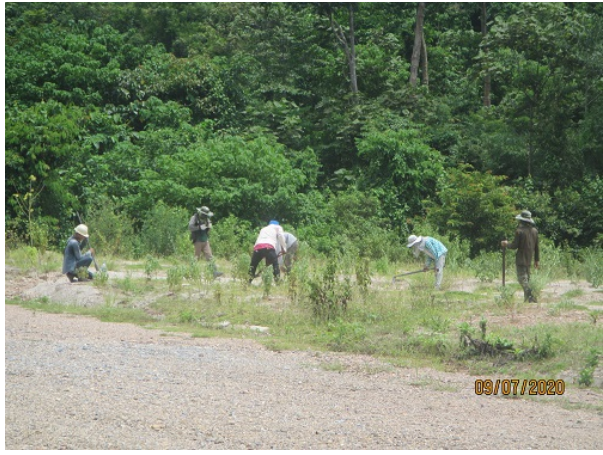
<b>SPOIL DISPOSAL AREA NO.8</b> Local grass species were additionally planted

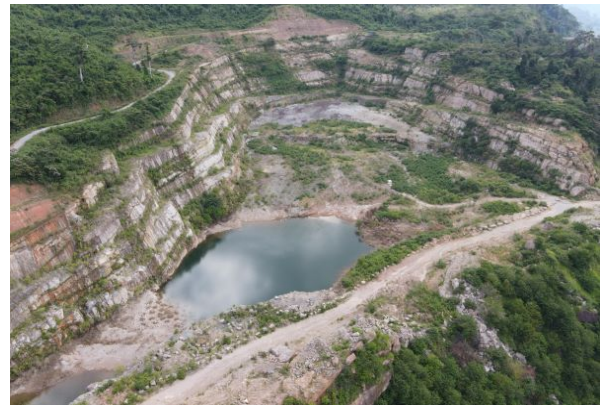
<b>MAIN QUARRY (TOP VIEW)</b>

**FIGURE 3-1: ADDITIONAL COUNTER MEASURES FOR THE SITE REHABILITATION IN JULY 2020**

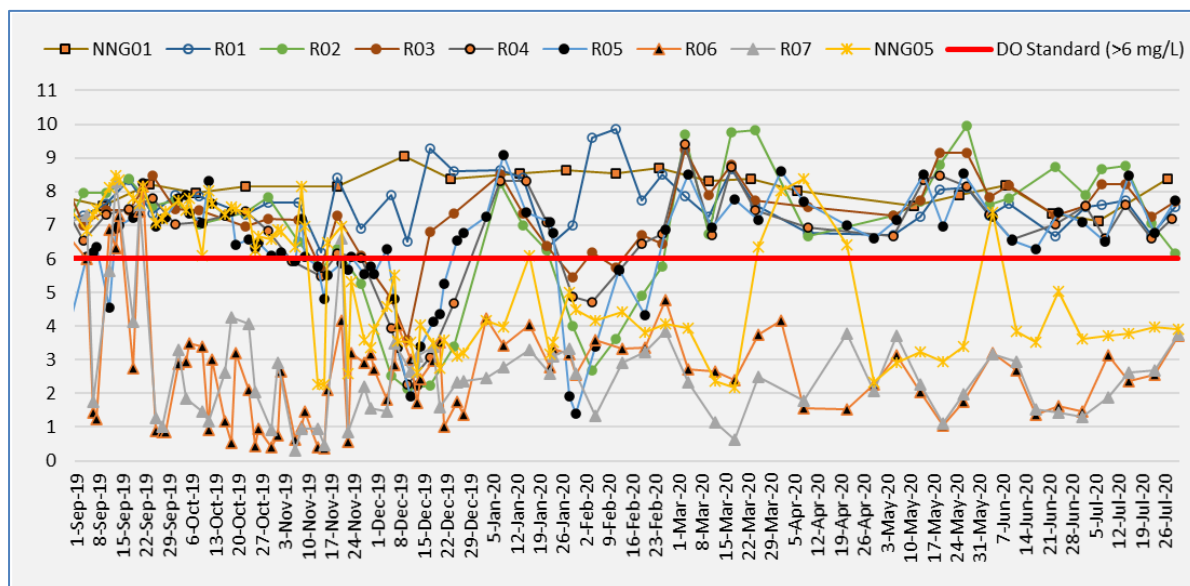
**FIGURE 3-3: Concentration of Dissolved Oxygen in the Upper 0.2 m since September 2019 to July 2020**

During the month, Dissolved Oxygen (DO) levels at the surface of the main reservoir (R1, R2, R3, R4 and R5) were generally between 6 and 8 mg/L. In the re-regulation reservoir (R6 and R7), the DO levels were below 4 mg/L.

The discharge from the re-regulation dam went through the turbines during the monitoring missions, similar to June 2020, and the DO levels were below 6 mg/L at Nam Ngiep downstream stations (except on 15 and 30 July 2020 at NNG08). However, same as the previous months with the same range of DO levels, no dead fish was observed during this monitoring period. NNP1PC is in the process of collecting information to assist in the design of additional aeration structures to improve the DO level downstream.

During July 2020, the discharge from the re-regulation dam was through the turbines. All DO concentrations (except on 15 and 30 July 2020 at NNG08) were less than 6 mg/L at the Nam Ngiep downstream stations and thus are non-compliant with the GoL Standard. No dead fish were observed in Nam Ngiep downstream during the periods with low DO. NNP1PC is in the process of collecting information to assist in the design of additional aeration structure to improve the DO level downstream.

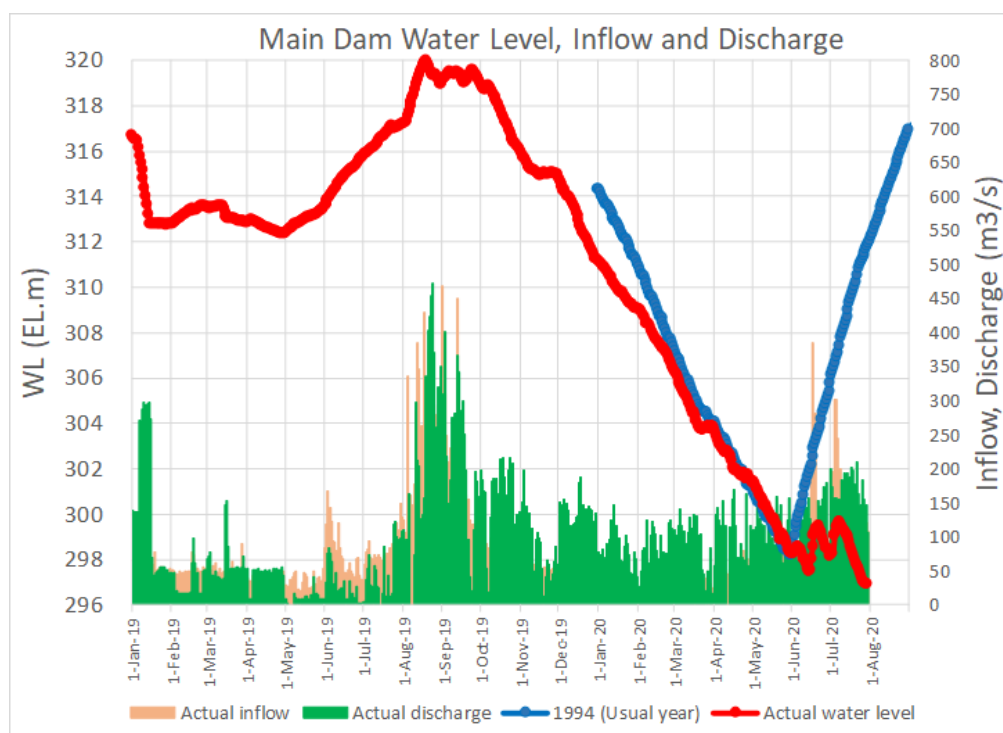
**FIGURE 3-4: WATER LEVEL, INFLOW AND DISCHARGE FOR THE MAIN RESERVOIR**

In July 2020, the turbine discharges from the main powerhouse varied between 70 m<sup>3</sup>/s and 227 m<sup>3</sup>/s and usually interrupted by night-time periods with no discharge.

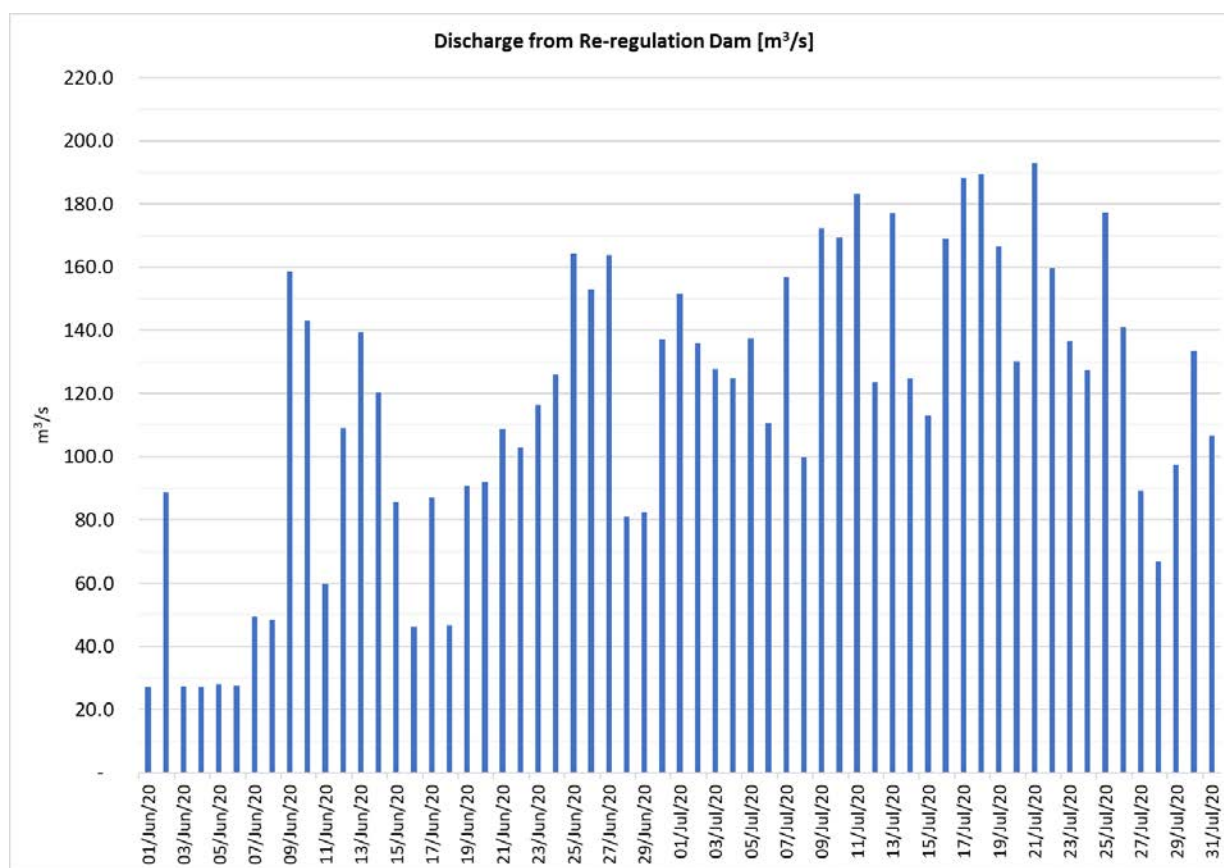
**FIGURE 3-5: DISCHARGE MONITORING AT THE RE-REGULATION DAM IN JUNE AND JULY 2020**

The discharge monitoring data for the re-regulation dam during June and July 2020 is presented in Figure 3-5.

The changes in the discharge from the re-regulation dam were informed in advance to the RMU and to the heads of the downstream villages, who then announced the changes to the communities over the village speaker systems.
