Nam Ngiep 1 Hydropower Project

Environmental Management Monthly Monitoring Report

June 2016

A	23 May 2016	Viengkeo Phetnavongxay	Peter G. Jensen	Prapant PanARam	
REV	DATE	AUTHOR	CHECKED	APPROVED	MODIFICATION DETAILS
<u>Accessibility</u>		Document No. NNP1-C-J0904-RP-018-A			
<input checked="" type="checkbox"/>	Public				
<input type="checkbox"/>	Internal				
<input type="checkbox"/>	Confidential

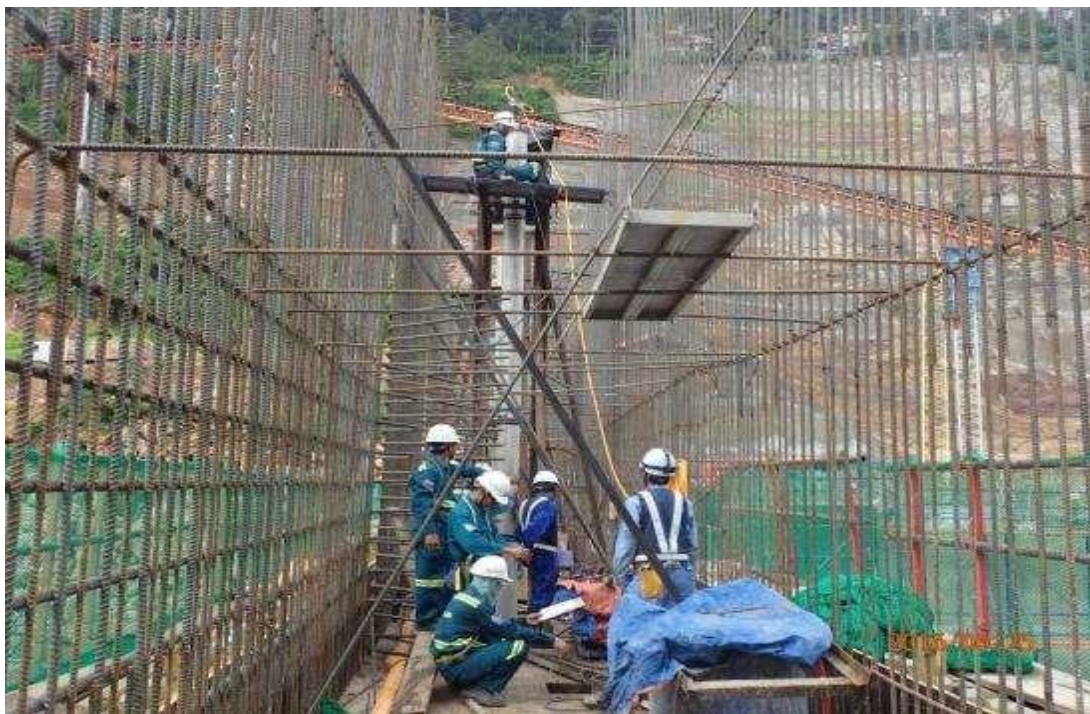
Figure 2-3: Embedded piping installation (Main powerhouse)

- c) The grounding works for the main powerhouse and re-regulation power house are under way in coordination with concrete casting work.
