Nam Ngiep 1 Hydropower Project

Environmental Management Monthly Monitoring Report

June 2017

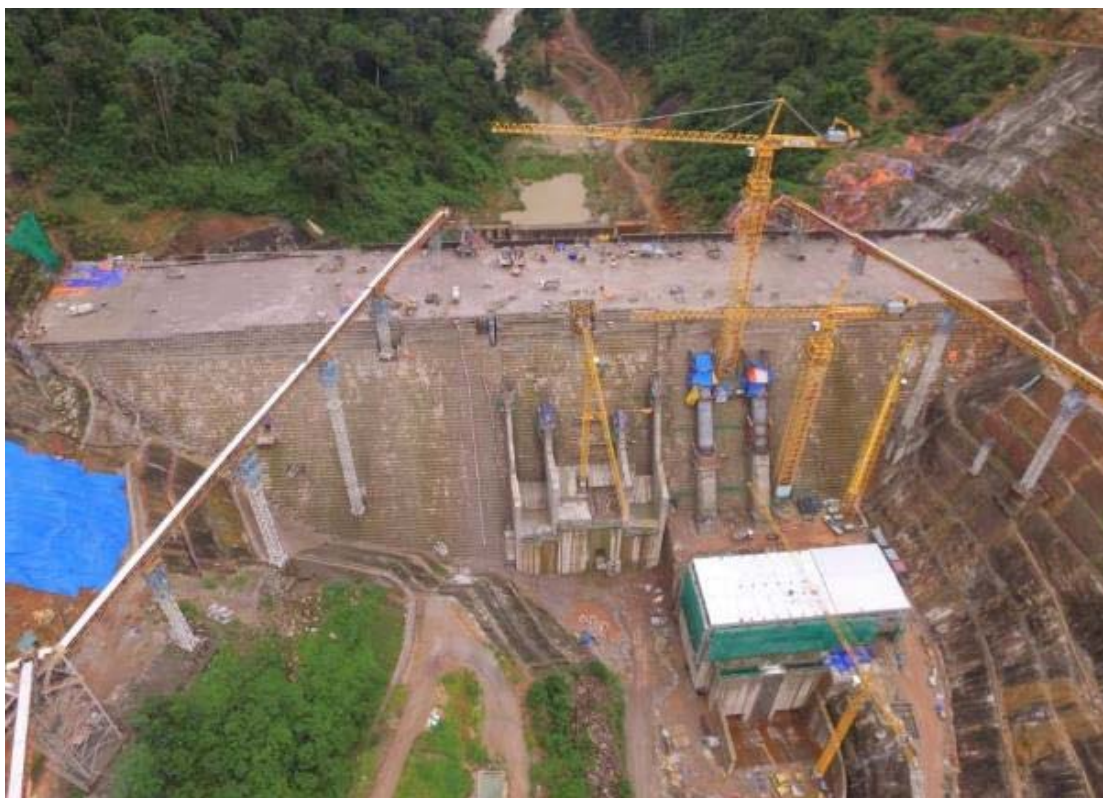
Figure 2-2: Main Dam and Powerhouse from Overhead Looking Upstream

After starting the main dam excavation works in October 2014 on the left bank, the works were about one month advanced when diversion of the Nam Ngiep River was achieved at the end of October 2015. However, excavated volumes were 20% greater than expected and part of this additional work is necessary to construct a 'shear key' structure due to the weak layers of rock encountered in the dam foundation. Following the efforts on Site, the additional excavation work was completed at the end of February 2016.

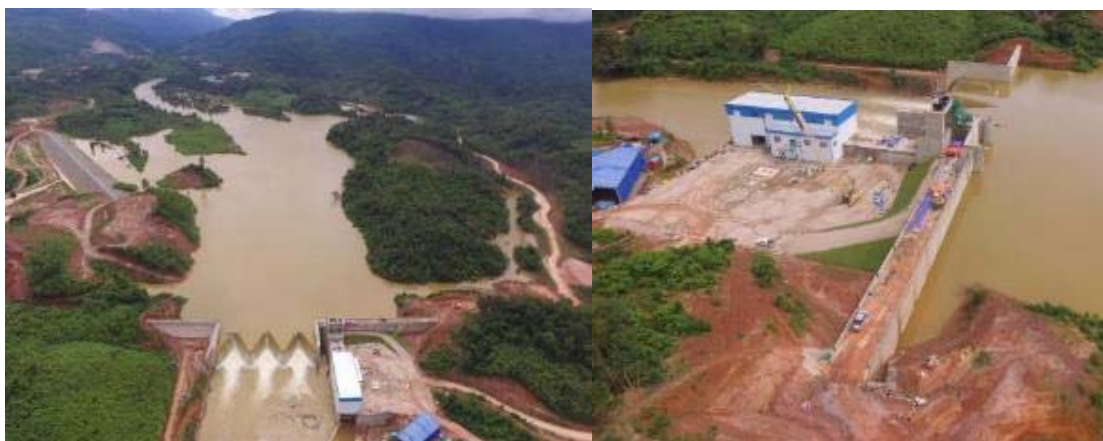
The powerhouse concreting has advanced well and secondary concrete embedment for the draft tube liner was completed at the end of April 2016. The left bank structure was re-designed as roller compacted concrete (RCC) and was completed on 18 March 2016. Installation of the re-regulation waterway gate and stop log and re-regulation intake gate and structural concrete works for the retaining wall to support the substation yard were completed in October 2016. Building superstructure work continued for the powerhouse with the commencement of construction of concrete columns.

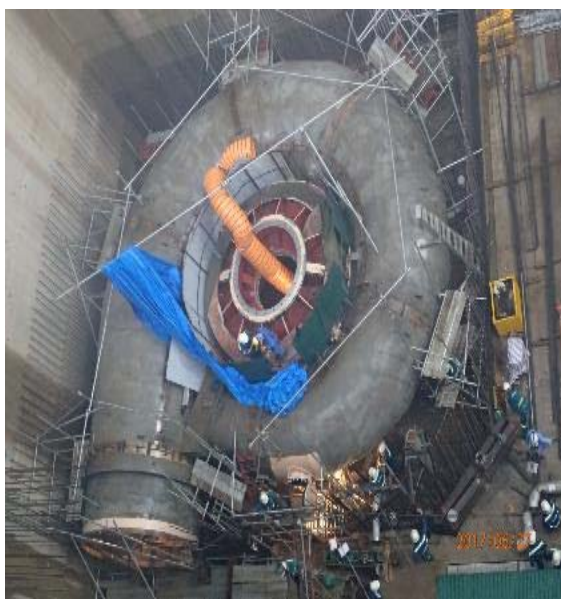
Figure 2-4: Preparation for installation of stay ring OHTC for unit 1 at the main powerhouse

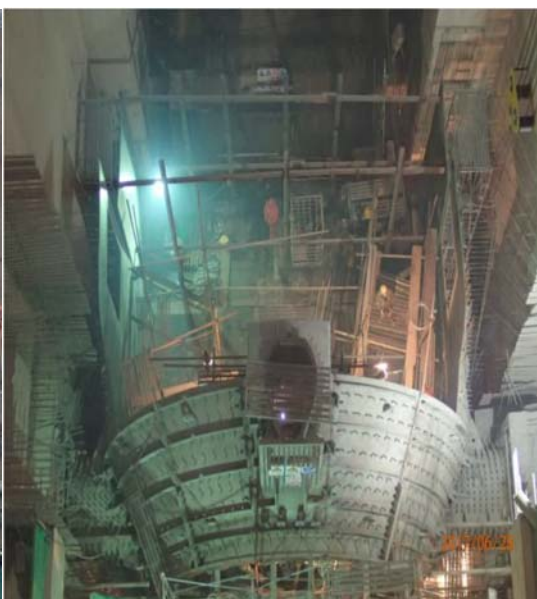
Figure 2-5: Preparation for Installation of Stay Cone at the re-regulation powerhouse

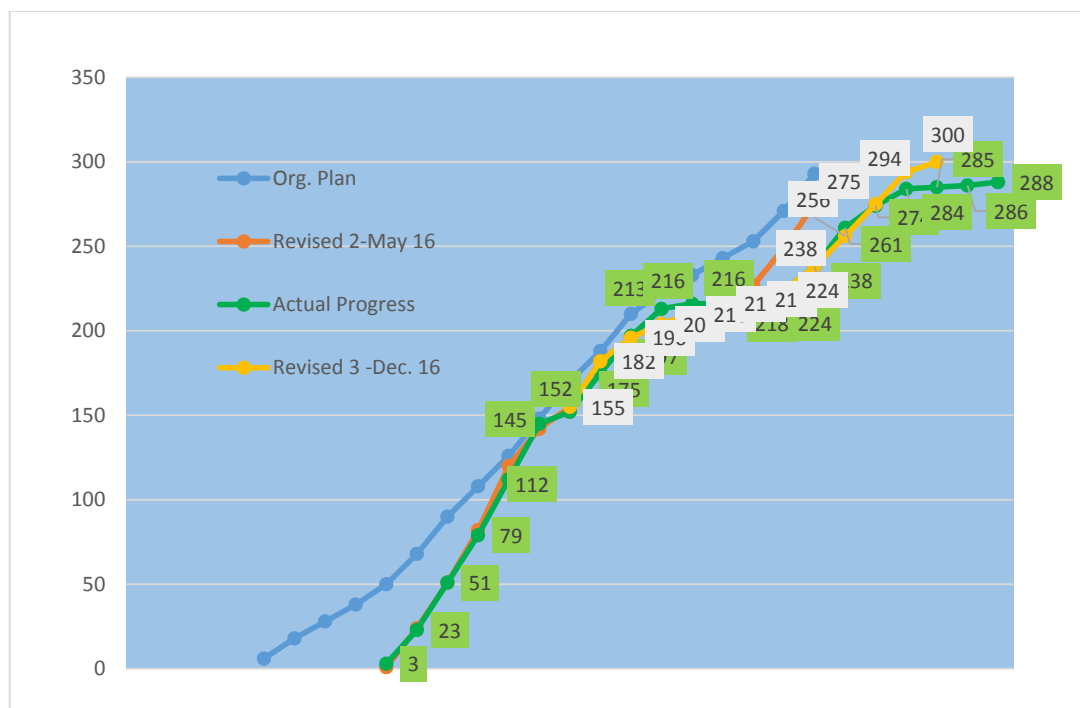
In respect of the delay to commencement of most works the Contractor is studying its programme to ensure that sufficient resources are committed as the works progress to ensure that completion is achieved in good time. Onset of daily rains has made access to all areas difficult but the Contractor follows its revised acceleration schedule, after the progress for the construction of tower foundations slowed after May, 2016 (See **Error! Reference source not found.6** below)

Figure 2-6: Cumulative Work Progress of Tower Foundation (Original Planned and Actual)

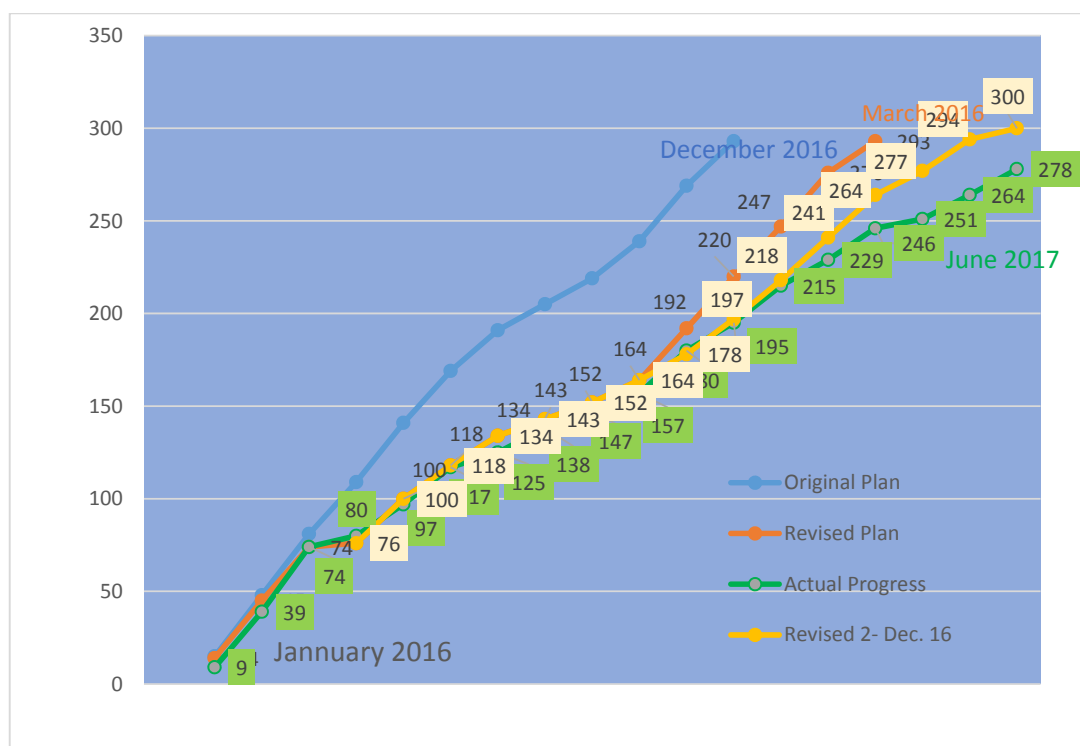
Figure 2-7: Cumulative Works Progress of tower foundation (Revised Planned & Actual)

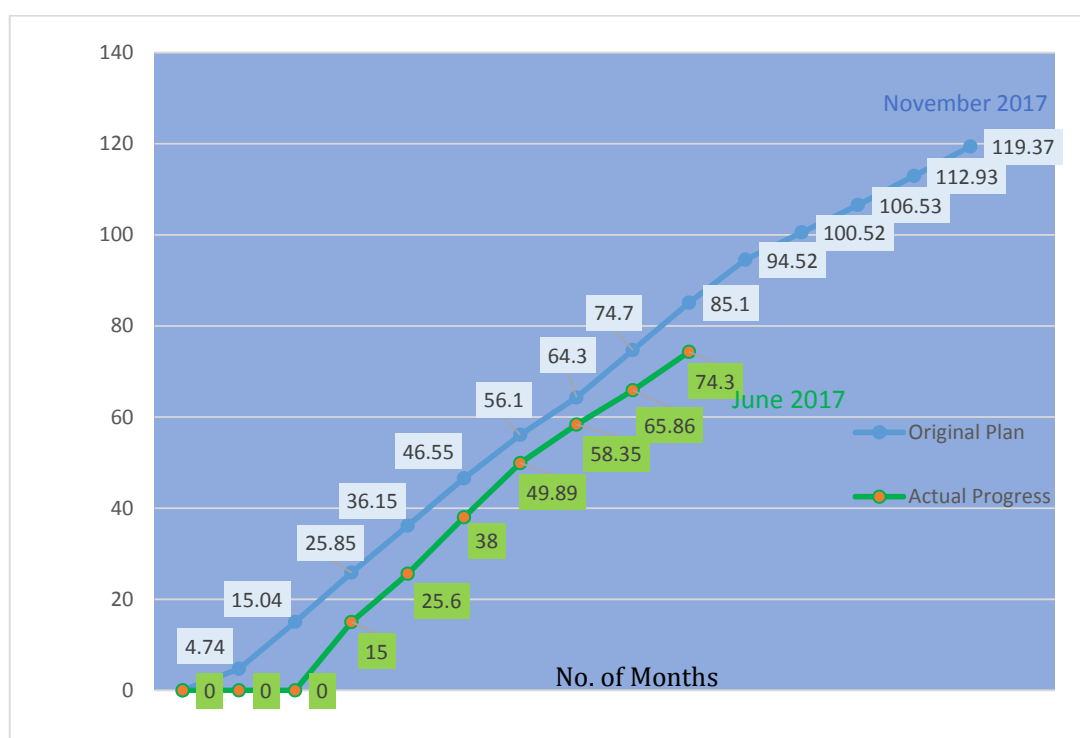
Figure 2-8: Revised Cumulative Works Progress of Tower Erection (Planned & Actual)

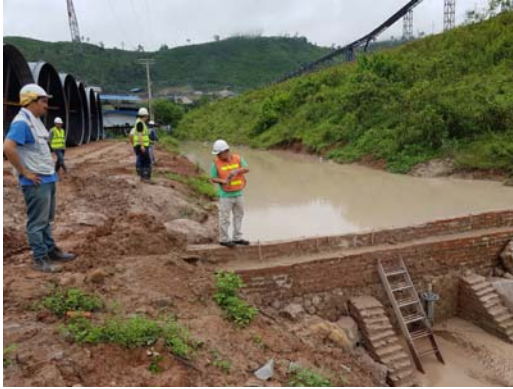
Photograph 1: EMU Inspected The RCC Plant's Sediment Ponds on 15 June 2017

Aggregate Crushing Plant	<ul style="list-style-type: none"> - Inadequate maintenance and implementation of agreed corrective actions on controlling the sediment pond at the Aggregate Plant below the Spoil Disposal Area No.7; - Improper monitoring and maintenance of the said sediment pond resulted in leakage of turbid water from the sediment pond into Nam Ngiep River. This is a serious non-compliance with CA Annex C and ESMMP-CP 2014 (NCR_OC-0013). <p>First inspection: 08 November 2016 Latest inspection: 28 June 2017</p>	NCR-2 (Closure Pending)	<p>During the Bi-Weekly Joint Site Inspection on 20 June 2017, the Contractor was asked to respond to the NCR by incorporating additional work done and propose long term operation and management measures by 04 July 2017.</p> <p>A high-level management meeting between NNP1PC and the contractor will be held on 7 July 2017 to further discuss mitigation measures to close this pending issue.</p>

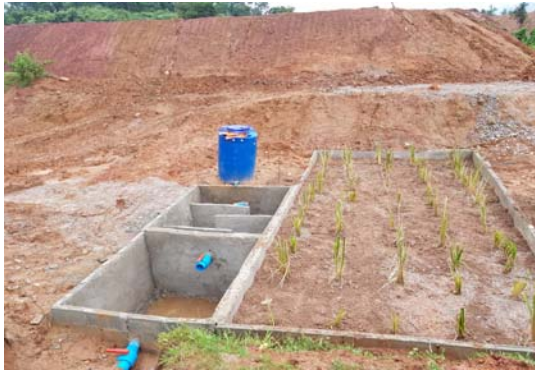
Photograph 3: Joint inspection of the new constructed WWTS of TCM/GFE Camps on 10 June 2017

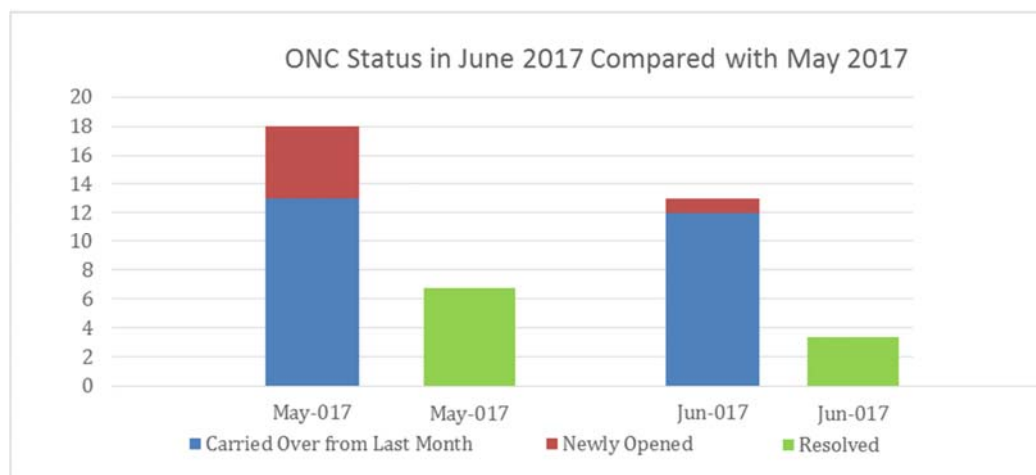
Items	ONC	NCR-1	NCR-2	NCR-3
Carried Over from the Last Month (May 2017)	12	2	2	1
Newly Opened in this Month (June 2017)	1	0	0	0
Resolved in this Month (June 2017)	3	1	1	0
Carried over into next Month (July 2017)	10	1	1	1
Unsolved exceeding deadline	10	1	1	1

Figure 3-3: Observations of non-compliance (ONCs) in June 2017 Compared with May 2017

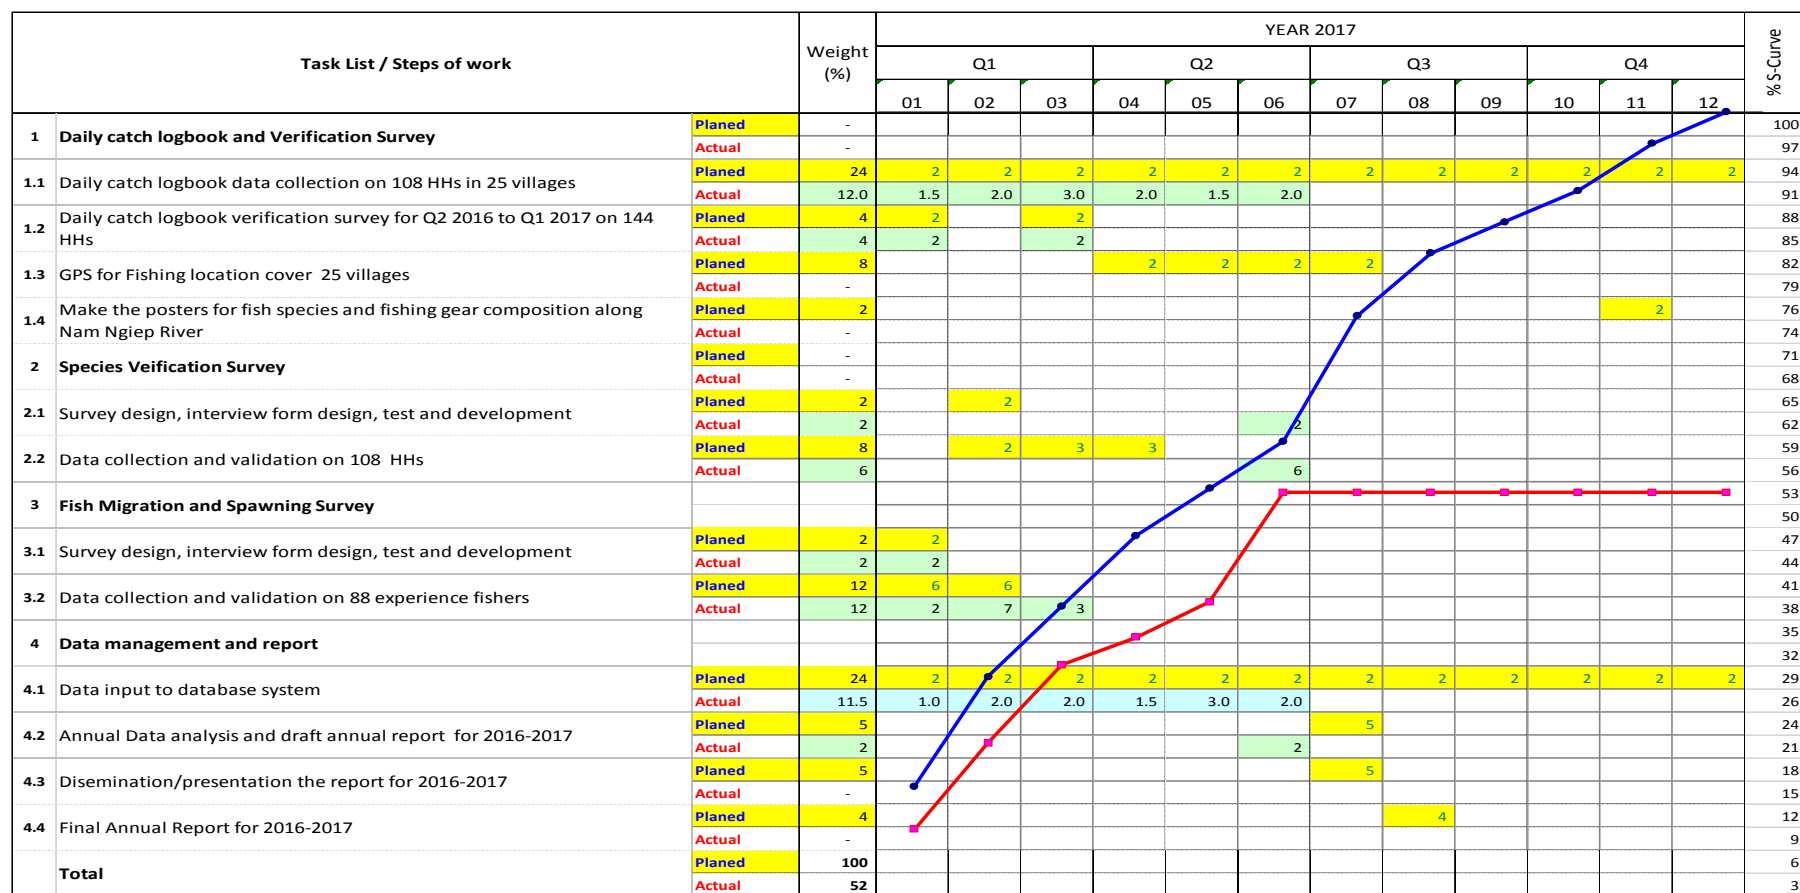
Figure 3-29: Gantt Chart of Fish Monitoring Programme as of 30 June 2017

The blue line and yellow highlights represent the planned activity, and the red line and green highlight represent the actual progress

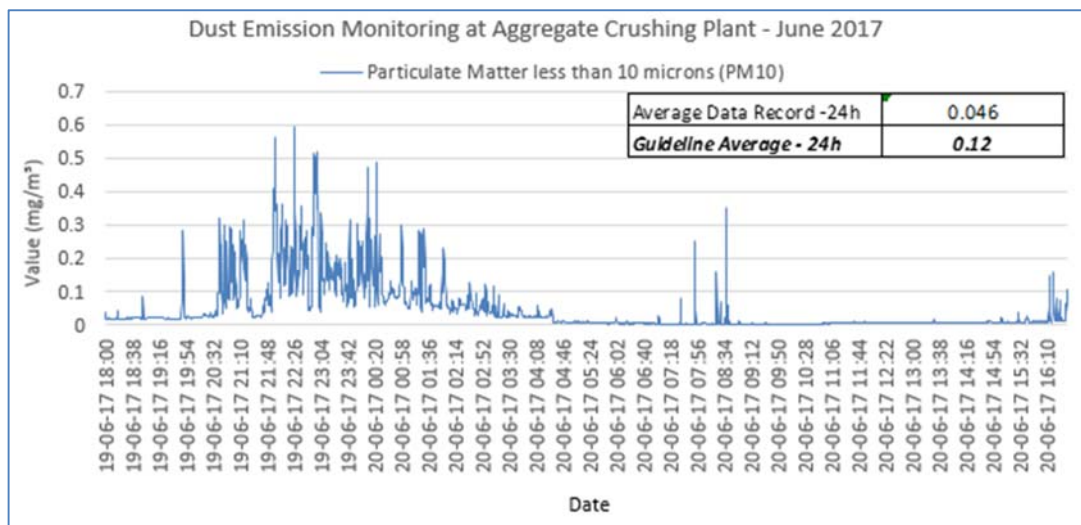
The monitoring points are indicated on the map in *Error! Reference source not found..* Most of dust measurements complied with the National Standard, except at the Aggregate Crushing Plant, Sino Hydro Temporary Worker Camp and RCC Plant. Staff have been advised to wear dust masks while working in the areas at risk. The results are presented in **Annex 2**.

Figure B- 3: Dust Monitoring Results at the Aggregate Crushing Plant in June 2017

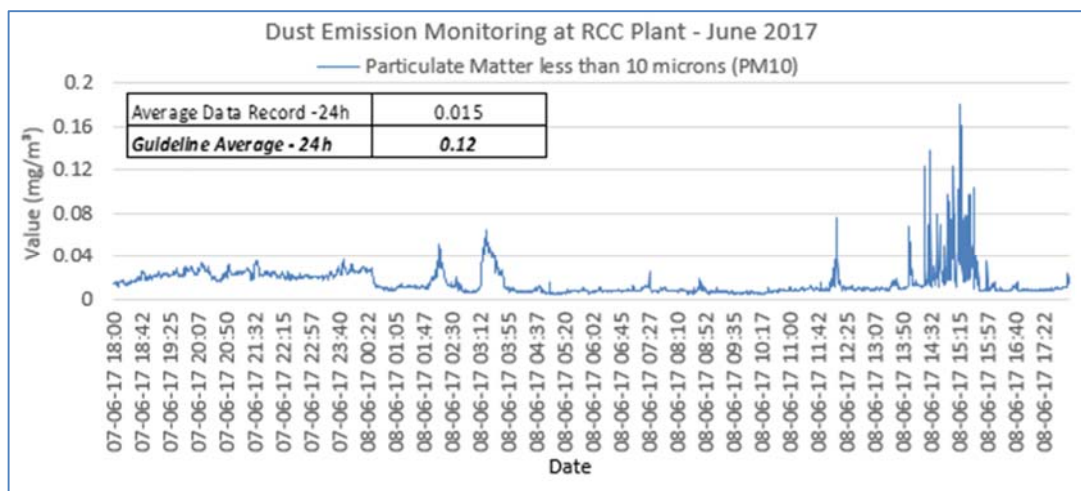
Figure B- 4: Dust Monitoring Results at the RCC Plant in June 2017

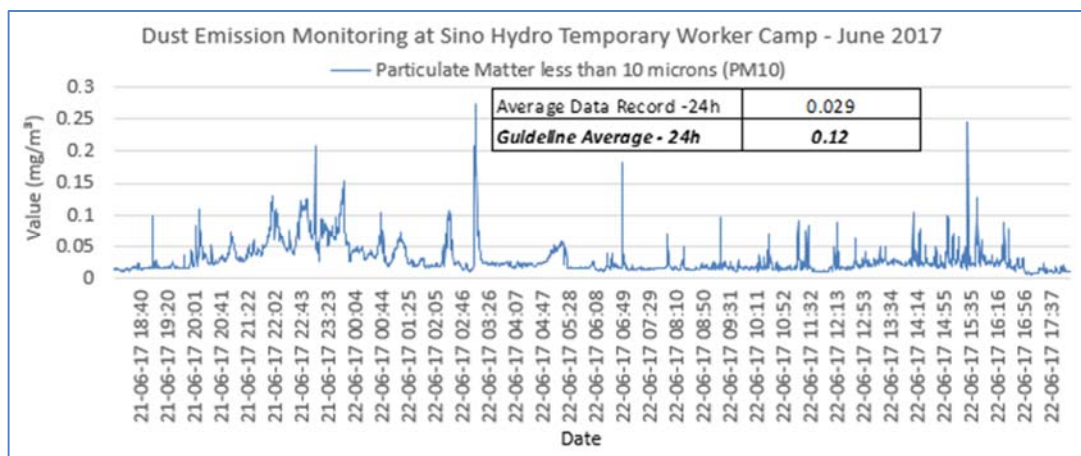
Figure B- 5: Dust Monitoring Results at the Sino Hydro Temporary Camp in June 2017

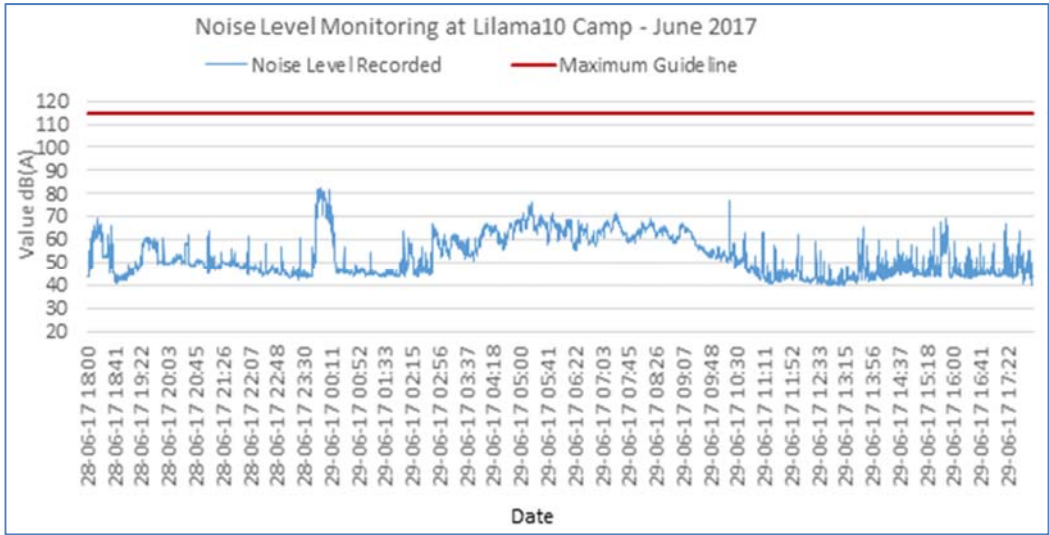
Figure C-7: Results of Noise Level Monitoring at Lilama10 Camp in June 2017

Noise Level (dB)	28-29/June/17		29/June/17
	18:00 – 22:00	22:01 – 06:00	06:01-18:00
Maximum Value Recorded	69.6	82.6	76.9
Guideline Max	115	115	115
Average Data Recorded	51.15	54.83	52.13
Guideline Averaged	70	50	70
