Nam Ngiep 1 Hydropower Project

Environmental Management Monthly Monitoring Report

March 2016

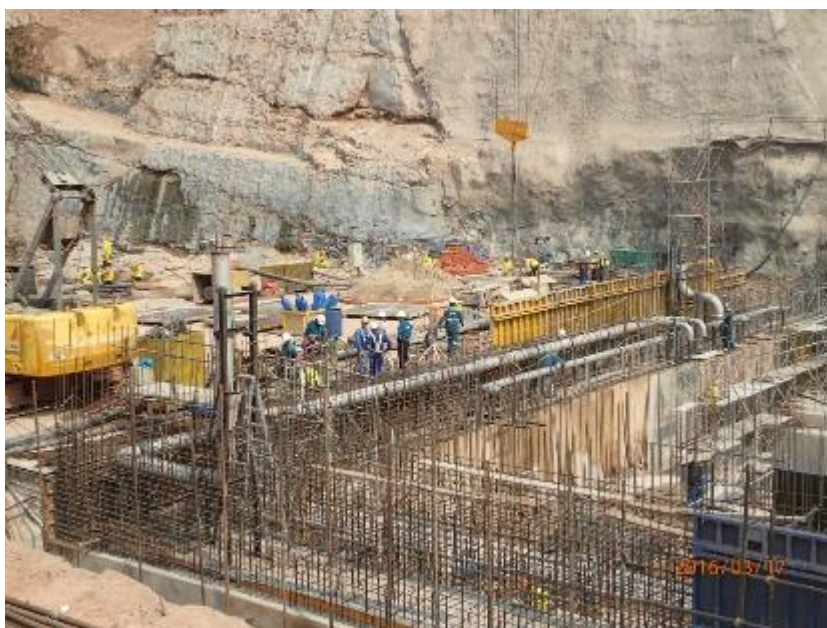
Figure 2-3: Embedded piping installation (Main powerhouse)

- c) The grounding works for the main powerhouse and re-regulation power house are under way in coordination with concrete casting work.
