Nam Ngiep 1 Hydropower Project

Environmental Management Monthly Monitoring Report

March 2017

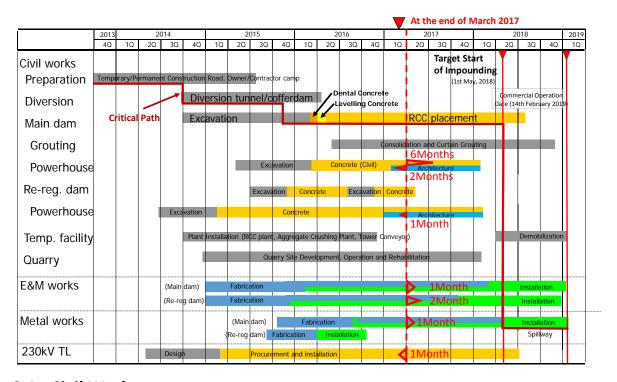
Figure 2-1: Overall Construction Schedule

The overall construction schedule and progress curve (by achieved Milestone Payments) are shown in Figure 2-1.

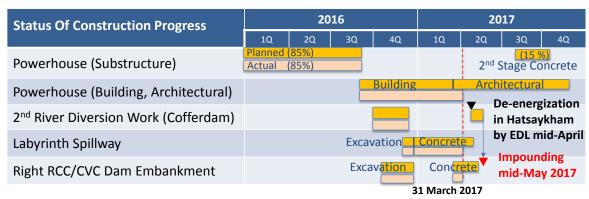
Figure 2-3: Progress of Re-regulation Dam Powerhouse Works to 31 March 2017

Structural concrete works were commenced in March 2015, in coordination with installation of the grounding system. The progress of structural concrete works is shown in *Figure 2-3* below

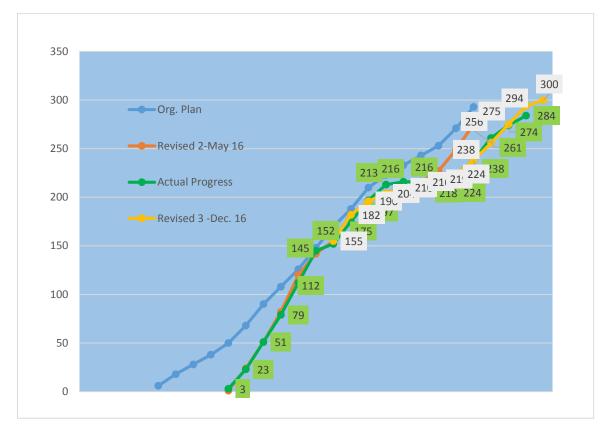
Figure 2-6: Cumulative Work Progress of Tower Foundation (Original Planned and Actual)

is achieved in good time. Onset of daily rains has made access to all areas difficult but the Contractor follows its revised acceleration schedule, after the progress for the construction of tower foundations slowed after April, 2016 (See Figure 2-6 below)

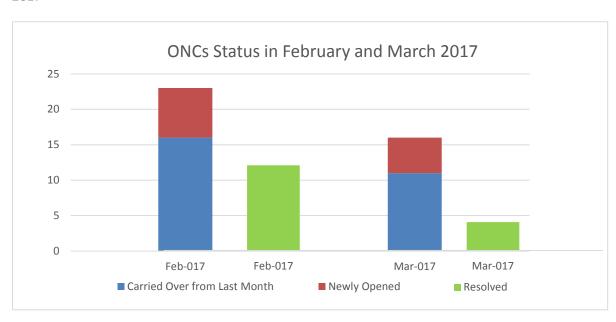
Figure 3-3: Observations of non-compliance (ONCs) in February 2017 Compared with March 2017

Reporting Period (01-31 March 2017)	ONC	NCR-1	NCR-2	NCR-3
Carried over from February 2017	11	1	4	0
New issues this month	5	1	1	0
Resolved this month	5	0	4	0
Carried forward into April 2017	11	2	1	0
Unresolved exceeding deadline	5	1	1	0

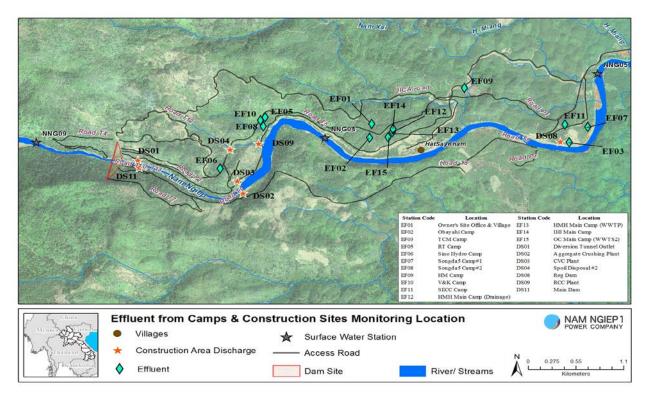
Figure 3-4: Map of Effluent Discharge Monitoring Locations

Since July 2016, the frequency of effluent monitoring has increased from monthly to fortnightly at all the camps, and from fortnightly to weekly at the construction sites. During March 2017, effluent discharge from the new Kenber Camp WWTS was added. Results of effluent monitoring from the camps and construction sites are presented in Table 3-4, and the monitoring locations are displayed on the map in **Figure 3-4**.

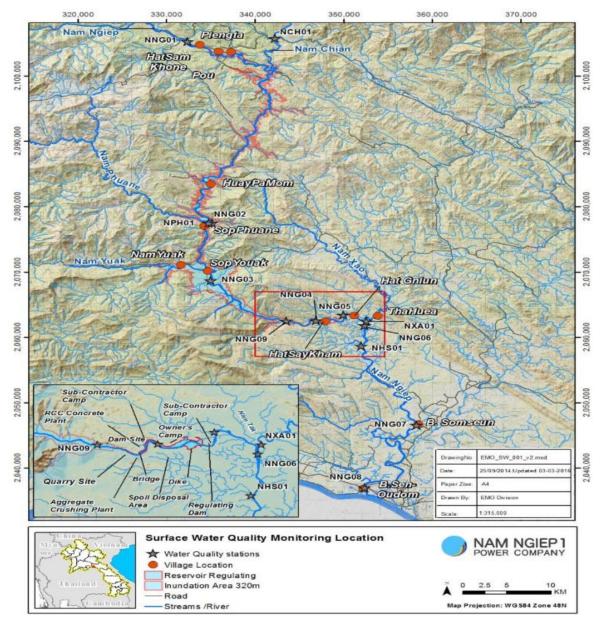
Figure 3-5: Surface Water Quality Monitoring Stations

immediately upstream of the Main Dam, NNG04 located in the reach within the Construction Area and NNG05 immediately downstream of Re-regulation Dam.

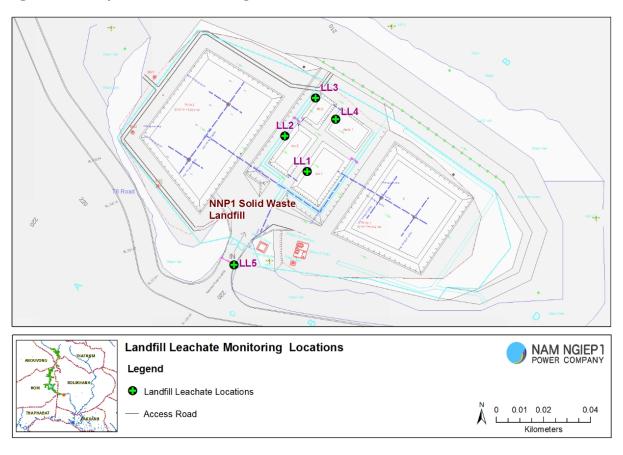
Figure 3-7: Landfill Leachate Monitoring Location

During March 2017, water samples were taken from the last landfill leachate ponds of the NNP1 Project Landfill (LL4). The location of landfill leachate monitoring is displayed in Figure 3-7. The results indicate compliance with the relevant standards in the final pond (LL4), except COD.

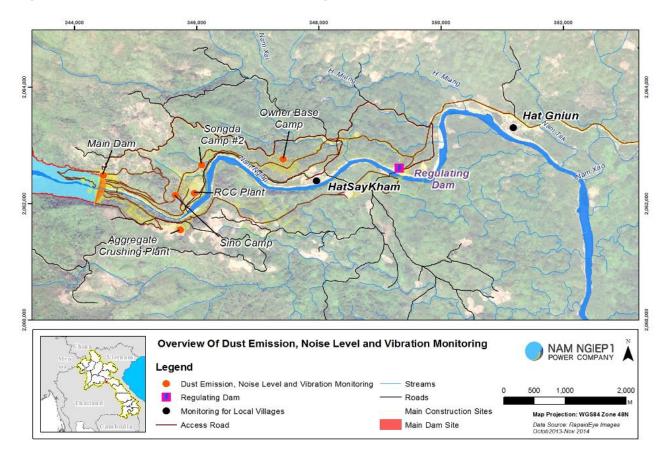
Figure 3-8: Noise and Dust Emission Monitoring Locations

The noise monitoring location are described in the Figure 3-8 below

The noise levels recorded at the monitoring stations indicated full compliance with the National Standard for the period of 06:01-22:00, except at the Aggregate Crushing Plant, Sino Hydro Camp and Sino Hydro Temporary Worker Camp. The noise levels during the period of 22:01-06:00 were higher than the Standard at the Aggregate Crushing Plant, RCC Plant, Sino Hydro Camp, Sino Hydro Temporary Worker Camp and the Main Dam [between 52.65 – 67.04 dB(A)] compared to the Standard of 50 dB(A)].

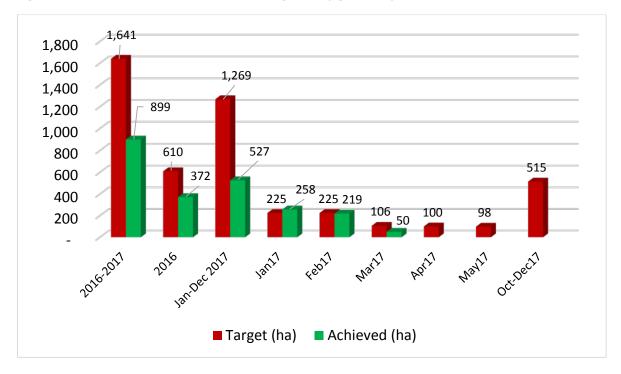
Figure 3-9: Biomass Clearance work Progress in figure as of 31 March 2017

- To date, the overall biomass clearance (cutting and burning) has been completed for around 899 ha. The biomass clearance progress to date can be seen in Figure 3-9, Figure 3-10 and Table 3-17.

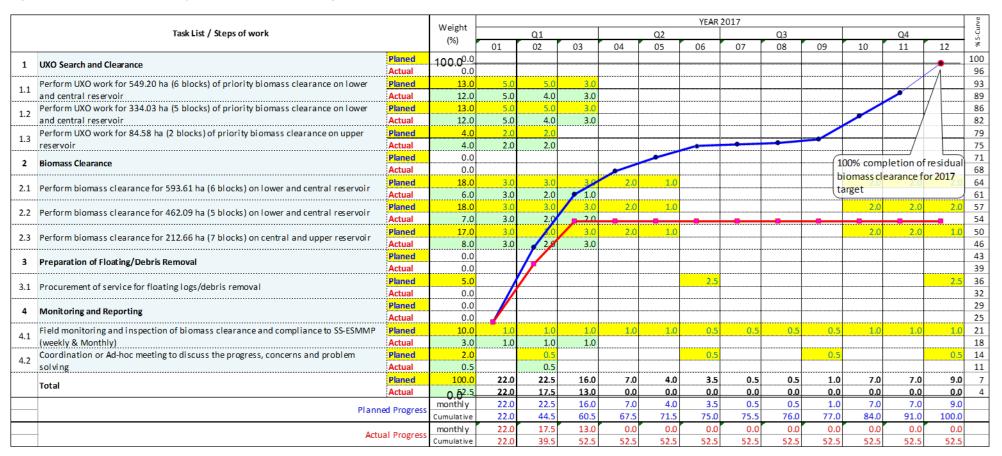
Figure 3-10: Gantt Chart of Biomass Clearance Programme in 31 March 2017

The overall progress of biomass clearance programme is demonstrated in Figure 3-10 below.

The blue graph and yellow highlight represent the planned activity, the red graph and green highlight represent the actual progress.

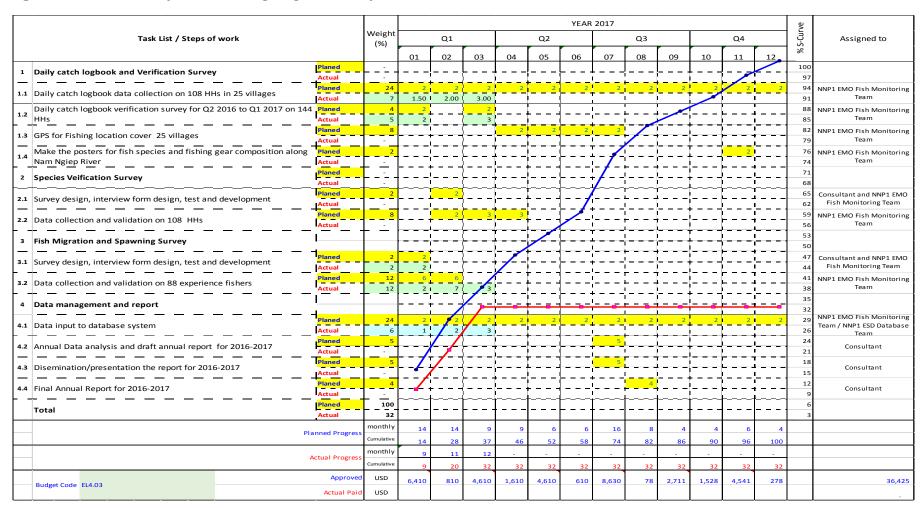
Figure 3-11: Gantt Chart of Fish Monitoring Programme as of 31 March 2017

The overall progress of fish monitoring programme is illustrated in *Figure 3-11* below.

The blue line and yellow highlights represent the planned activity, and the red line and green highlight represent the actual progress

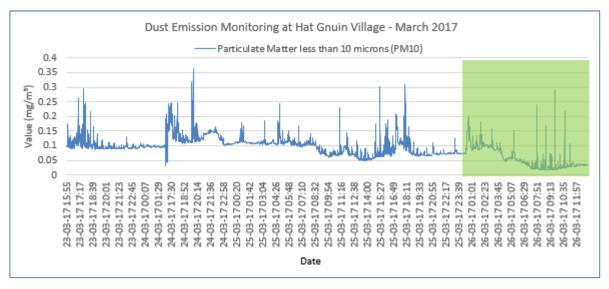
Figure B- 1: Dust Monitoring Results at Ban Hat Gnuin in March 2017

Hat Gnuin Village - 24 Hours Average Particulate Matter (PM10) Concentration									
Period	00 to 24 Hours	24 to 48 Hours	48 to 72 Hours						
Start Time	23-03-17 15:55	24-03-17 17:05	25-03-17 17:05						
End Time	24-03-17 02:26	25-03-17 17:05	26-03-17 13:09						
Average Data Record in 24h (mg/m3)	0.11	0.08	0.03						
Guideline Average in 24h (mg/m3)	0.12	0.12	0.12

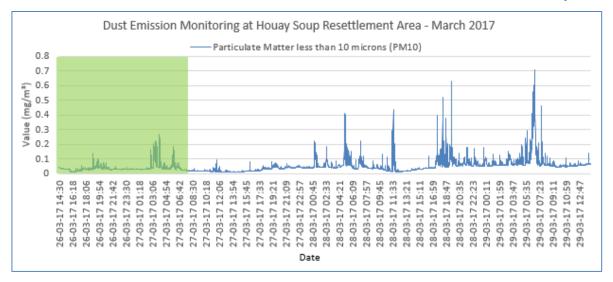
Figure B- 2: Dust Monitoring Results at Houay Soup Resettlement Village in March 2017

Houay Soup Resettlement Area - 24 Hours Average Particulate Matter (PM10) Concentration						
Period	00 to 24 Hours	24 to 48 Hours	48 to 72 Hours			
Start Time	26-03-17 14:30	27-03-17 14:30	28-03-17 14:30			
End Time	27-03-17 14:30	28-03-17 14:30	29-03-17 14:18			
Average Data Record in 24h (mg/m3)	0.03	0.04	0.08			
Guideline Average in 24h (mg/m3)	0.12	0.12	0.12

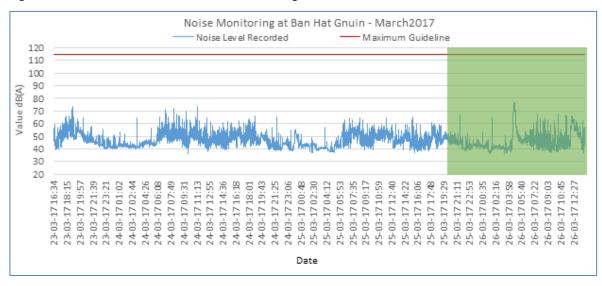
Figure C- 1: Result of Noise Level Monitoring at Ban Hat Gnuin in March 2017

Noise Level (dB)	2	23-24/03/2017		24-25/03/2017		25-26/03/2017			26/03/2017	
	16:34-18:00	18:01 - 22:00	22:01 - 06:00	06:01 - 18:00	18:01 - 22:00	22:01 – 06:00	06:01 - 18:00	18:01 - 22:00	22:01 – 06:00	06:01 - 13:58
Maximum Value Recorded	61.00	73.40	64.60	73.30	66.10	56.90	65.20	66.90	76.70	67.80
Guideline Max	115	115	115	115	115	115	115	115	115	115
Average Data Recorded	47.72	50.72	43.05	49.30	46.00	42.34	48.13	47.20	44.08	47.49
Guideline Averaged	55	55	45	55	55	45	55	55	45	55

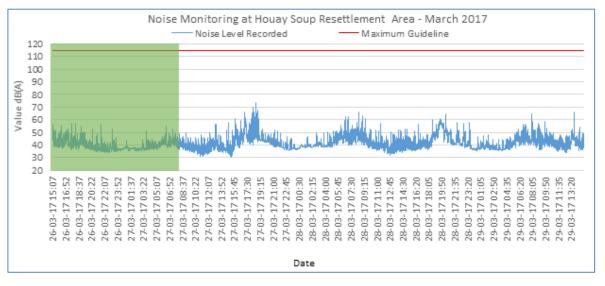
Figure C- 2: Result of Noise Level Monitoring at Houay Soup Resettlement Village in March 2017

Noise Level (dB)		26-27/03/201	7	2	27-28/03/2017		28-29/03/2017		29/03/2017	
Noise Level (dB)	15:07-18:00	18:01 - 22:00	22:01 – 06:00	06:01 - 18:00	18:01 – 22:00	22:01 – 06:00	06:01 - 18:00	18:01 – 22:00	22:01 – 06:00	06:01 - 15:07
Maximum Value Recorded	57.50	57.30	52.80	66.20	73.60	51.50	66.20	65.00	58.10	65.90
Guideline Max	115	115	115	115	115	115	115	115	115	115
Average Data Recorded	42.87	39.53	37.79	40.50	44.44	39.84	41.46	47.64	39.60	42.55
Guideline Averaged	55	55	45	55	55	45	55	55	45	55
