Nam Ngiep 1 Hydropower Project

Environmental Management Monthly Monitoring Report

March 2018

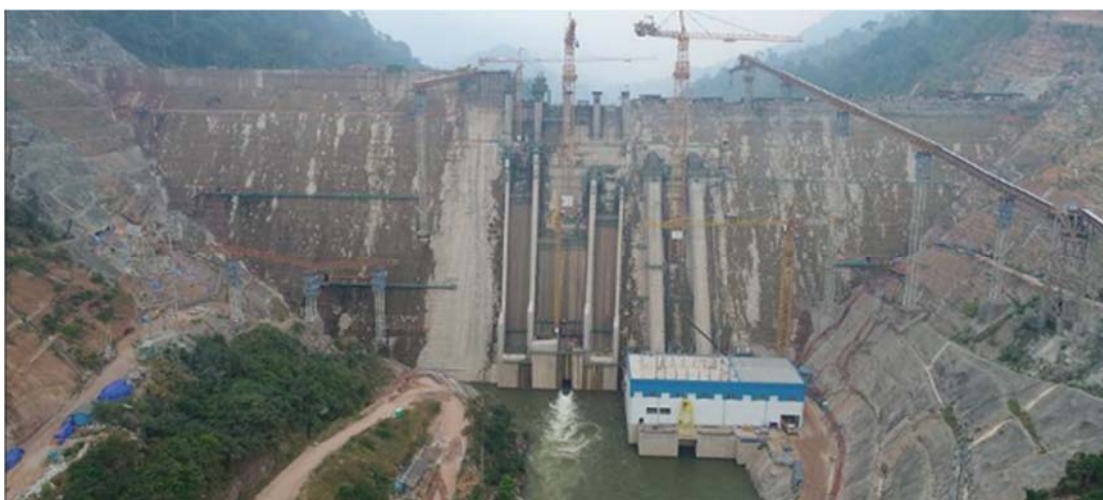
Figure 2-2: Main Dam and Powerhouse from Overhead Looking Upstream

After starting the main dam excavation works in October 2014 on the left bank, the works were about one month advanced when diversion of the Nam Ngiep River was achieved at the end of October 2015. However, excavated volumes were 20% greater than expected and part of this additional work is necessary to construct a 'shear key' structure due to the weak layers of rock encountered in the dam foundation. Following the efforts on Site, the additional excavation work was completed at the end of February 2016.
