Nam Ngiep 1 Hydropower Project

Environmental Management Monthly Monitoring Report

March 2020

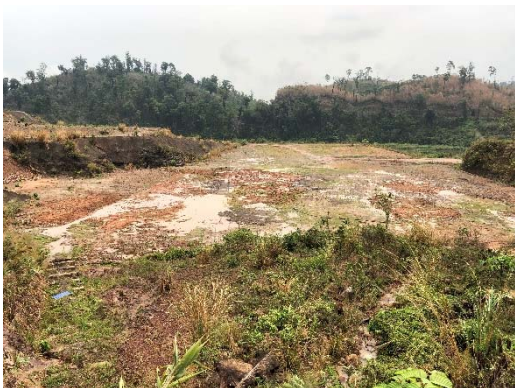
Figure 2-4 : Re-vegetation of RCC Plant Yard

Demobilization of plant facilities for both RCC and CVC plants was completed in December 2019. The vegetation improvement for rehabilitation of those areas is ongoing

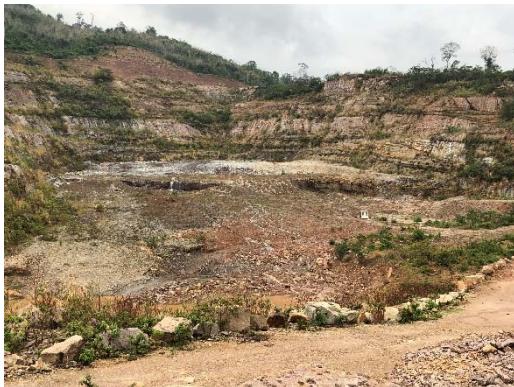
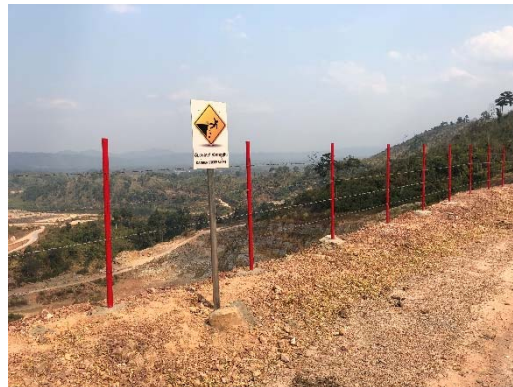
Figure 2-6: Quarry Area View Showing Re-Vegetation and Safety Fence Installation

After removal of overburden the excavation of raw materials for aggregate crushing were started in July 2015. The nature and type of the rock being exploited was acceptable though unsuitable soil layers were removed to spoil disposal areas, and good quarry management prevailed. It was considered that the quarry as originally conceived would not yield enough rock material of the required specification to complete all RCC and CVC concrete works for the Project. Permission was taken to extend the existing quarry within the boundaries already approved after a preliminary soil investigation confirmed that appropriate material could be exploited as below. The planned extension area of the quarry received approval from local government. (See **Figure 2-4** below)

The surface clearing, topsoil and overburden removal works at the extension area were completed in December 2016 and its development works was commenced in January 2017. The final blasting was carried out 27 March 2018. GOL have acknowledged that the quarry operation is complete. After several inspections by GOL and ADB for the Lenders, the quarry site has been improved by such as partial levelling, vegetation at the berms of slopes and large rock installation at top of slopes from an environmental and a safety point of view. Furthermore, a fence around the pond, which is created at the quarry only during the rainy season and is dry during dry season, will be installed to prevent people and animals from entering the pond, subject to ADB approval. A gate near the steel bridge also a barrier to public access. Permanent fence installation around pond as shown in the below picture will not be installed and fence for road safety will be installed at the top of the right bank upper quarry roadside. The levelling of quarry bottom will be implemented from January 2020.

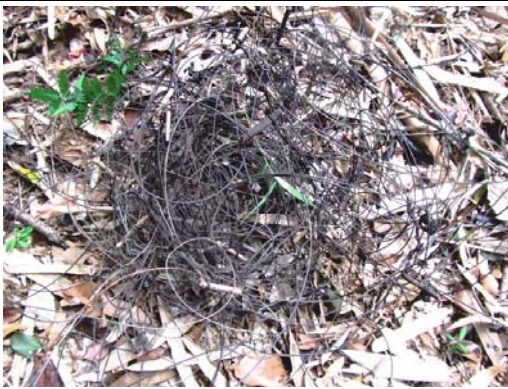
<p>Figure 3-7: Small Wire Snares around Houay San at TPZ High Priority Area</p>

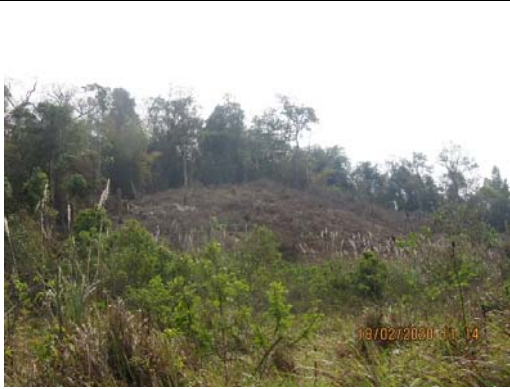
<p>Figure 3-8: Land Clearance for Agriculture outside TPZ High Priority Area</p>

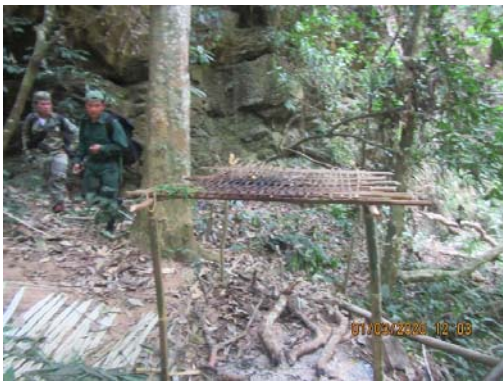
In February 2020, the fourth team carried out patrolling at the TPZ Highest Priority Area, around Thongnachang Area including Nam Sone, Nam San, Nam Xi, Nam Chang, Houay Xai Yai, Houay Xai Noi and Houay Pong. They spent 16 days covering a distance of 86 km on forest patrolling. The team made a total of eight direct observations and seven indirect observations of the following wildlife: great hornbill, muntjac, red junglefowls, silver pheasant, white-cheeked gibbon, civet, Indochinese serow, macaque, otter, sambar, and wild pig. The team also encountered one active fishing camp with the dry rack. This camp was later destroyed by the patrol team.

<p>Figure 3-9: Fishing camp with the dry rack at Thongnchang area</p>
