**NAM NGIEP 1**  
POWER COMPANY

## Nam Ngiep 1 Hydropower Project

# Environmental Management Monthly Monitoring Report

May 2016

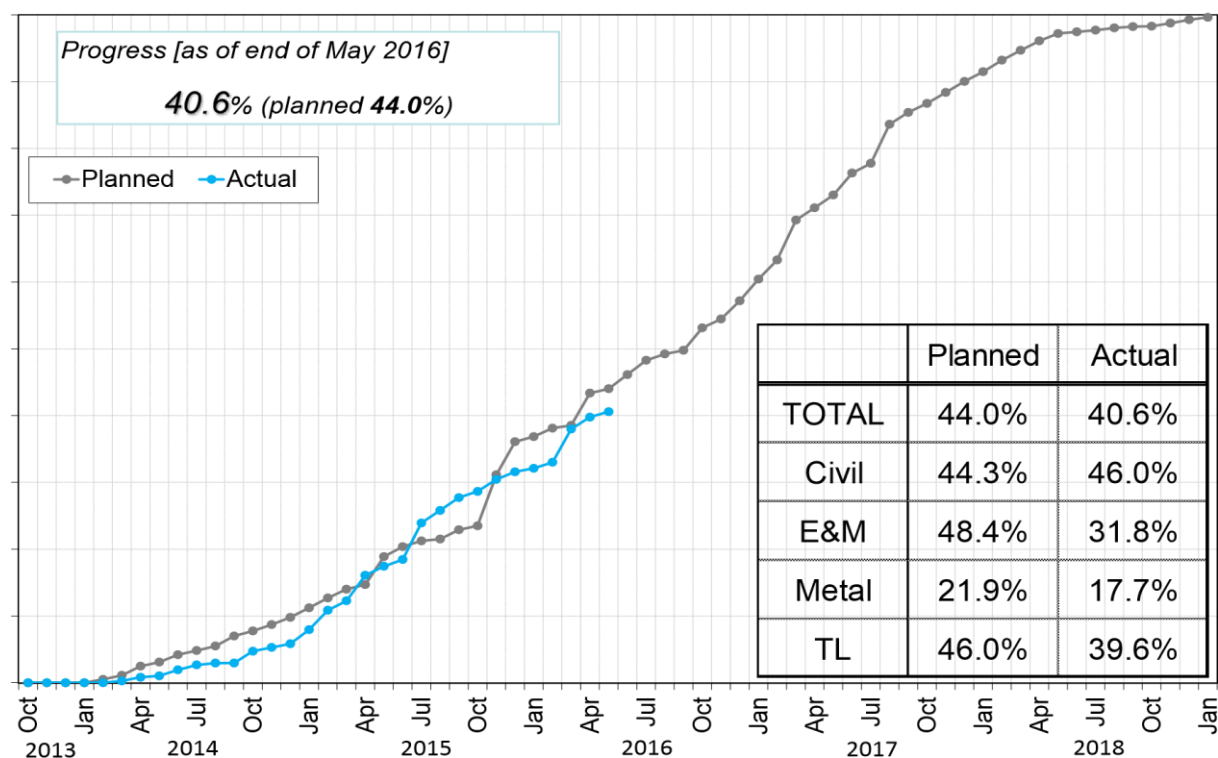
**Figure 2-2: Progress Curve (All Construction Works)**

40.6%<sup>1</sup> (compared to planned progress of 44.0%), based on achieved Interim Milestone Payments for all Contracts excluding the value of Advance Payments, varied works and other adjustments allowed under each Contract. In terms of the value of actual work done the percentage is slightly understated since work completed, but not paid, is not included. It is shown in **Fig. 2-2** that the main reason for this 3.4% difference between actual and planned is because payment for 230 kV Transmission Line Works are later than expected as the works are being accelerated and fell behind target during April 2016 to get back onto the original schedule due to a design approval delay that caused a shortfall in materials required for tower erection. This delay is being managed to recover the lost time. Also, for the Electrical and Mechanical Works, the application for payment of stator material for Unit 1 of the main powerhouse (USD 22.4 million) has been postponed but it is not a critical path item. It should be noted that the actual value of the Civil Works completed includes payment for the greater-than-anticipated excavation volume carried out in the river bed to enable an acceptable foundation to be established for the main dam. Whilst the Civil Works Contractor was previously ahead of schedule for main dam excavation (which lies on the critical path), the additional excavation works that were required in the river bed has meant that this time has now been used for this purpose. However, it is considered that the Civil Works programme for RCC placement that started on 21 May 2016 and with the crushing, batching and placing capacity now provided, has more than enough capacity to achieve a position whereby the dam will be ready for impounding before the rainy season of 2018.

The overall construction schedule and progress curve (by achieved Milestone Payments) are shown in **Fig.2-1** and **Fig.2-2** respectively.

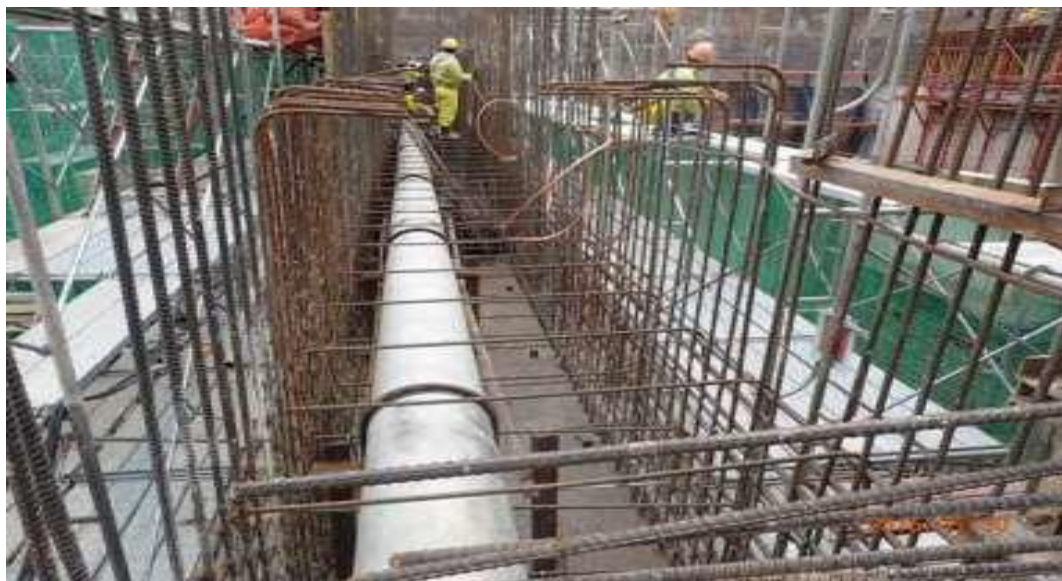
*Figure 2-3: Embedded piping installation (Main powerhouse)*

- c) The grounding works for the main powerhouse and re-regulation power house are under way, also in coordination with concrete casting work.

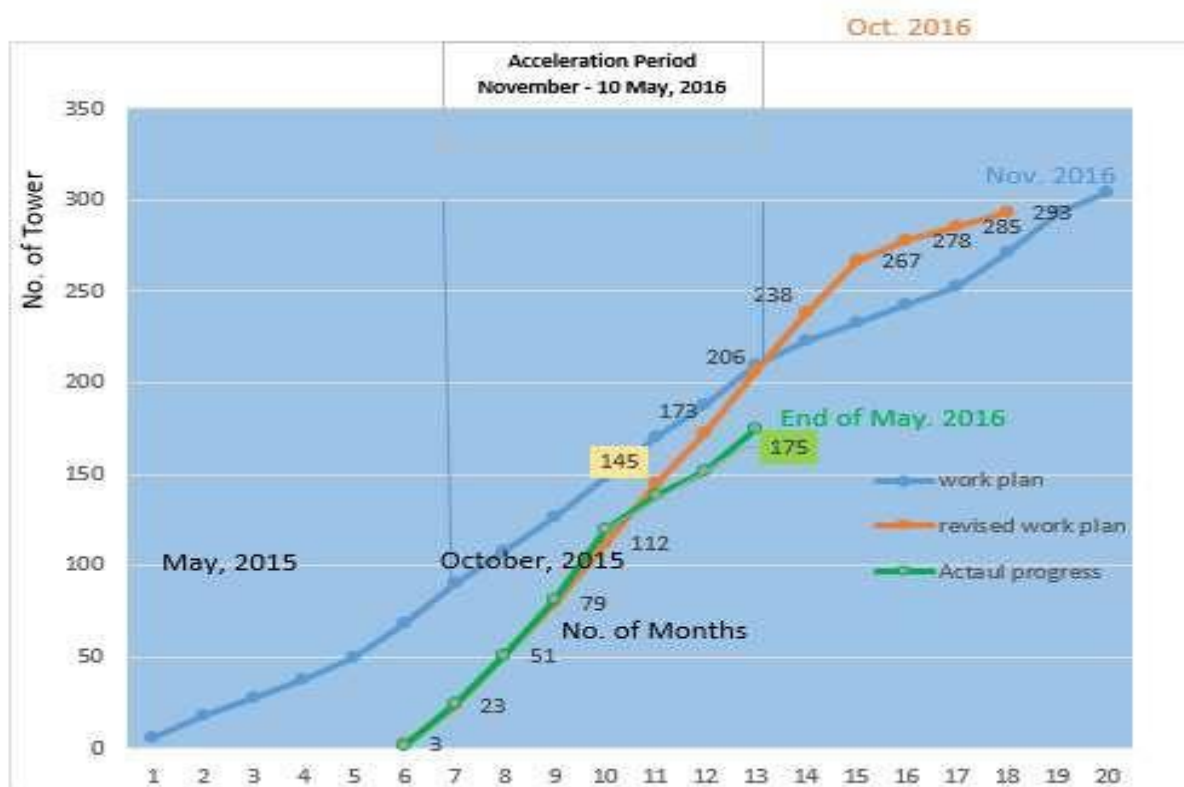
Figure 2-4 Cumulative Work Progress of Tower Installation (Plan and Actual)

- Fabrication drawings of Tower type LDC are not submitted for approval yet, while foundation design for all other Tower types have already been approved
- The construction progress by the end of May 2016 is completion of 175 out of an expected total of 293 tower foundations, tower erection of 100 towers and the checking and tightening of bolts and nuts for 74 towers. The progress in May 2016 is behind schedule due to the delay to late importation of some construction materials and because preparatory work for construction in the mountainous areas is a more protracted process.

Acceleration schedule, after the progress for the construction of tower foundations slowed after April, 2016, See (See Figure 2:4 below)

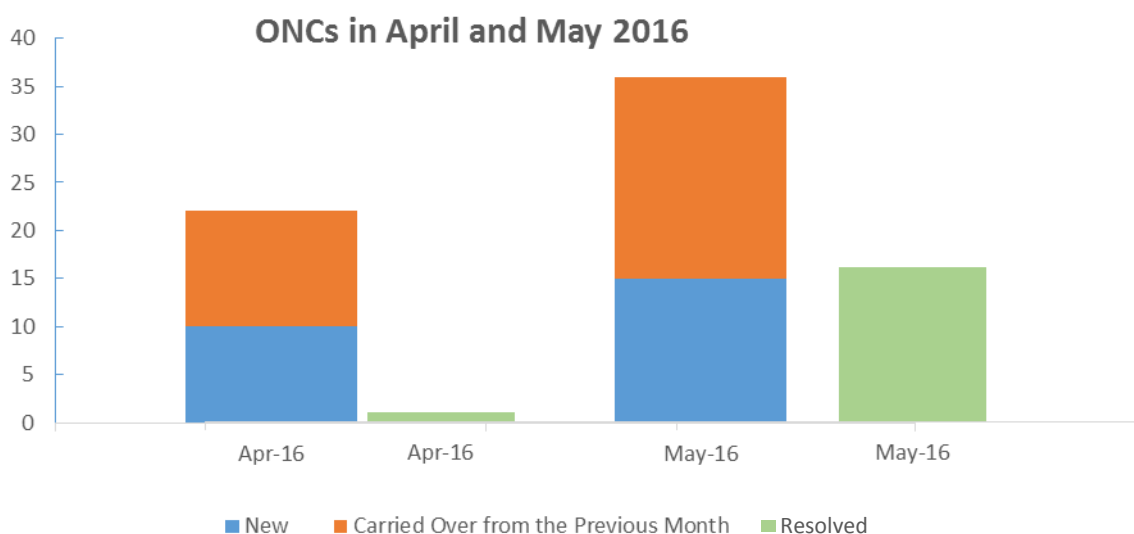
**Figure 3-3: Observations of non-compliance this month compared with previous month**

As shown in Table 3-33 and Figure 3-34, the number of new ONCs decreased from 21 in April to 15 in May 2016. With a carry-over from April 2016, a total of 36 ONCs were active in May 2016. Out of these, 16 ONCs were resolved, 14 ONCs were not resolved exceeding the deadlines<sup>2</sup> and a total of 20 ONCs will be carried over into June 2016. NNP1PC will follow up with the Contractors to resolve the remaining issues in June 2016.

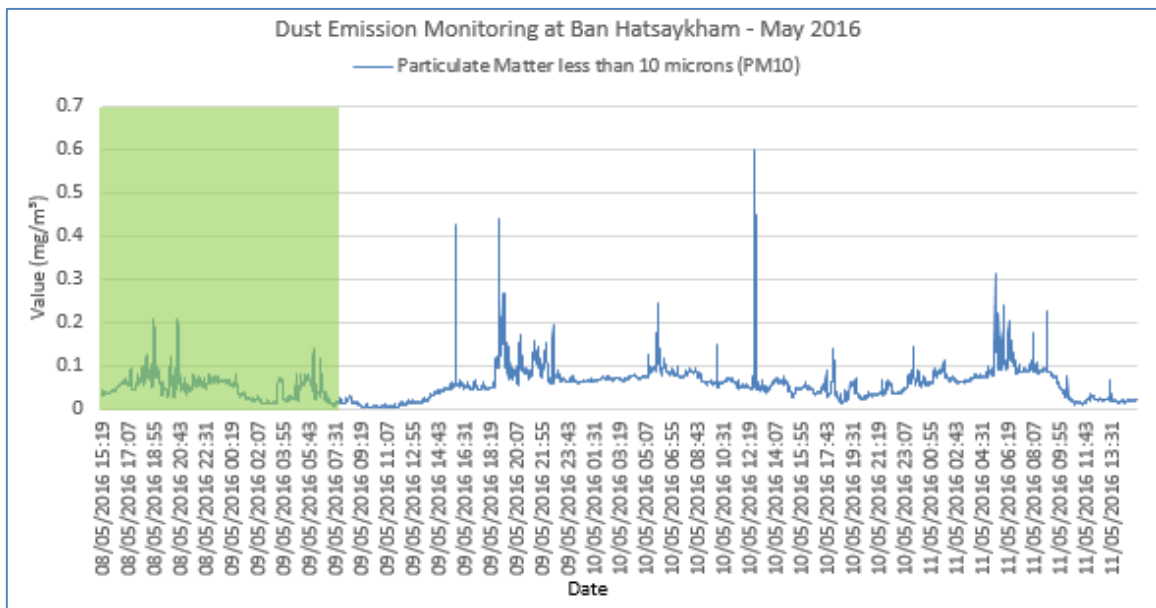
**Figure B- 2: Dust Monitoring Results at Ban Hatsaykham May 2016**

Ban Hatsaykham - 24 Hours Average Particulate Matter (PM10) Concentration			
Period	00 - 24 Hours	24 - 48 Hours	48 - 72 Hours
Start Time	08/05/2016 15:19	09/05/2016 15:19	10/05/2016 15:19
End Time	09/05/2016 15:19	10/05/2016 15:19	11/05/2016 15:19
Average Data Record in 24 h (mg/m <sup>3</sup> )	0.04	0.07	0.05
Guideline Average in 24 h (mg/m <sup>3</sup> )	<b>0.12</b>	<b>0.12</b>	<b>0.12</b>

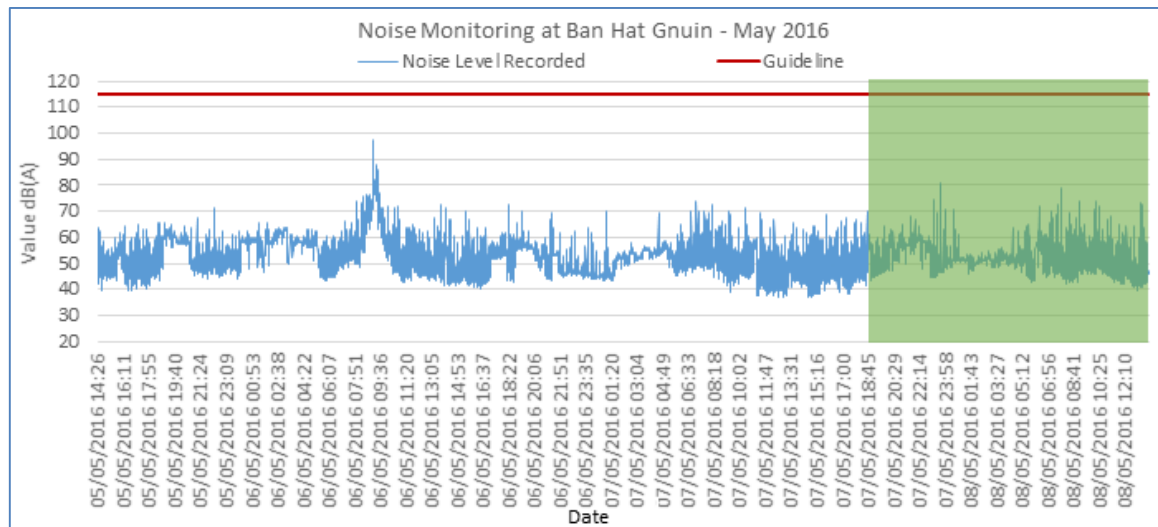
**Figure C- 1: Results of Noise Level Monitoring at Ban Gnuin in May 2016**

The recorded noise levels indicate full compliance with the National Standard for the period of 06:01-22:00 for all stations monitored. For the period of 22:01-06:00, slightly higher levels than the Standard were recorded at Ban Hat Gnuin and Ban Hatsaykham [between 46.20-47.39 dB(A) compared to the Standard of 45 dB(A)]; the RCC, Aggregate Crushing Plant, Sino Hydro Camp and the Main Dam [between 51.74-66.48 dB(A)] compared to the Standard of 50 dB(A)]. With reference to the investigation on this matter conducted in February 2016, the key causes of high noise levels are most likely the windy and rain conditions during the night time period.

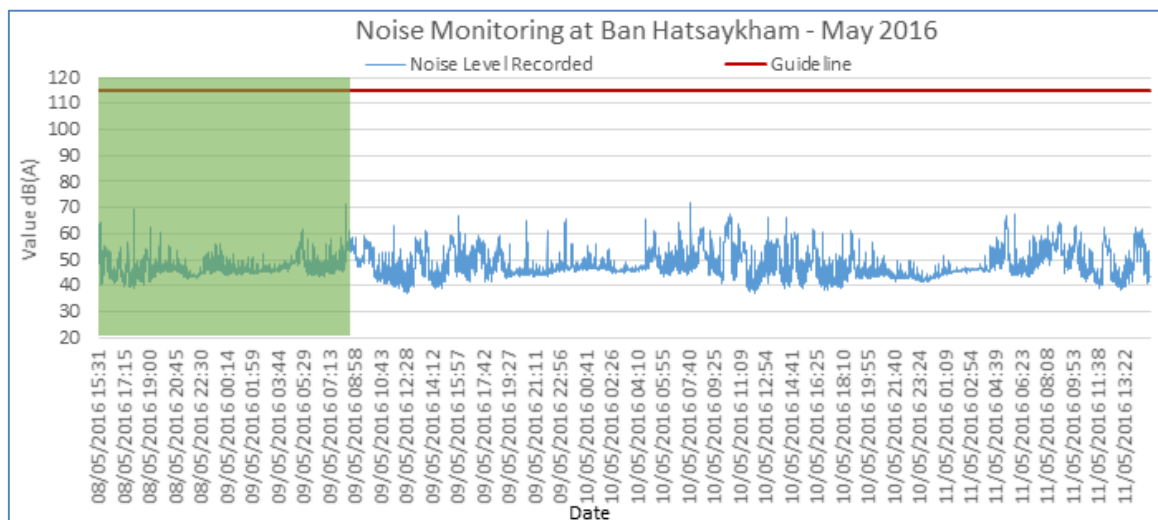
**Figure C- 2: Results of Noise Level Monitoring at Ban Hatsaykham in May 2016**

Noise Level (dB)	08-09/05/2016			09-10/05/2016			10-11/05/2016			11/05/2016
	15:31-18:00	18:01-22:00	22:01-06:00	06:01-18:00	18:01-22:00	22:01-06:00	06:01-18:00	18:01-22:00	22:01-06:00	06:01-15:31
Maximum Value Recorded	69.40	62.60	61.60	71.60	64.70	65.70	72.20	60.90	67.50	64.60
<b>Guideline Max</b>	<b>115</b>	<b>115</b>	<b>115</b>	<b>115</b>	<b>115</b>	<b>115</b>	<b>115</b>	<b>115</b>	<b>115</b>	<b>115</b>
Average Data Recorded	45.89	46.03	46.94	48.06	46.30	47.39	48.63	45.36	46.20	49.66
<b>Guideline Averaged</b>	<b>55</b>	<b>55</b>	<b>45</b>	<b>55</b>	<b>55</b>	<b>45</b>	<b>55</b>	<b>55</b>	<b>45</b>	<b>55</b>
