Nam Ngiep 1 Hydropower Project

Environmental Management Monthly Monitoring Report

May 2017

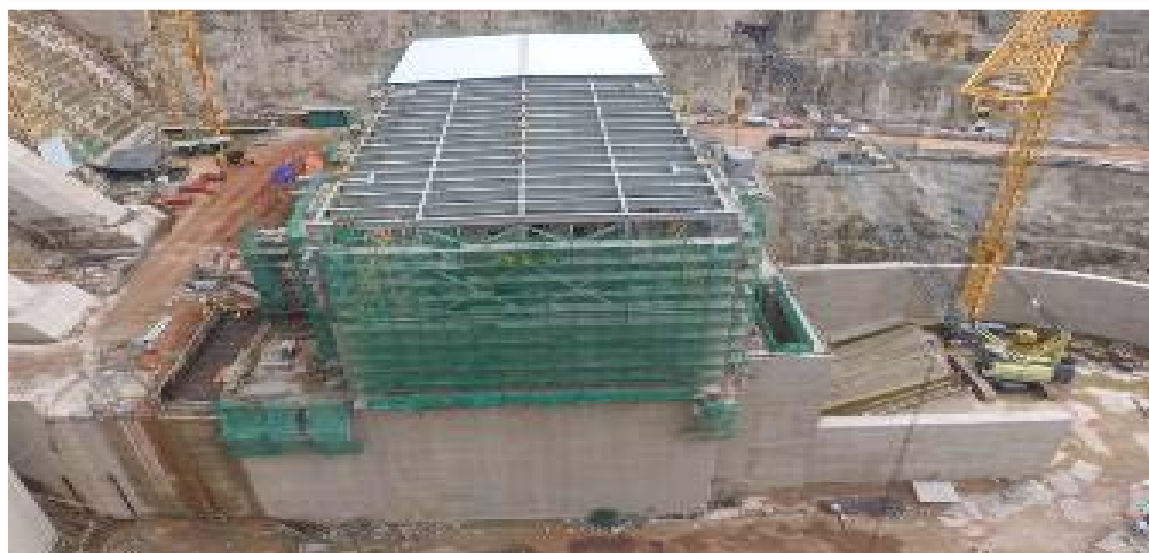
Table 2-2: Progress of Main Powerhouse Sub-Structure Concrete Works to May 2017.

Location	Total Anticipated Volume (m ³)	Completed (m ³)	Progress (%)
Main Powerhouse	32,600	24,769	76
Penstock Embedment	10,117	7,625	74

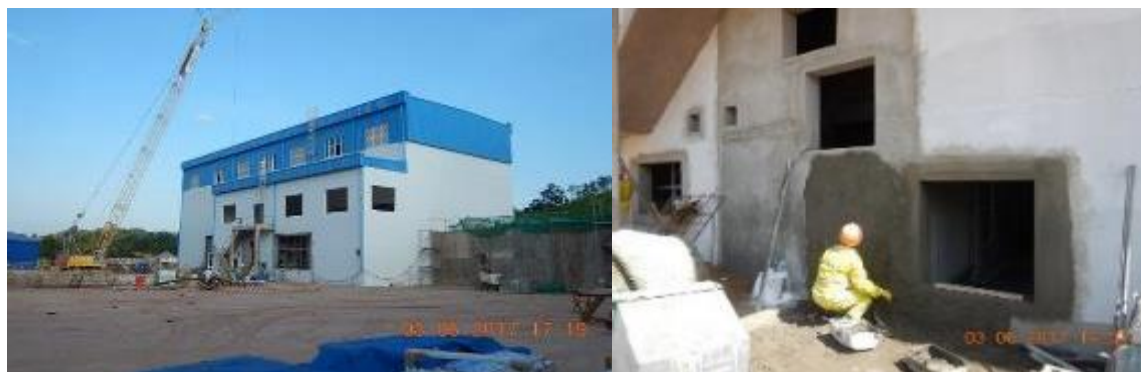
Structure	Civil Structure	Building				Right Bank RCC Structure	Left Bank Backfill
	Intake, Powerhouse and Tailrace	Plastering Work	Painting Work	Windows	Block Wall over El. 177 m	RCC and CVC	Powerhouse and Switch Yard
	(m ³)	(m ³)	(m ²)	(m ²)	(m ²)	(m ³)	(m ³)
Design	26,549	17,515	6,135	27	1,576	11,576	45,000
Completed	24,748	17,515	4,372	14	1,563	11,576	44,000
Progress %	93	100	96	52	99	100	98

The powerhouse concreting has advanced well and secondary concrete embedment for the draft tube liner was completed at the end of April 2016. The left bank structure was re-designed as roller compacted concrete (RCC) and was completed on 18 March 2016. Installation of the re-regulation waterway gate and stop log and re-regulation intake gate and structural concrete works for the retaining wall to support the substation yard were completed in October 2016. Building superstructure work continued for the powerhouse with the commencement of construction of concrete columns.

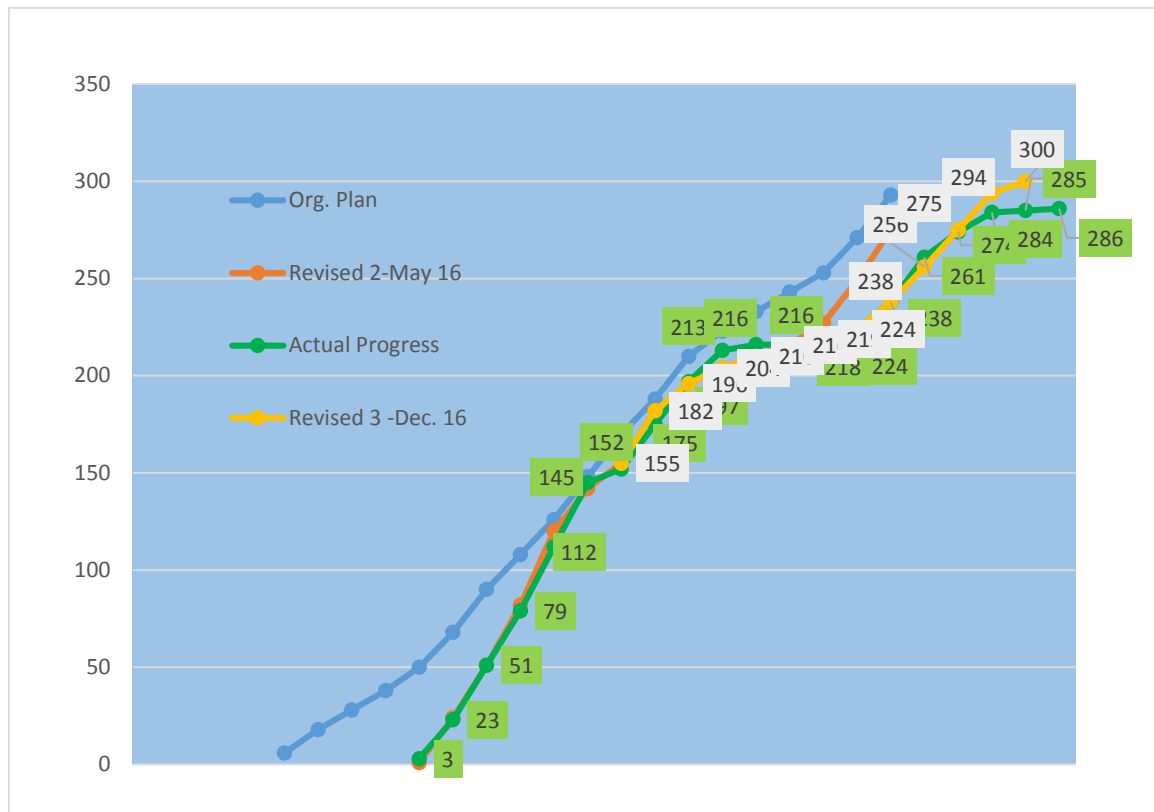
Figure 2-6: Cumulative Work Progress of Tower Foundation (Original Planned and Actual)

Contractor follows its revised acceleration schedule, after the progress for the construction of tower foundations slowed after May, 2016 (See Figure 2-6 below)

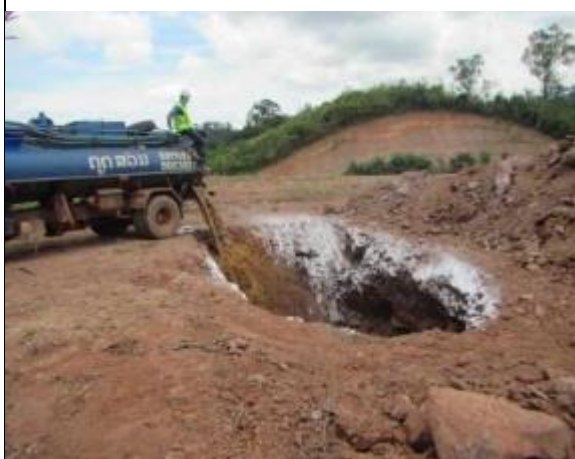
Photograph 9: Septic tank sludge from Hatsaykham clean-up was Disposed of At the Designated Spoil Disposal Area No. 6

During 11 – 14 May 2017, NNP1PC (Environmental and Social Division) carried out a final waste cleaning-up at Hatsaykham Village prior to start of impounding the re-regulating reservoir. A total of 13.5 m³ of solid waste in the former Hatsaykham Village was disposed of at Houay Soup Landfill (see below). In addition, approximately 160 kg of recyclable waste was separated and stored at a Community Recyclable Waste Bank at Hat Gniun Village; 145 m³ of combustible waste was burned on site and 29 m³ of sewage sludge from the septic tanks was disposed of at the designated Spoil Disposal Area No. 6 following NNP1PC Standard Operating Procedures (SOP) for Sewage/Black Water Disposal (See and below). NNP1PC continued the clean-up after completion of impounding by collecting floating rubbish and debris during 24-27 May 2017. A total of 275 kg of floating rubbish was transported and disposed of at the NNP1 Project landfill and 4.3 m³ of floating debris was transported and disposed of at the designated Spoil Disposal Area No. 6.
