Nam Ngiep 1 Hydropower Project

Environmental Management Monthly Monitoring Report

May 2020

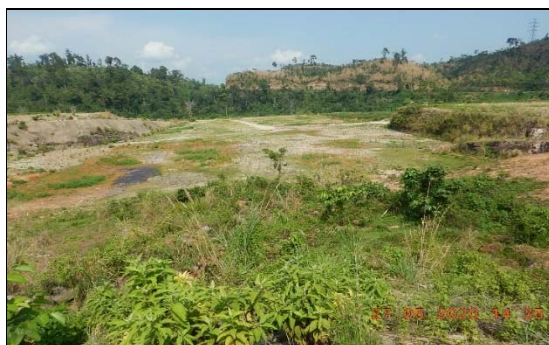
Figure 2-4: Re-vegetation of RCC Plant Yard

Demobilization of plant facilities for both RCC and CVC plants was completed in December 2019. The vegetation improvement for rehabilitation of those areas is ongoing.

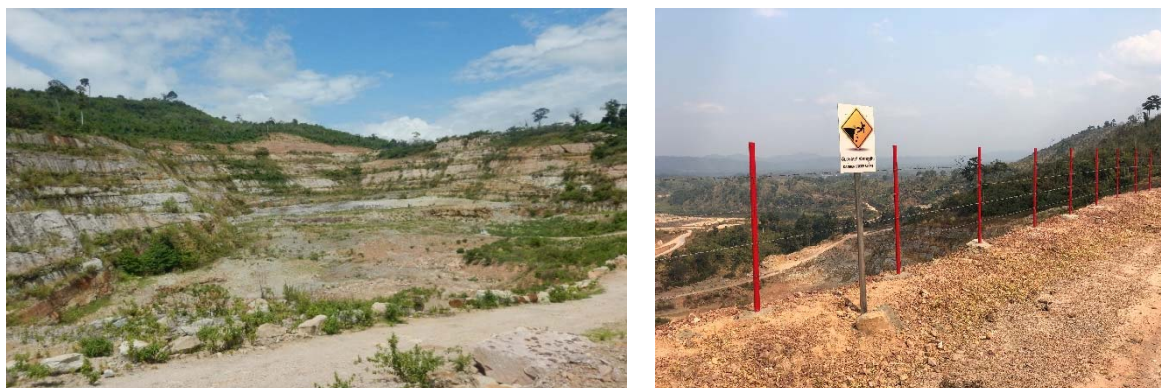
Figure 2-6: Quarry Area View Showing Re-Vegetation and Safety Fence Installation

The final blasting was carried out 27 March 2018. GOL have acknowledged that the quarry operation is complete. After several inspections by GOL and ADB for the Lenders, the quarry site has been improved by such as partial levelling, vegetation at the berms of slopes and large rock installation at top of slopes from an environmental and a safety point of view. Fence for safety was installed at top slope at right side. The grading at the quarry bottom and spreading of top soil was completed in January 2020.

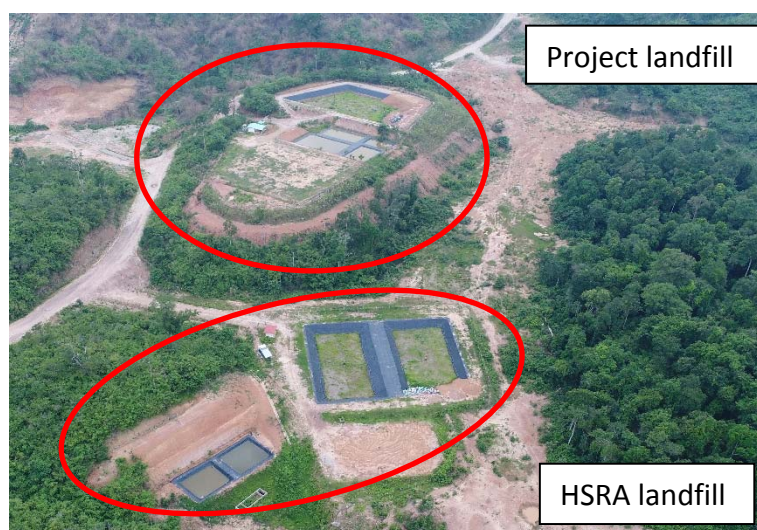
Figure 2-7: Phase 2 of Project Landfill Development on 8 June 2017

The operation of both HSRA and Project landfills is ongoing with collection waste material from Resettlement “Phouhomxay”, neighbour villages and the Owner Site Office and Village.

Current condition of landfill

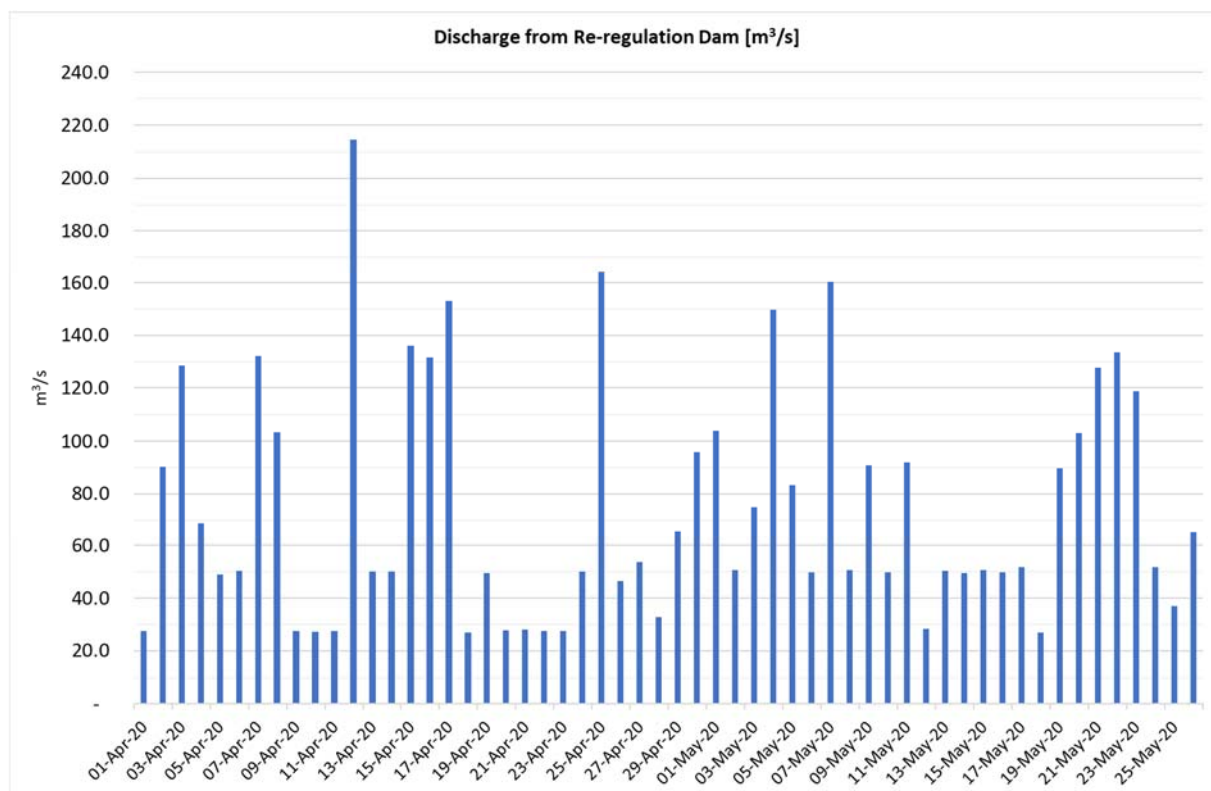
FIGURE 3-4: DISCHARGE MONITORING AT THE RE-REGULATION DAM IN APRIL 2020 AND MAY 2020

The discharge monitoring data for the re-regulation dam during April 2020 and May 2020 is presented in Figure 3-4.

During May 2020, the mean discharge from the re-regulation dam was about 77 m³/s with turbine discharges varying between 50 m³/s and 160 m³/s interrupted by periods with gate discharge of about 28 m³/s. The discharge was kept above the minimum flow requirement of 27 m³/s at all times.

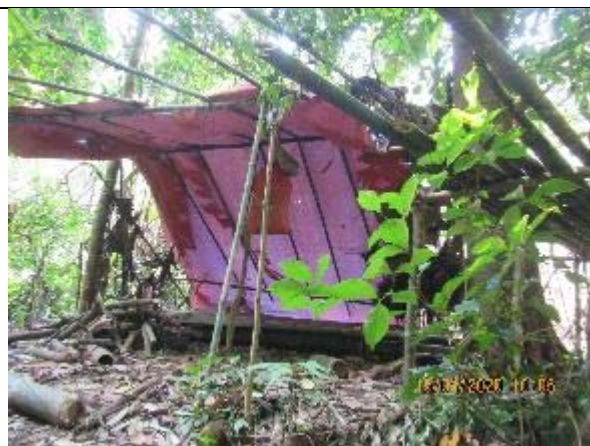
Figure 3-7: Fishing camp observed at Nam Chouane, Viengthong District

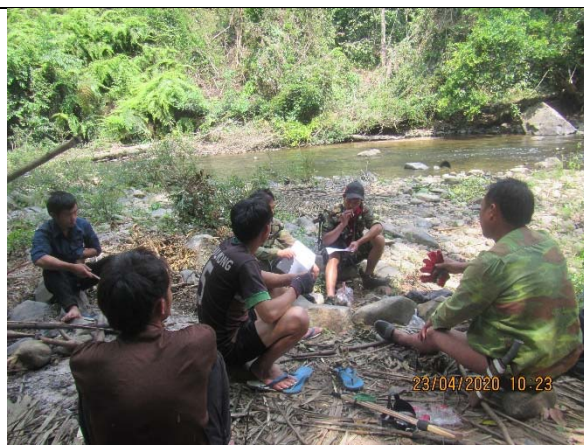
Figure 3-8: A group of people fishing was observed by the patrol team at Nam Chouane, Viengthong District

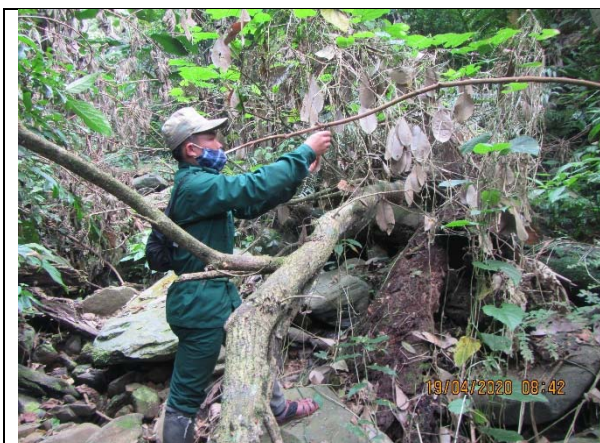
Figure 3-9: Patrol team removing the snare at Houy Wod-Wod, Xaychamphone District

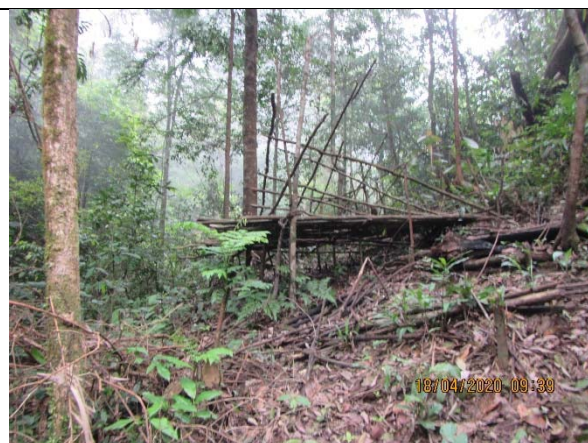
Figure 3-10: Inactive hunting camp was observed at Houy Tong, Xaychamphone District
