Nam Ngiep 1 Hydropower Project

Environmental Management Monthly Monitoring Report

November 2016

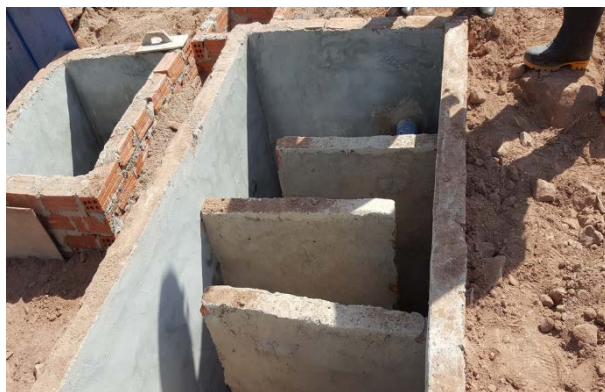
Photograph 1: Completed chlorine contact tank and monitoring tank at Song Da 5 Camp No. 2

The improvements of the Wastewater Treatment Systems (WWTS) at Song Da 5 Camp No. 2 has almost been completed. The system is being built in accordance with the conceptual design prepared by an external consultant and the NNP1PC Instruction Letter (reference no. NNP1/0750-016/OBA/EPC-CE dated 12 October 2016). In addition, NNP1PC closely monitored the construction

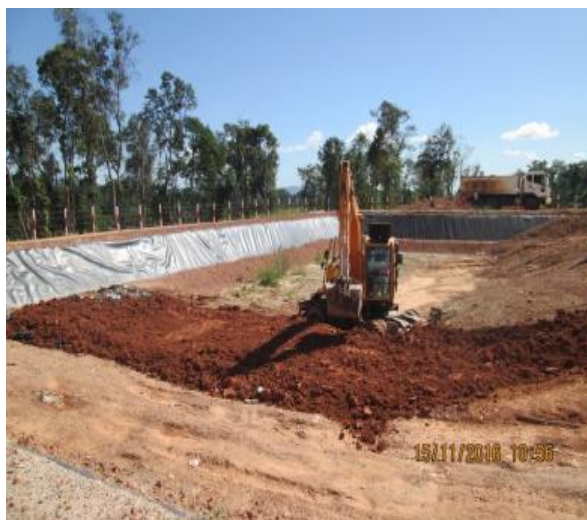
Photograph 3: Waste Compaction and Soil Cover at the NNP1 Project Landfill

In November 2016, NNP1PC closely supervised the landfill operations including waste disposal, compaction and soil cover activities using crawler excavator. Solid waste being delivered to the NNP1 Project landfill is regularly checked by NNP1PC staff. For example, on 22 November 2016, through bag checking, it was found that mixed waste was disposed of at the NNP1 landfill. The subcontractor was instructed to properly segregate the mixed waste prior to disposal. Approximately 145.2 m³ of waste was disposed at the NNP1 Project Landfill during November 2016, an increase of 18.6 m³ compared with October 2016.

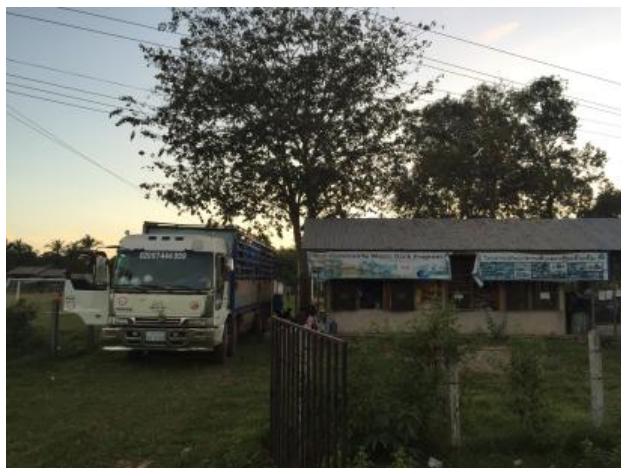
Photograph 7: Recyclables from Recycle Waste Bank was sold to Khounmixay Processing Factory

In November 2016, the purchase of recyclables from the Community Recycle Waste Bank was 331 kg, it is reduced by 327 kg compared to October 2016 as indicated above. Recyclables waste from construction camps will continue to be stockpiled at the Community Recycle Waste Bank with the intention of arranging a routine collection by the Khounmixay Processing Factory (see **Photograph 7** and **Photograph 8** below):

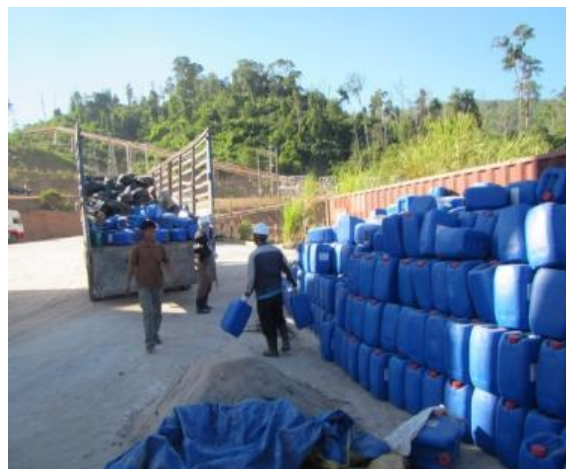
Photograph 8: Recyclables and hazardous waste from the Contractor was sold to Khounmixay Processing Factory

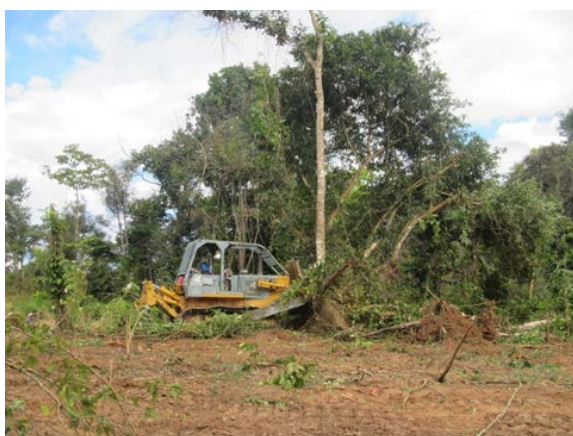
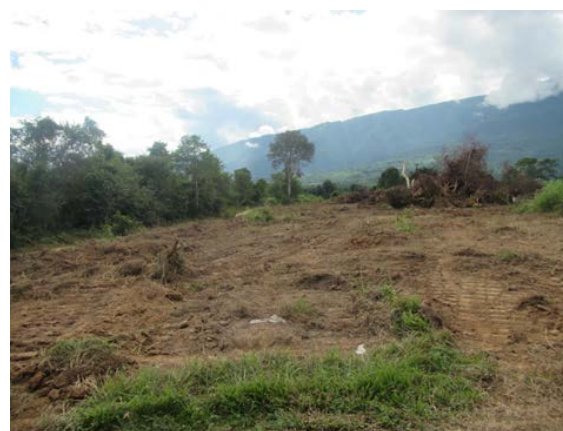
Photograph 13: Vegetation clearing using a bulldozer in Blocks 3 and 5

Activities in November 2016	Results
Labour recruitment	<ul style="list-style-type: none"> • 15 village labourers from Ban Nong were employed for vegetation clearing in Block 1 as the work resumed in late November 2016. • Daily contract for 30 village labourers from Ban Houaypamom for vegetation clearing in Block 10 is under preparation.
Perform UXO work for 9 blocks of priority biomass clearance	<ul style="list-style-type: none"> • UXO work (scrub cutting and UXO detection) completed around 128 ha in Block 10. There is no UXO found during the reporting period. • The progress of the UXO work in Block 10 can be seen in Figure 3-10.
Perform biomass clearance of block 1-9 on lower and central reservoir	<ul style="list-style-type: none"> • The meeting with Xaysomboun authorities on the remaining valuable timber in biomass clearance areas was held on 9 November 2016 at Xaysomboun Provincial Governor Office. Results of the meeting are as follows: <ul style="list-style-type: none"> ○ Biomass clearance shall continue as planned. ○ The contractor has to cut and stockpile the remaining timber with diameter >20 cm in the priority biomass clearance area. ○ NNP1PC, the Contractor and Xaysomboun Province will conduct weekly inspection and general inventory of felling and stockpiling of remaining value timber with diameter >20 cm in the priority biomass clearance area ○ Xaysomboun Provincial Authorities will consult with MONRE and MAF on utilization of remaining value timber. The remaining value timber trees shall be cut, stockpiled and burned at site if the Ministries decide that the timber may not be utilized. • Village consultation meeting on commencement of biomass clearance on Block 13-Block 18 in 2UR in Thathom District was held on 11 November 2016 with the following highlights: <ul style="list-style-type: none"> ○ Biomass clearance can start in Block 13-Block 18 (203 ha) in 2UR without any issue of land asset compensation. ○ Most of biomass clearance in B13-B18 in 2UR can be accessed by boat and walk. Biomass clearing will involve only hand cutting. ○ Decision on stockpiling of remaining value timber with diameter >20 cm will be made during ground survey for block demarcation and tree inventory. ○ Local labourers for biomass clearance in 2UR are available only from December 2016 after rice harvesting period. • Biomass clearance resumed in third week of November 2016 in Block 1, 3 and 5 using manual clearing in Block 1 and machinery clearing in Block 3 and 5. By the end of November 2016, the biomass cutting was completed in around 9 ha in Block 3 and 10 ha in Block 5.

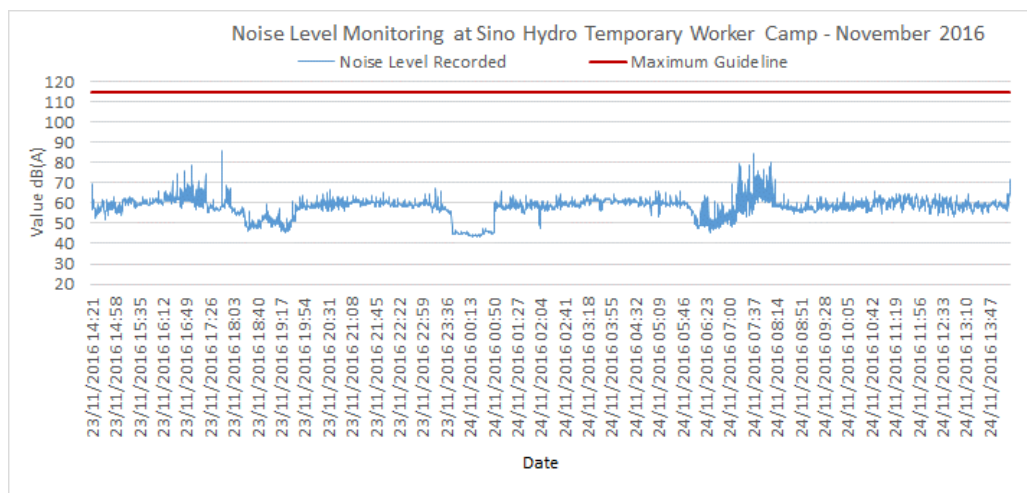
Figure C-8: Results of Noise Level Monitoring at Sino Hydro Temporary Worker Camp

Noise Level (dB)	23-24/11/2016		24/11/2016
	14:21 – 22:00	22:01 – 06:00	06:01-14:21
Maximum Value Recorded	85.9	67.1	84.7
Guideline Max	115	115	115
Average Data Recorded	58.10	57.31	58.46
Guideline Averaged	70	50	70
