NAM NGIEP 1
POWER COMPANY

Nam Ngiep 1 Hydropower Project

Environmental Management Monthly Monitoring Report

November 2017

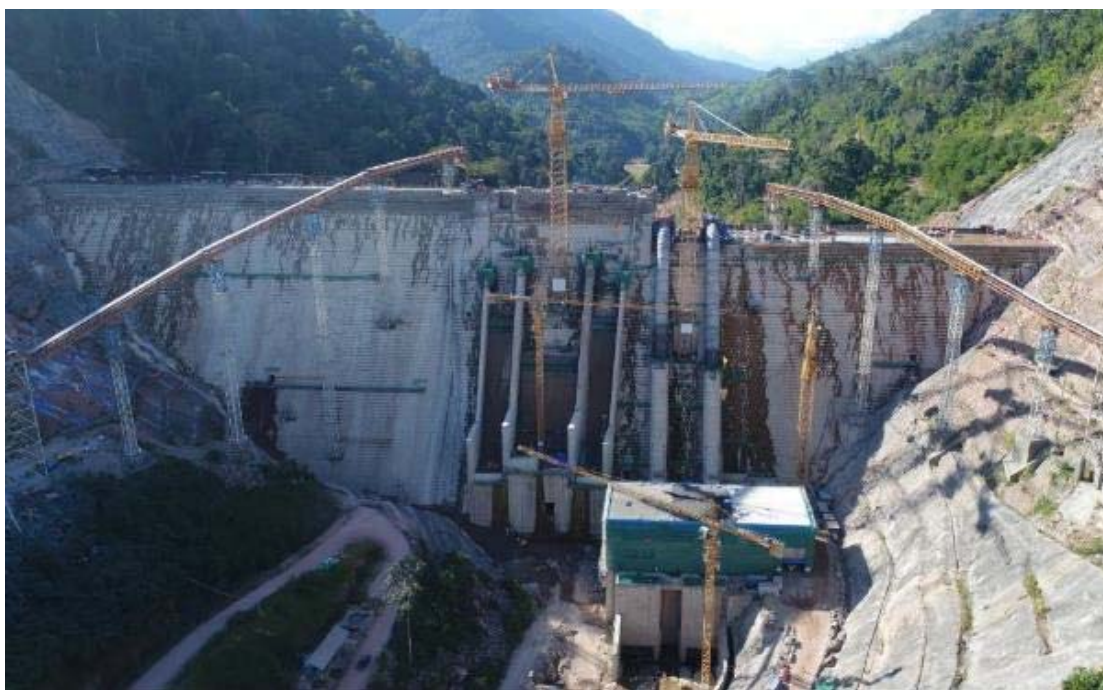
Figure 2-2: Main Dam and Powerhouse from Overhead Looking Upstream

After starting the main dam excavation works in October 2014 on the left bank, the works were about one month advanced when diversion of the Nam Ngiep River was achieved at the end of October 2015. However, excavated volumes were 20% greater than expected and part of this additional work is necessary to construct a 'shear key' structure due to the weak layers of rock encountered in the dam foundation. Following the efforts on Site, the additional excavation work was completed at the end of February 2016.

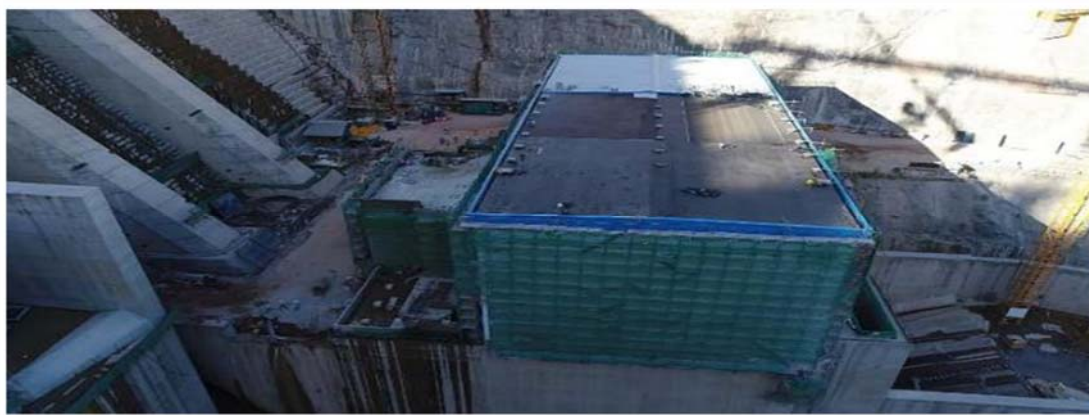
Table 2-2: Progress of Main Powerhouse Sub-Structure Concrete Works to November 2017.

Location	Total Anticipated Volume (m ³)	Completed (m ³)	Progress (%)
Main Powerhouse	32,600	31,870	97
Penstock Embedment	10,257	8,571	83
Spillway	37,650	10,861	29

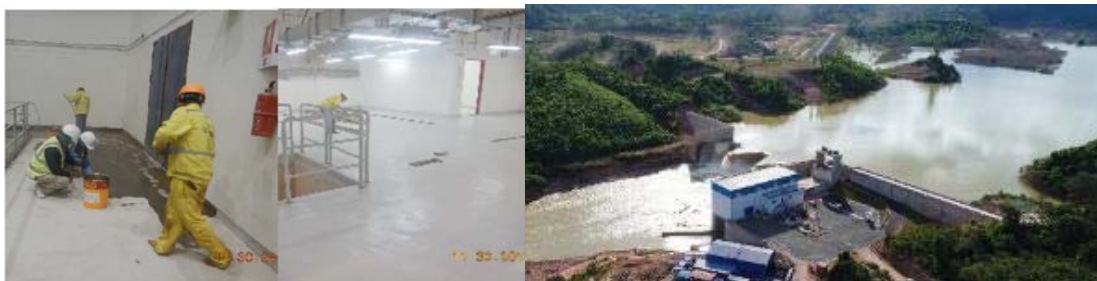
Powerhouse Building Works	Concrete Second Phase (m ³)	Painting Inside and Outside (m ²)	Lighting Fixture (nos)	Electrical Conduit and Wire (m)	Handrail (m)	Duct Work (m)	Fire Alarm System (Conduit) (m)	Epoxy Coating (Dust and Acid) (m ²)
Designed	3,496	6,135	311	2,510	460	345	1,208	1,476
Completed	3,496	5,024	296	2,460	414	345	1,208	875
Progress	100 %	82 %	95 %	98 %	90 %	100 %	100%	59%

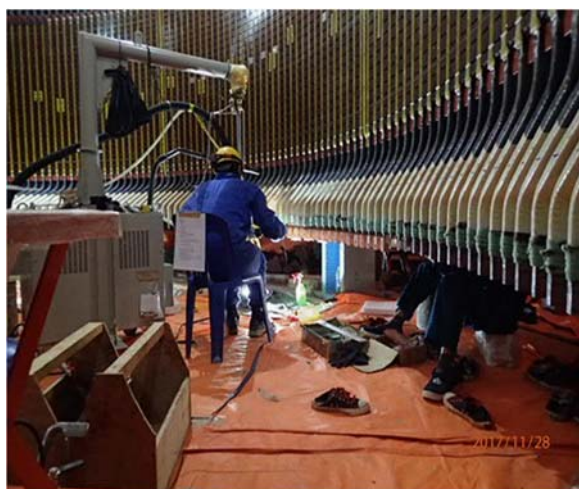
Figure 2-4: Preparation for installation of stay ring OHTC for unit 1 at the main powerhouse

The EMWC was executed between Hitachi-Mitsubishi Hydro Corporation and NNP1PC on 13 June 2014 and the NTP was issued on 03 October 2014. The cumulative work progress of the Electrical and Mechanical Works by value at the end of November 2017 was 91.6 % (compared to planned progress of 95.1 %).

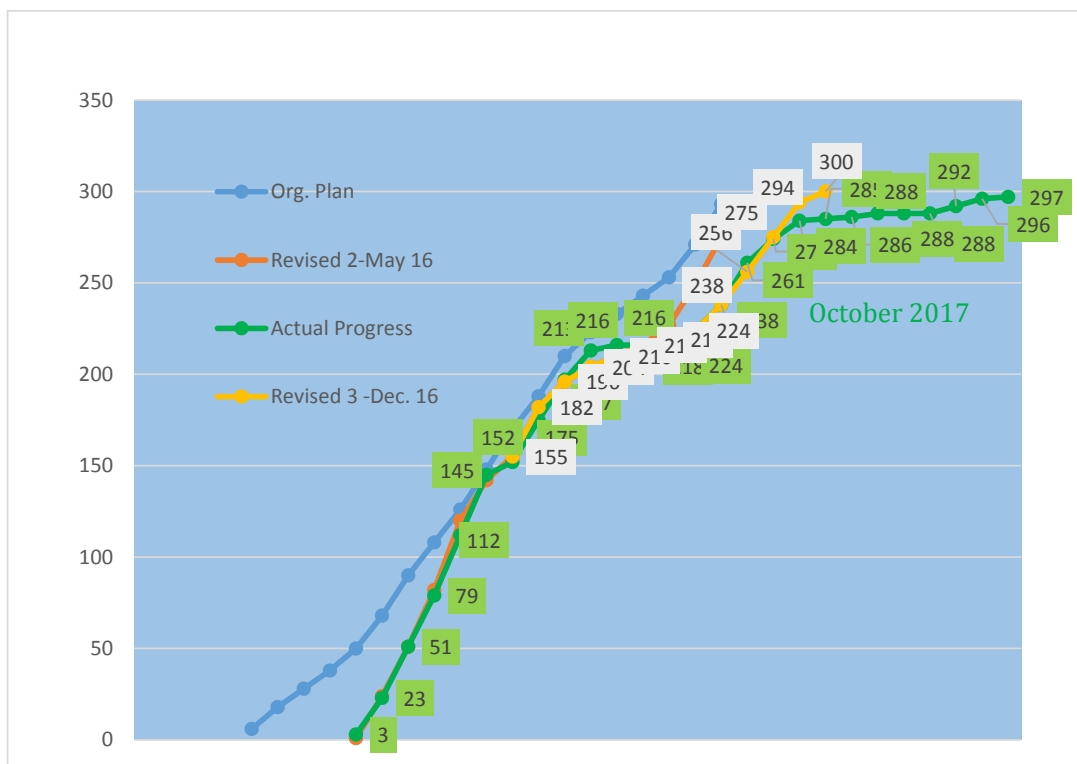
Figure 2-7: Cumulative Work Progress of Tower Foundation (Original Planned and Actual)

In respect of the delay to commencement of most works the Contractor is studying its programme to ensure that sufficient resources are committed as the works progress to ensure that completion is achieved in good time. Onset of daily rains has made access to all areas difficult but the Contractor follows its revised acceleration schedule, after the progress for the construction of tower foundations slowed after May, 2016 (See **Figure 2-7** below)

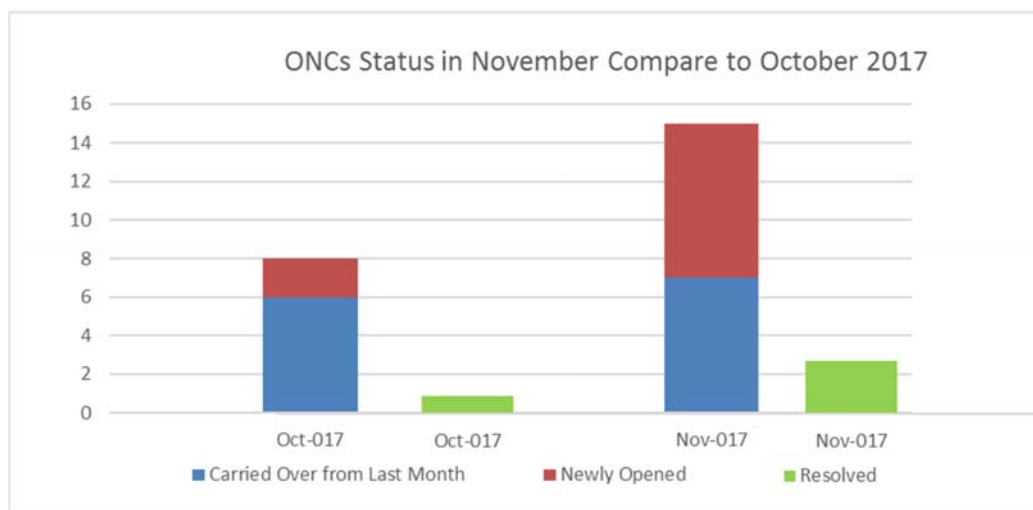
Figure 3-1: Summary of ONC and NCR

Total in November 2017	15	0	2	0
Resolved in November 2017	3	0	1	0
Carried over into December 2017	12	0	1	0
Unsolved Exceeding Deadlines	6	0	1	0

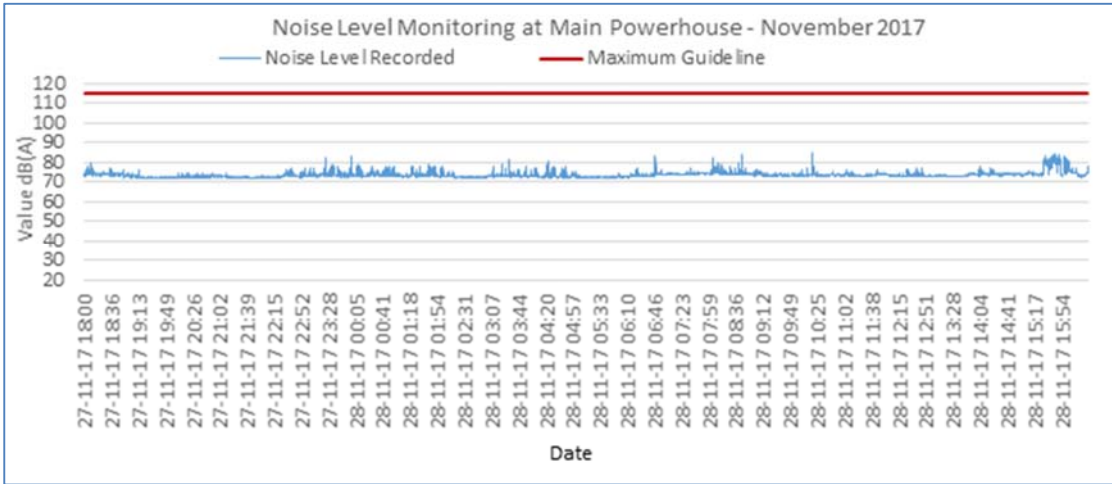
Figure C- 8: Results of Noise Level Monitoring at Main Powerhouse in November 2017

The results at all stations (except Hat Gniun Village and Main Powerhouse) indicated compliance with National Standard for the period of 06:01-22:00. The noise levels during the period of 22:01-18:00 were higher than the Standard at the Main Powerhouse.

Noise Level (dB)	27-28/November/17		28/November/17
	16:00 – 22:00	22:01 – 06:00	06:01-17:30
Data Record Max	79.9	83.5	84.7
Guideline Max	115	115	115
Data Record Average	72.88	73.20	74.03
Guideline Averaged	70	70	70
