## Nam Ngiep 1 Hydropower Project

# Environmental Management Monthly Monitoring Report

October 2016

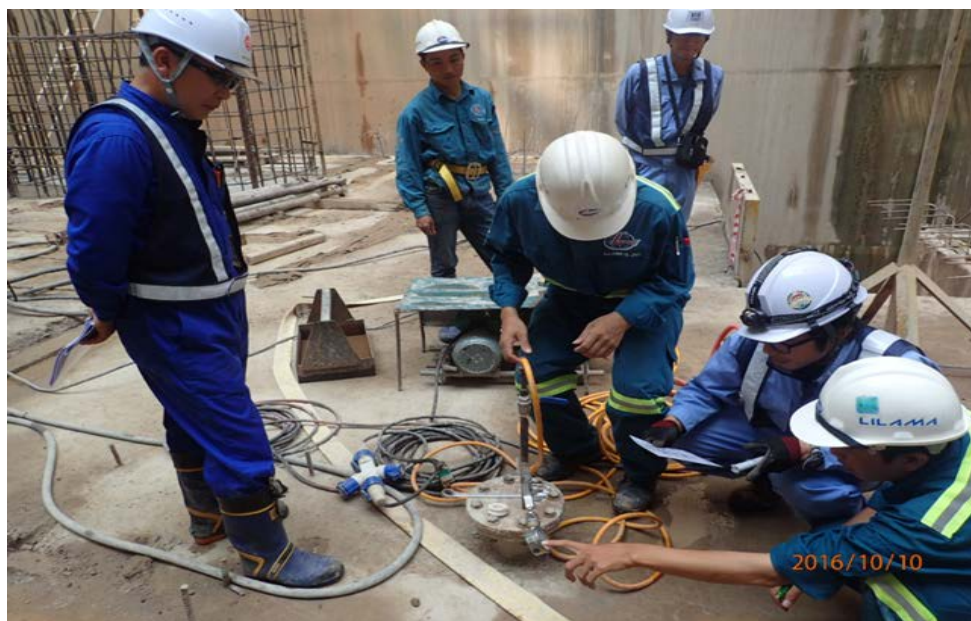
Figure 2-5: Embedded piping installation (Main powerhouse)

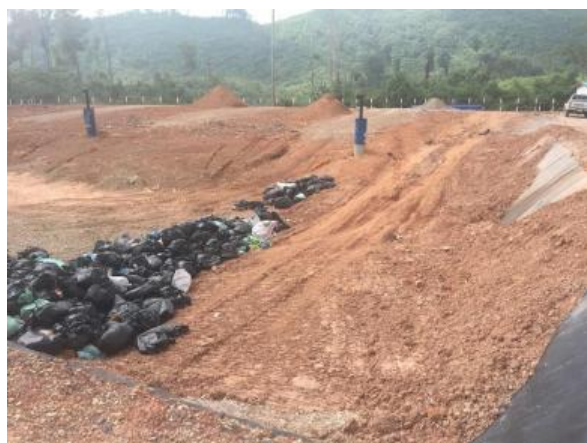
In October 2016, NNP1PC closely supervised the landfill operation including waste disposal, waste compaction and soil cover activities. The Landfill operation has generally improved when compared to the last month. With dry weather a rubber-tyred excavator replaced a crawler based excavator for spreading and compaction of waste and soil cover. The Contractors were instructed to properly segregate the waste prior to disposal. This practice helped reducing disposal of mixed waste in the landfill, as verified during the daily spot checking and supervision. Approximately 127 m<sup>3</sup> of waste was disposed of at the NNP1 Project Landfill during October 2016, a decrease of 44 m<sup>3</sup> compared to September 2016 (see Photograph 1 and Photograph 2).

Photograph 1: Waste compaction and soil cover at the NNP1 Project landfill

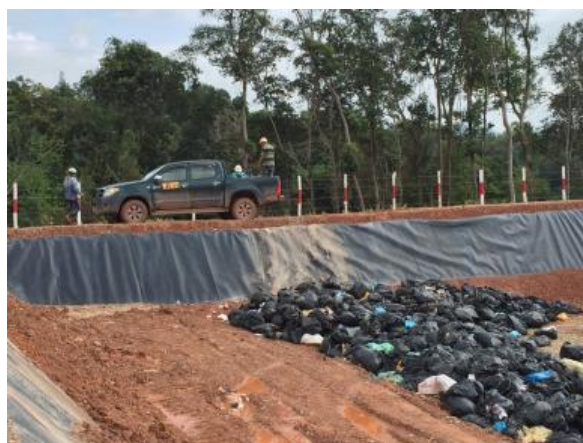
Photograph 2: Waste disposal spot checking by supervision at NNP1 Project Landfill

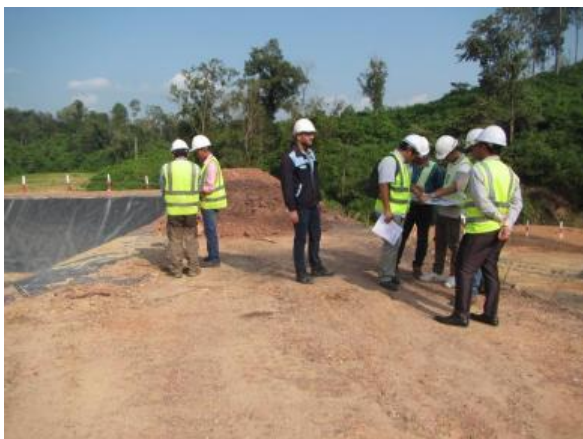
In October 2016, a joint final inspection of the 1<sup>st</sup> stage construction of the Houay Soup Landfill was conducted by NNP1PC and a Contractor which consisted of a waste pit (P1) with a capacity of 900 m<sup>3</sup>, 2 anaerobic ponds and a wetland pond for leachate treatment, a groundwater monitoring borehole and a temporary fence. The Houay Soup Landfill was operated every Tuesday and Thursday from 09:30 to 10:30 am through individual arrangement with NNP1PC-EMO staff for waste disposal from host villages, residents and Contractors who work in the Houay Soup Resettlement Area. A total of 10 m<sup>3</sup> of solid waste from HSRA's Contractors was disposed at the permanent waste pit. This amount is likely to increase once Hatsaykham villagers move to the HSRA and new groups of Contractors start the construction activities for villagers in 2LR (lower Reservoir) at HSRA in December 2016 (see **Photograph 7** and **Photograph 8** below).

Photograph 7: A final inspection on the 1<sup>st</sup> stage Houay Soup Landfill construction

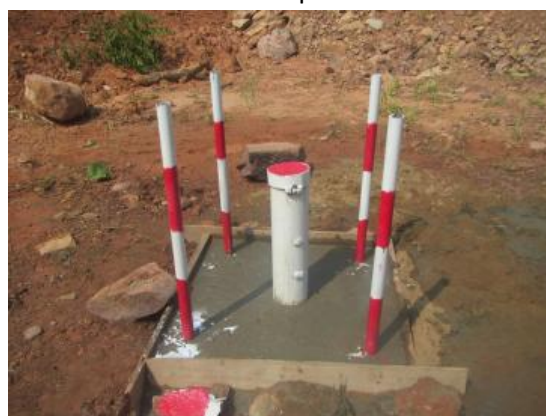
Photograph 8: Construction of the ground water monitoring borehole was completed
