Nam Ngiep 1 Hydropower Project

Environmental Management Monthly Monitoring Report

September 2016

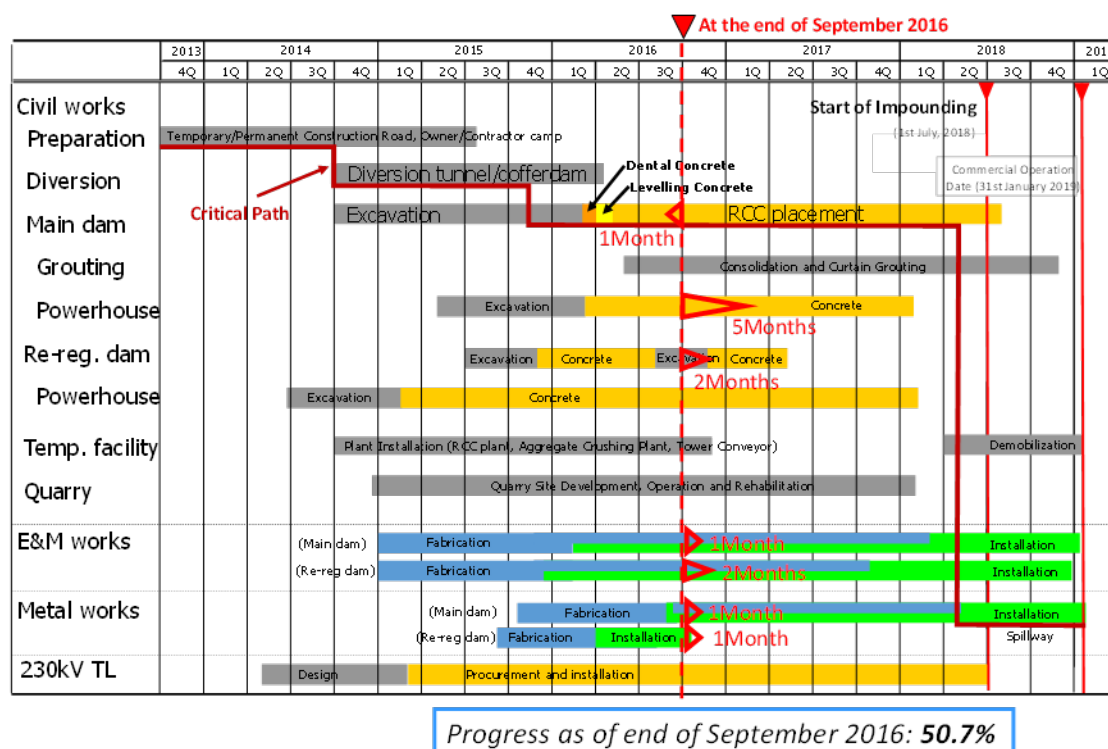
Figure 2-1: Overall Construction Schedule

The overall construction schedule and progress curve (by achieved Milestone Payments) are shown in Figure 2-1.

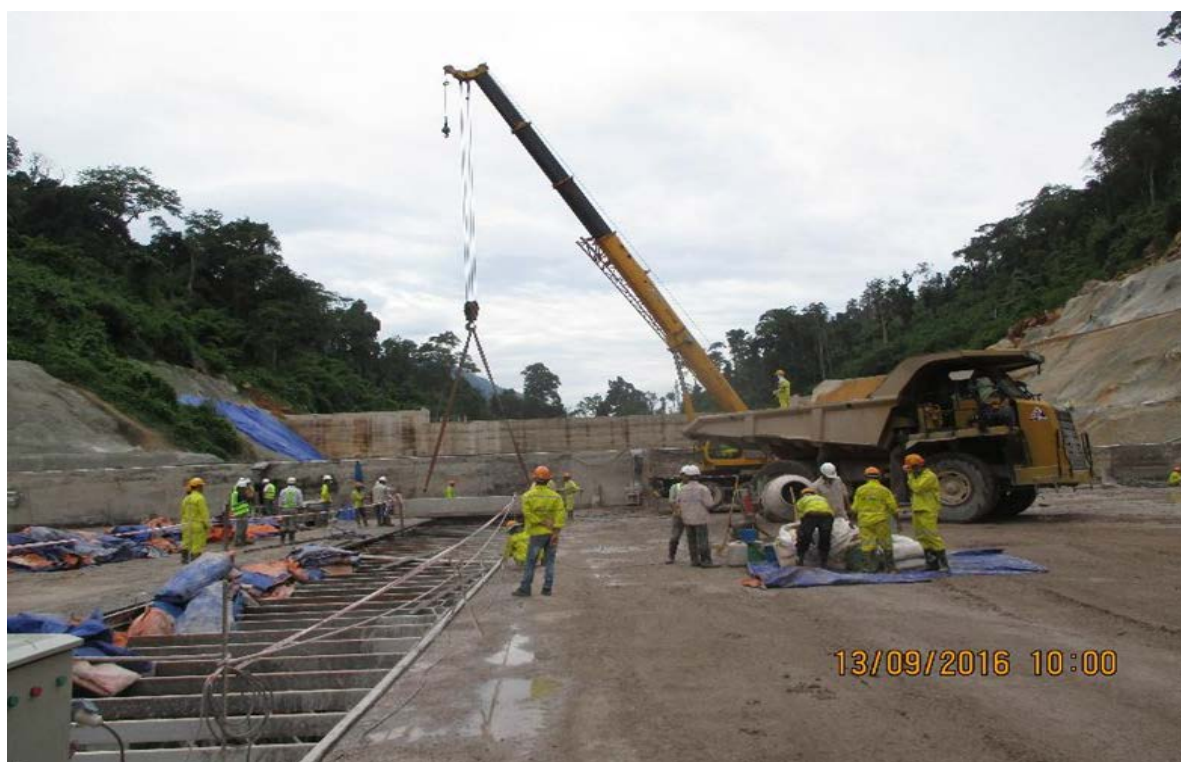
Figure 2-2 Installation of precast concrete lintels for Diversion Conduit at El.189.7 m

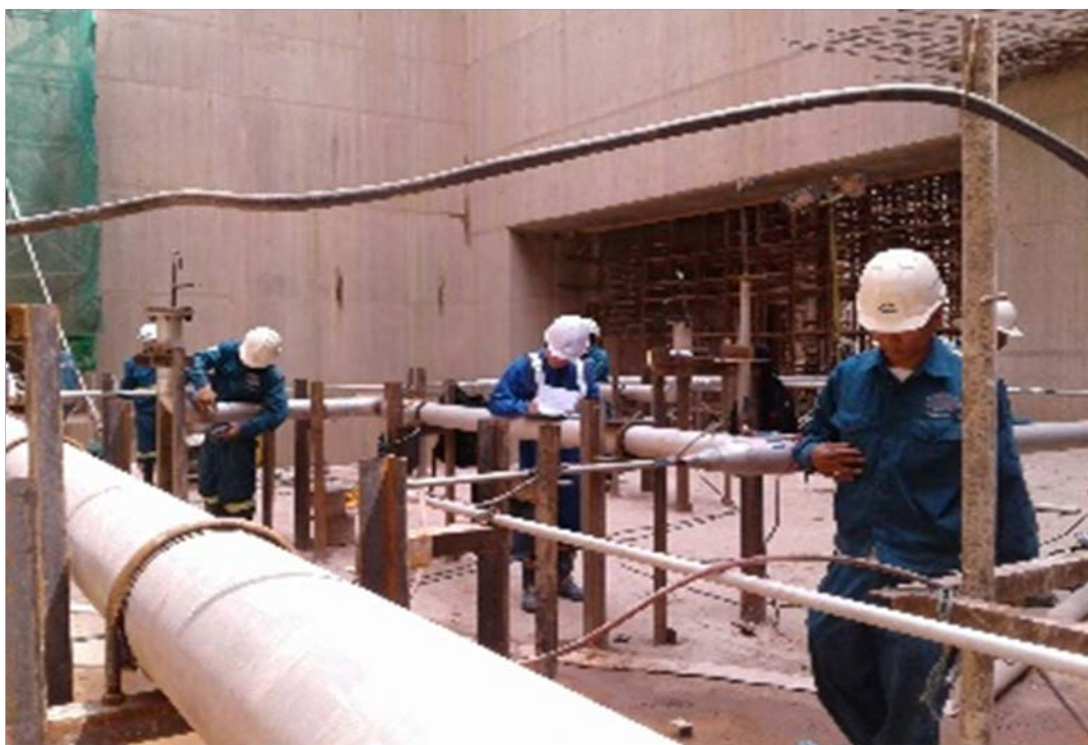
Figure 2-3: Embedded piping installation (Main powerhouse)

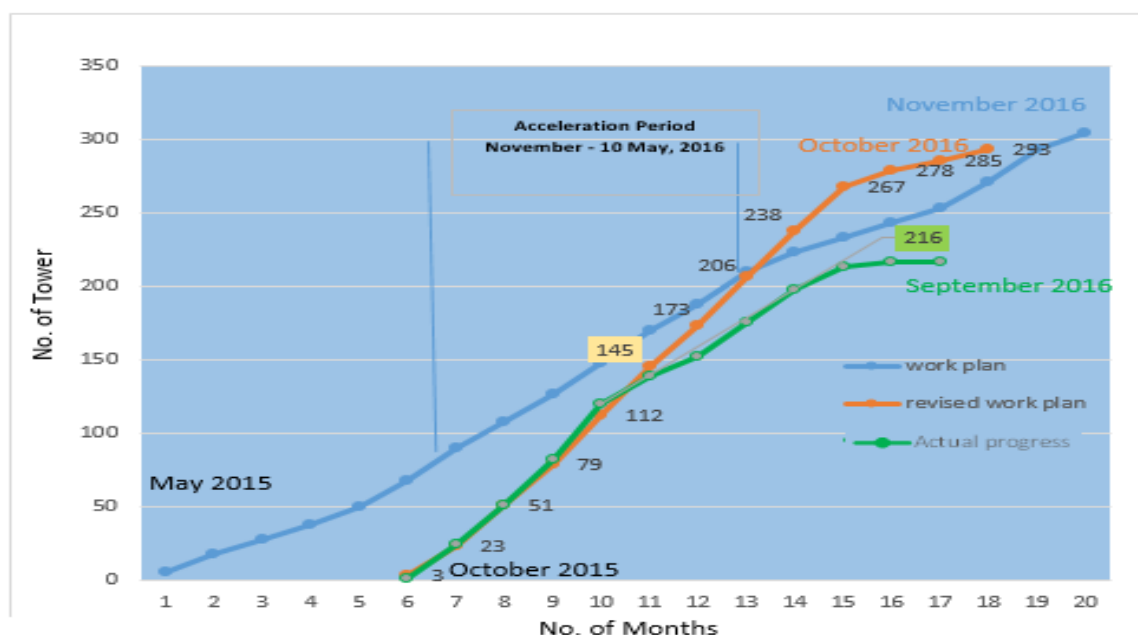
In respect of the delay to commencement of most works the Contractor is studying its programme to ensure that sufficient resources are committed as the works progress to ensure that completion is achieved in good time. Onset of daily rains has made access to all areas difficult but the Contractor follows its revised acceleration schedule, after the progress for the construction of tower foundations slowed after April, 2016 (See Figure 2-4 below)

Figure 2-4 Cumulative Work Progress of Tower Installation (Plan and Actual)

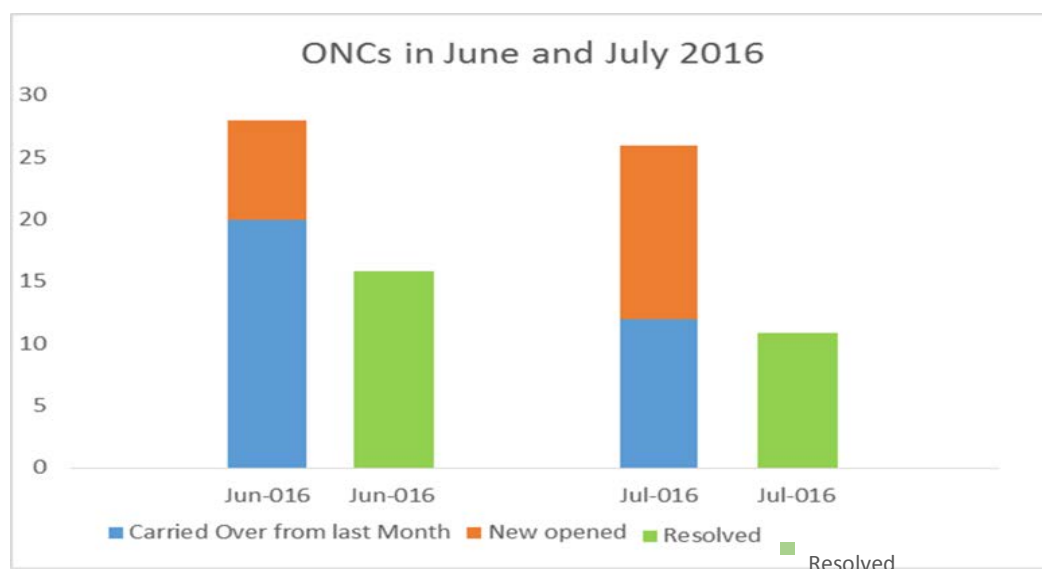
Reporting Period (01-30 September 2016)	ONC	NCR-1	NCR-2	NCR-3
Carried over from August 2016	15	1	0	0
New issues this month	6	0	0	0
Resolved this month	8	0	0	0
Carried forward into October 2016	13	1	0	0
Unresolved exceeding deadline	8	1	0	0

Figure 3-5: Observations of non-compliance (ONCs) this September 2016 Compared with August 2016

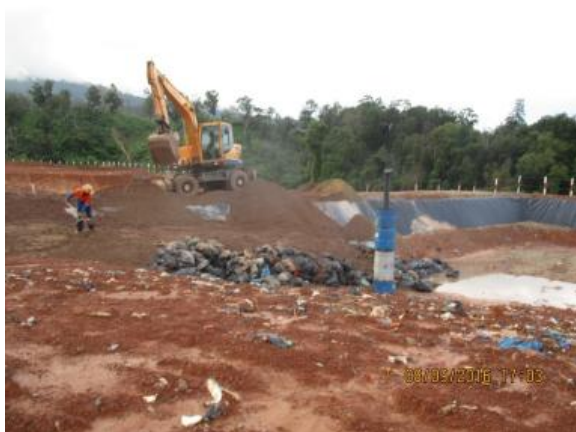
In September 2016, NNP1PC closely supervised the landfill operations including waste disposal and compaction. Inadequate waste segregation at the source was still evident at a number of subcontractors' camps where some recyclables were mixed with general and construction wastes. The Contractors and their Subcontractors were instructed to properly segregate the mixed waste prior to the disposal. Approximately 170.5 m³ of waste was disposed of at the NNP1 Project Landfill during September 2016, an increase of 67.5 m³ compared with August 2016 (see Photograph 1 and Photograph 2).

Photograph 1: Waste Compaction and Soil Cover at the Landfill

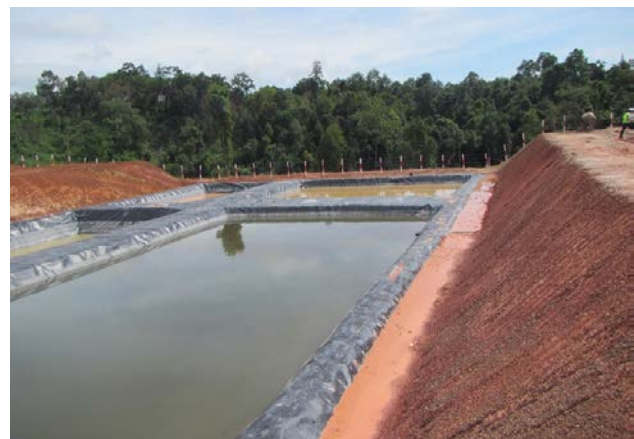
During September 2016, water samples were taken from all four (04) landfill leachate ponds. During the mission, it was found that leachate overflowed from the ponds into the open drainage around the ponds and was discharged to the side drainage at the entrance to the landfill. A sample of the leachate was also collected (LL5) from the outlet drainage pipe to understand the potential impacts of the unscheduled discharge of untreated leachate which was caused by a number of heavy rain events. As a temporary solution to this issue, the landfill operators are recycling the leachate by pumping it from the last pond back to the waste pit.

Photograph 2: The Leachate from the Final Treatment Pond was pumped to the Waste Pit

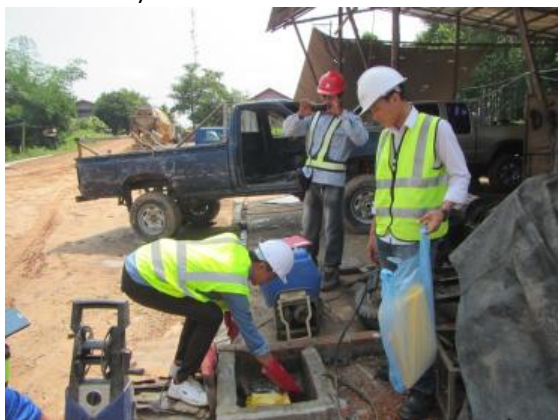
Photograph 3: Hazardous Waste Management for Loxley's RCR Subcontractor (230 kV TL Contractor)

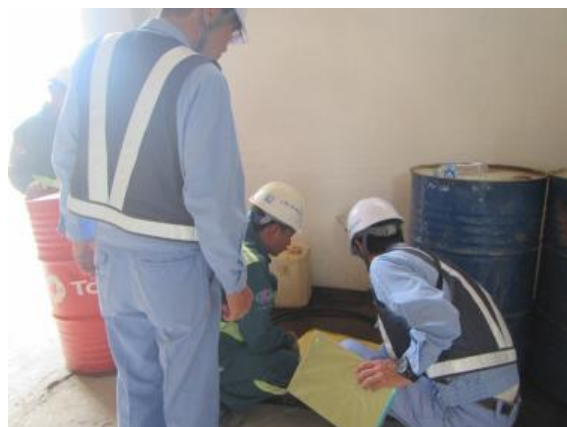
Photograph 4: Hazardous Waste Management for H-M Hydro's LILAMA10 Subcontractor

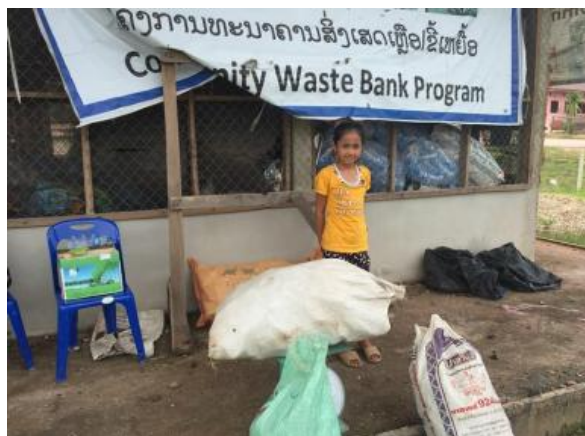
Photograph 5: Recyclable Waste Were Sold to the Community Recycle Waste Bank

In September 2016, the purchase of recyclables from villagers and students continued. Some recyclables were transported from Contractors' camps to the Recycle Waste Bank at Hat Gniun Village. Recyclables will continue to be stockpiled at the Community Recycle Waste Bank, the Owner's Site Office and Village and the Contractors/subcontractors with the intention of arranging a routine collection by the Khounmixay Processing Factory. Houay Soup Resettlement Area Waste Management.

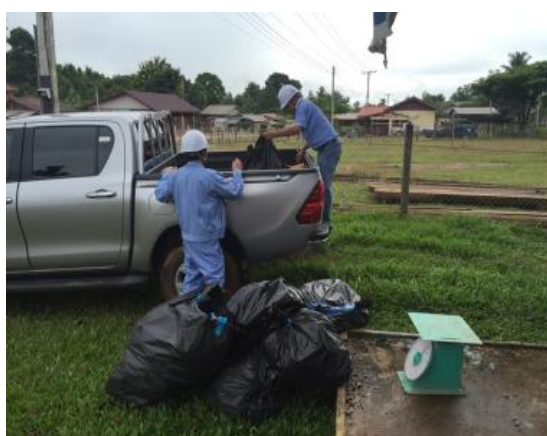
**Photograph 6: Recyclables Received from the Contractor**

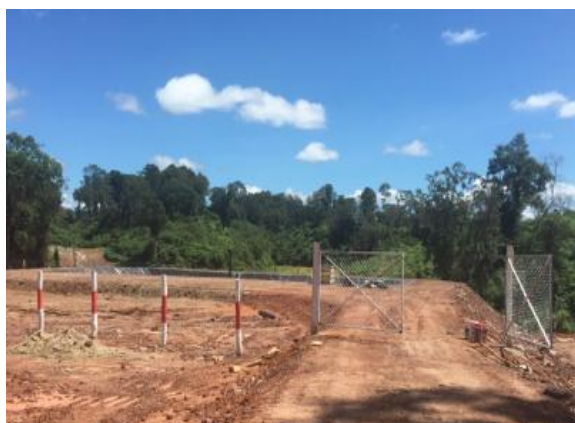
In September 2016, the Houay soup landfill temporary waste pit started operating and will be opened every Tuesday and Thursday from 09:30 to 10:30 am through individual arrangement with NNP1PC-EMO staff. A total of 0.2 m3 of solid waste from HSRA's Contractors was disposed at the temporary waste pit. In addition, the wetland pond and temporary fence construction was nearly completed.

Photograph 7: Temporary Fence and Gate Construction at Houay Soup Landfill

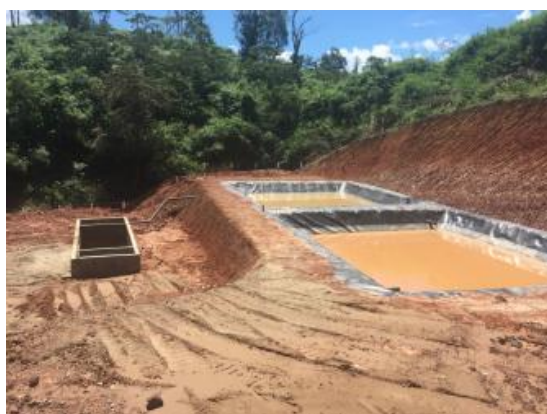
Photograph 8: Wetland pond construction was Nearly Completed

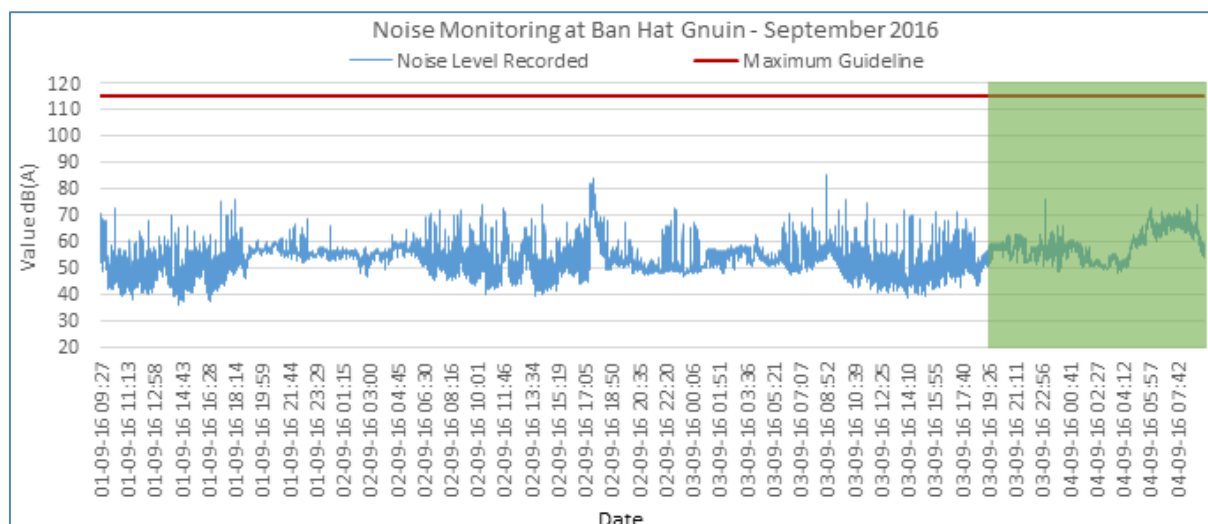
At Hat Gnuin Village, the records indicated that most average noise level monitored during 01 -04 September 2016 were higher than the standard. The average noise level during the period of 18:01-

Figure B- 1: Result of Noise Level Monitoring at Ban Hat Gnuin in September 2016

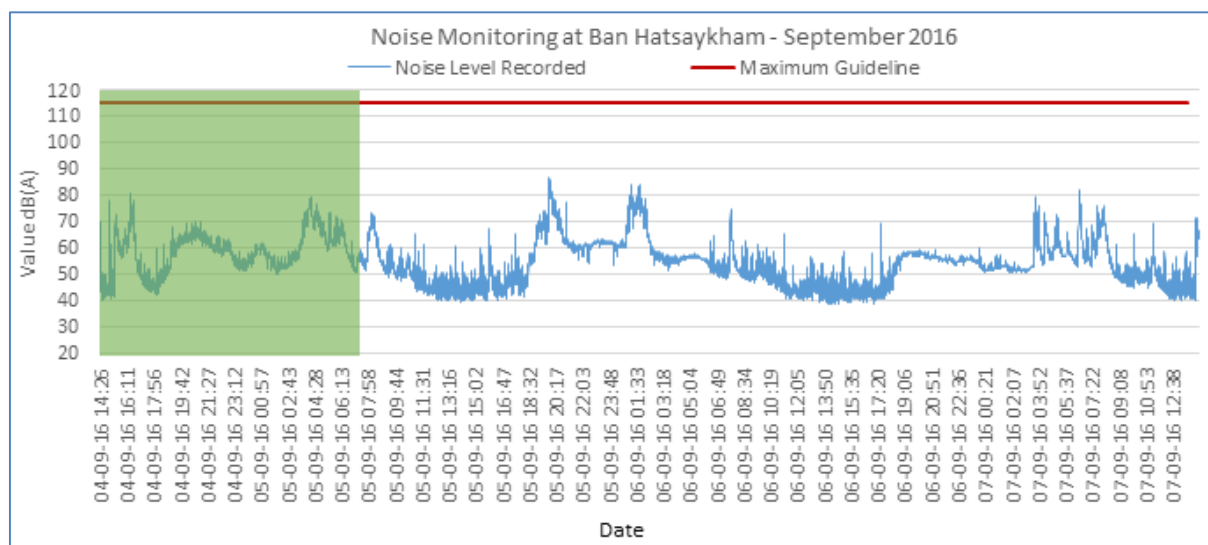
06:00 at Hatsaykham Village monitored during 04-07 September 2016 were higher than the standard with an average data recorded between 55.58 – 63.22 dB(A).

Figure B- 2: Results of Noise Level Monitoring at Ban Hatsaykham September 2016

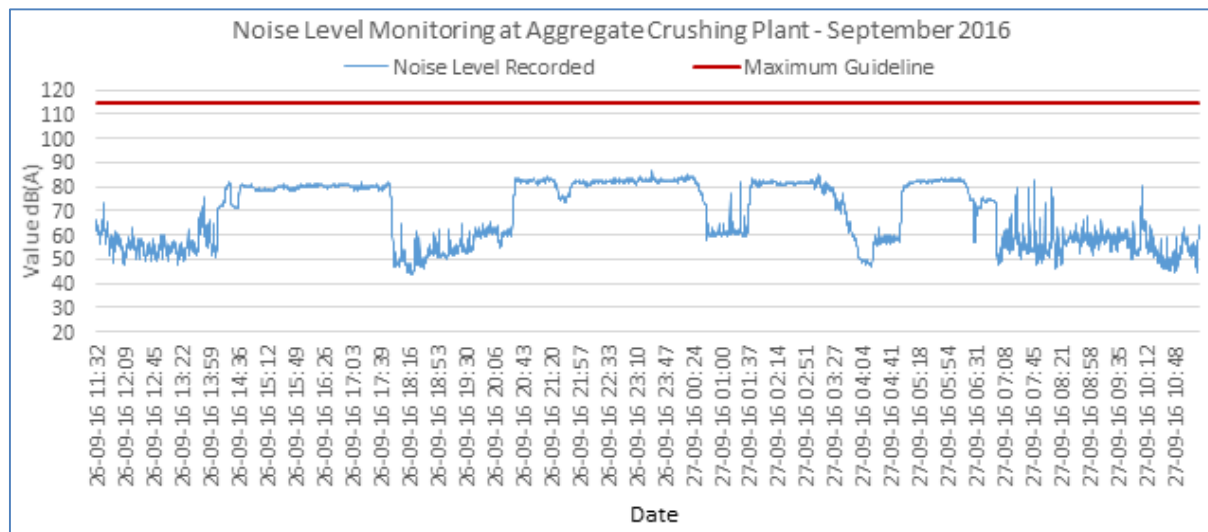
The noise levels recorded at all Project Construction Site's stations indicated full compliance with the National Standard for the period of 06:01-22:00. However, for the period of 22:01-06:00, slightly higher noise levels than the Standard were recorded at the RCC, Aggregate Crushing Plant, Sino Hydro Camp, Sino Hydro Temporary Workers' Camp, Song Da 5 Camp No. 2, the Main Dam and Owner's Site Office and Village [between 51.09 – 75.32 dB(A) compared to the Standard of 50 dB(A)]. The key causes of high noise levels were most likely to be the windy and raining conditions during the night time period except at the Aggregate Crushing Plant where the crushing machine operated during the night time period.

Figure B- 3: Results of Noise Level Monitoring at Aggregate Crushing Plant in September 2016

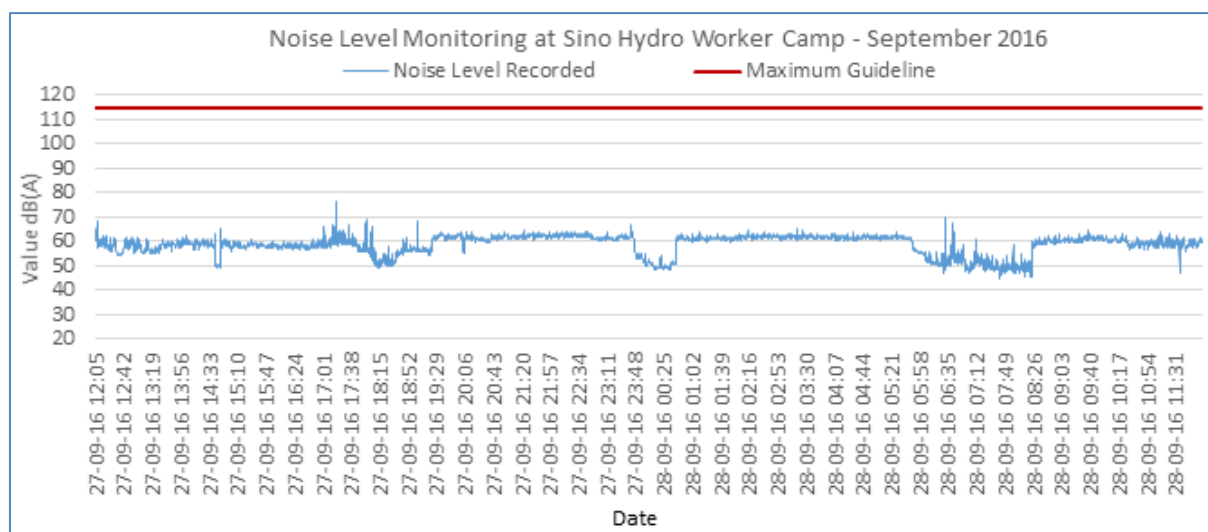
Noise Level (dB)	27-28/09/2016		28/09/2016
	12:05 - 22:00	22:01 - 06:00	06:01 12:05
Maximum Value Recorded	76.7	66.5	69.5
Guideline Max	115	115	115
Average Data Recorded	58.68	60.26	56.27
Guideline Averaged	70	50	70

Figure B- 9: Results of Noise Level Monitoring at Sino Hydro Temporary Worker Camp
