## Nam Ngiep 1 Hydropower Project

# Environmental Management Monthly Monitoring Report

September 2020

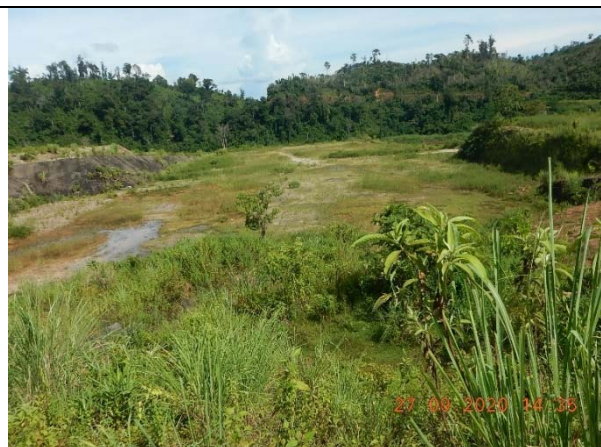
**FIGURE 2-9: RE-VEGETATION OF RCC PLANT YARD**

Demobilization of plant facilities for both RCC and CVC plants was completed in December 2019. The vegetation improvement for rehabilitation of those areas is ongoing.

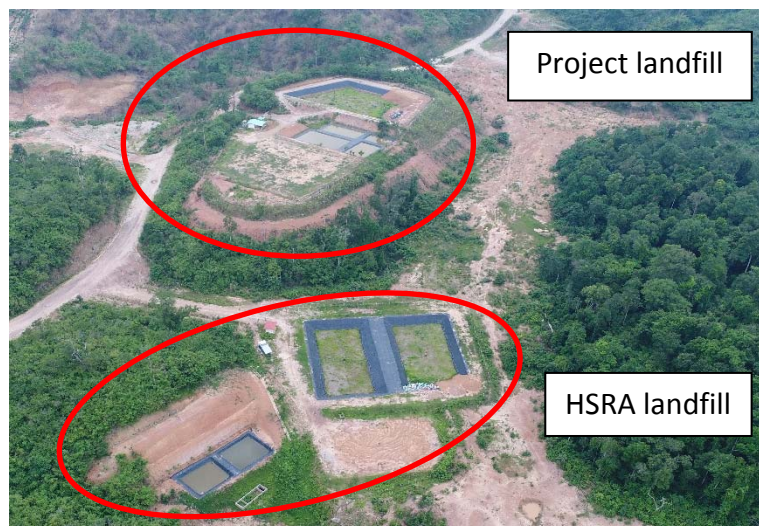
**FIGURE 2-12: PHASE 2 OF PROJECT LANDFILL DEVELOPMENT ON 08 JUNE 2017**

The operation of both HSRA and Project landfills is ongoing with collection waste materials from Resettlement “Phouhomxay”, neighbour villages and the Owner Site Office and Village.

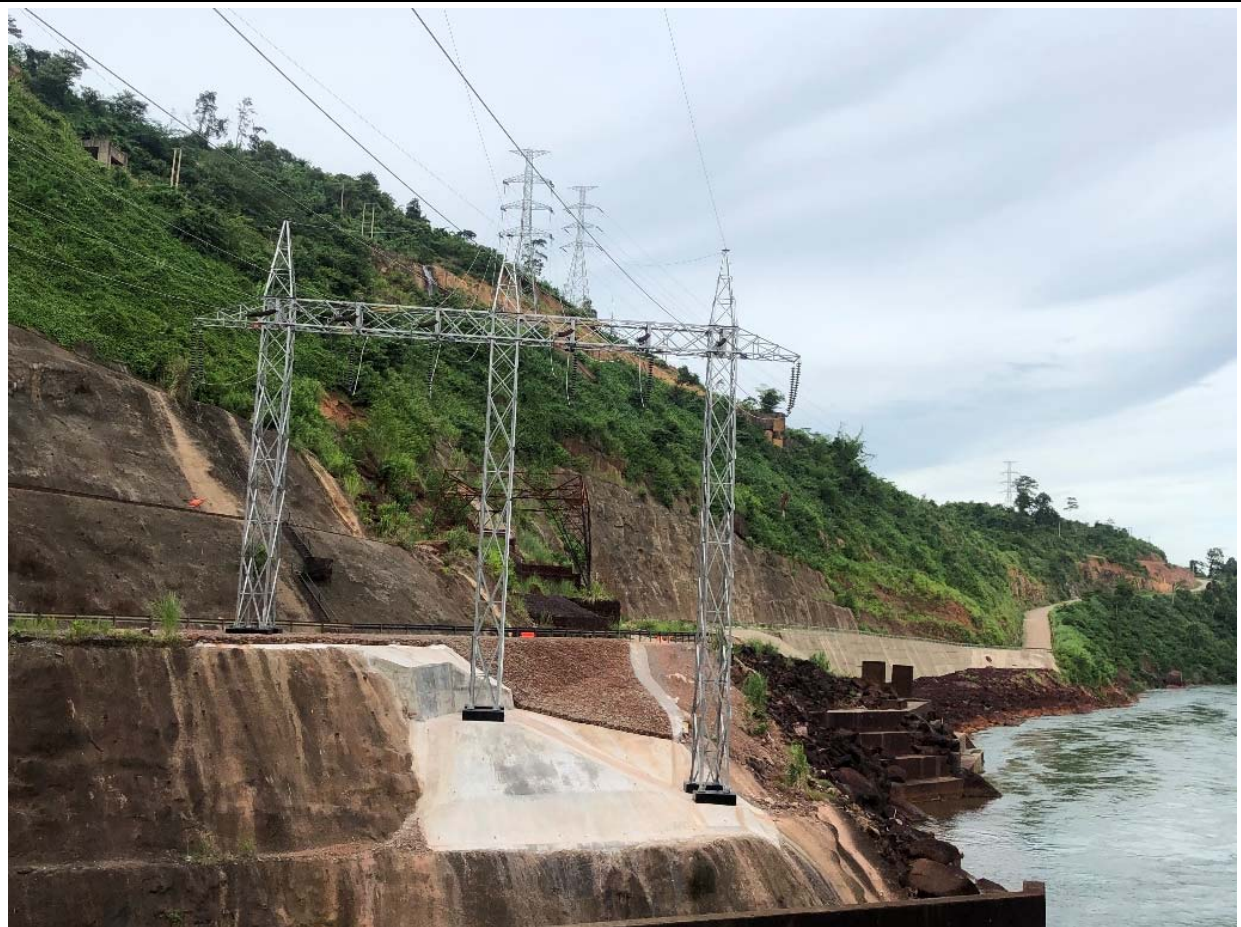
**FIGURE 2-14: TOP VIEW OF GANTRY STRUCTURE \_SLOPE PROTECTION AROUND FOUNDATION ONGOING**

The Tower No.1 was damaged due to the slope failure of approximately 150 m<sup>3</sup> volume of material above and behind Tower No.1 that occurred overnight on 17 to 18 of August 2019. Some of the structural steel members of the Tower No.1 were deformed. Tower No.1 did not move significantly but remained an unsafe structure. Movement of the upper part of the steel structure of the tower was observed.

Therefore, a Temporary Tower No.1 was constructed and the transmission line was moved to this tower from the damaged tower over the period of 06 to 24 September 2019. The construction of the permanent Replacement Tower No.1 and disassembly of existing Tower No.1 was contracted in late December 2019. The foundation excavation for the legs of the new Tower No.1 started in the middle of January 2020 was completed on February 2020; the damaged Tower No.1 was almost dismantled in January 2020. The installation of gantry structure and new Tower No.1 was completed in the beginning of April 2020. Energization test was completed on 30 April 2020. The gabion mattress installation for slope protection of gantry structure was completed in September. An additional slope protection work around existing tower foundation will be started in October 2020 and will be completed in middle of October.

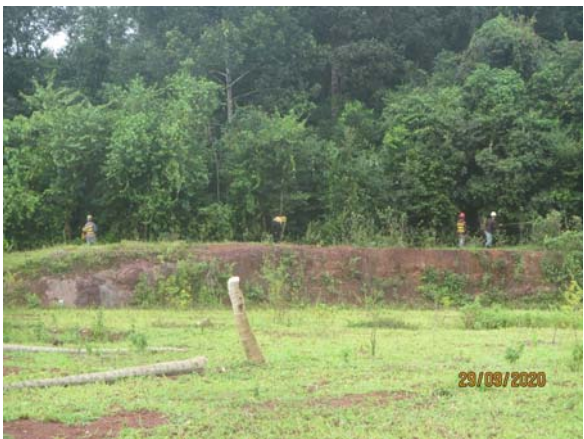
**FIGURE 3-1: ADDITIONAL COUNTER MEASURES FOR THE SITE REHABILITATION IN SEPTEMBER 2020**

<b>OC CAMP</b> Temporary perimeter fence maintenance

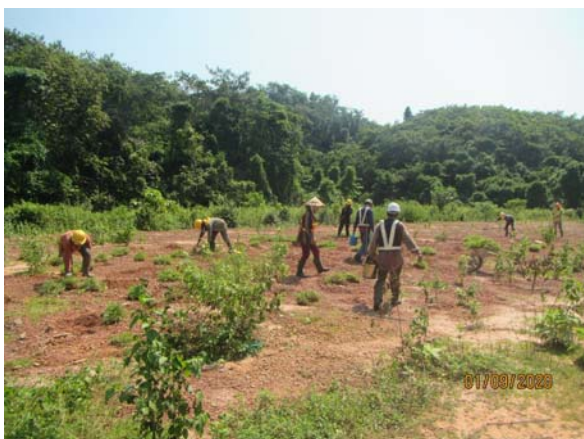
<b>LILAMA10 CAMP</b> Local grass planting/revegetation

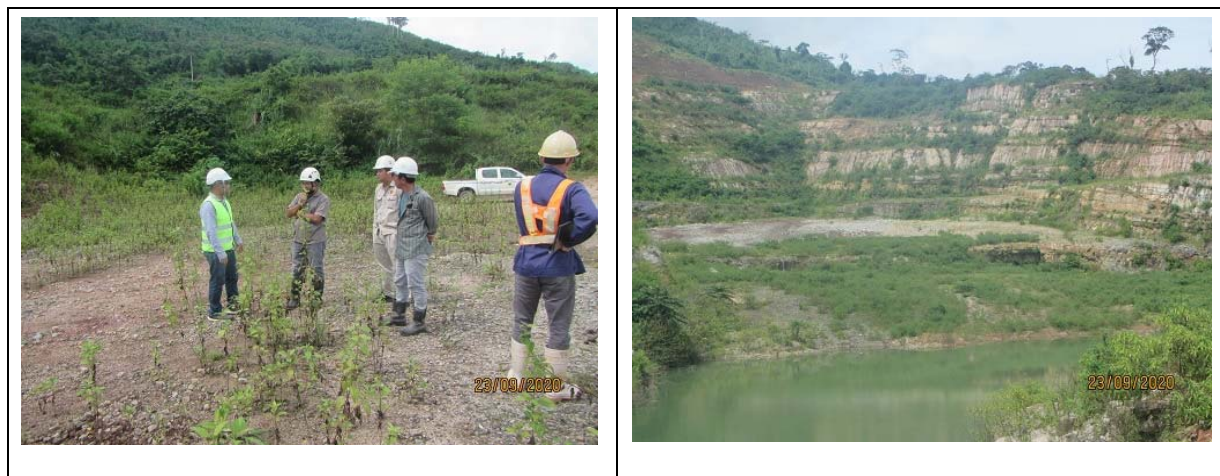
<b>AGGREGATE PLANT (BOTTOM PLATFORM)</b> EMO, TD and OC joint quarterly inspection	<b>MAIN QUARRY (BOTTOM VIEW)</b>
