Nam Ngiep 1 Hydropower Project

Environmental Management Monthly Monitoring Report

October 2021

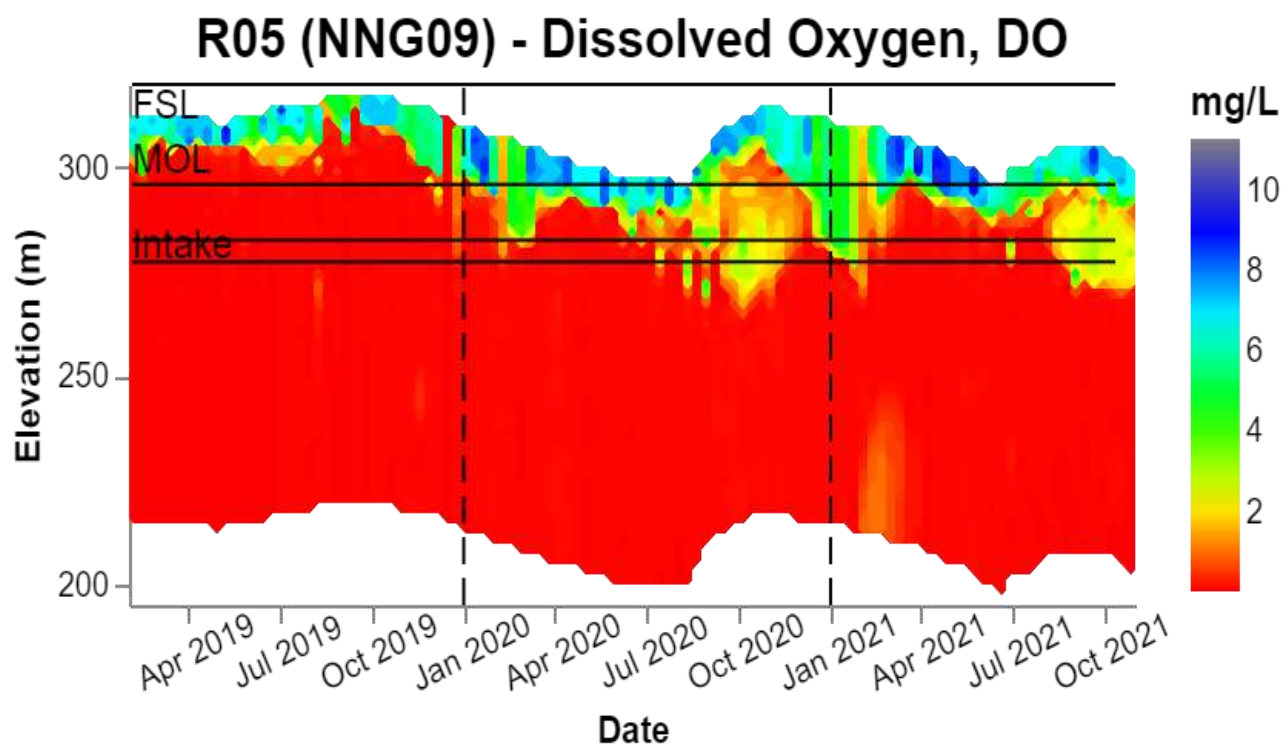
FIGURE 1-2 DO DEPTH PROFILES IN R05 (INDIVIDUAL MEASUREMENT DATA)

At R05, the average DO concentration was 7.3 mg/L in the upper 9.5 m varying between 6.5 mg/L and 8.1 mg/L, and the oxycline was generally found at a depth of 10.0 – 13.0 m with DO concentrations between about 2 mg/L and 5 mg/L – similar to September 2021. As shown in *Figure 1-2*, at the intake level (approximately 24 m below surface), the mean DO concentration was 2 mg/L during October 2021. DO concentrations below 0.5 mg/L (anoxic condition) were recorded at depths below 34 m corresponding to 7.5 m below the Intake in early October 2021 to 7.4 m below the Intake by the end of the month, taking into consideration the decreased water level in the reservoir over the period.

As also indicated in *Figure 1-2*, the slightly elevated DO concentrations at the intake level appeared around August 2021 and has continued at least until the end of October 2021. A somewhat similar picture is seen in August-October 2020.

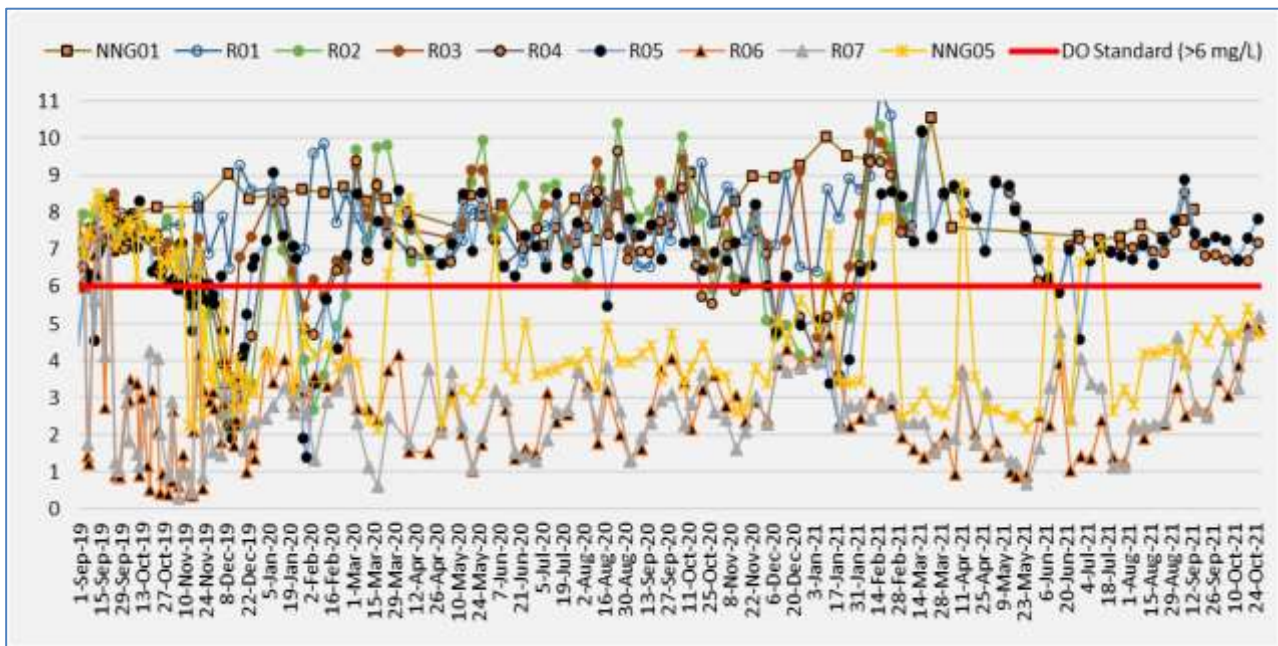
FIGURE 1-4: CONCENTRATION OF DISSOLVED OXYGEN (MG/L) IN THE UPPER 0.2 M SINCE SEPTEMBER 2019 TO OCTOBER 2021

The mean DO concentration at the water surface were 4.1 mg/L and 4.4 mg/L in R06 and R07 respectively during October 2021.

During periods with turbine discharge, the DO concentrations at NNG05 about 1.8 km downstream of the Re-regulation Dam varied between 4.6 mg/L and 5.4 mg/L with an average of 4.8 mg/L.

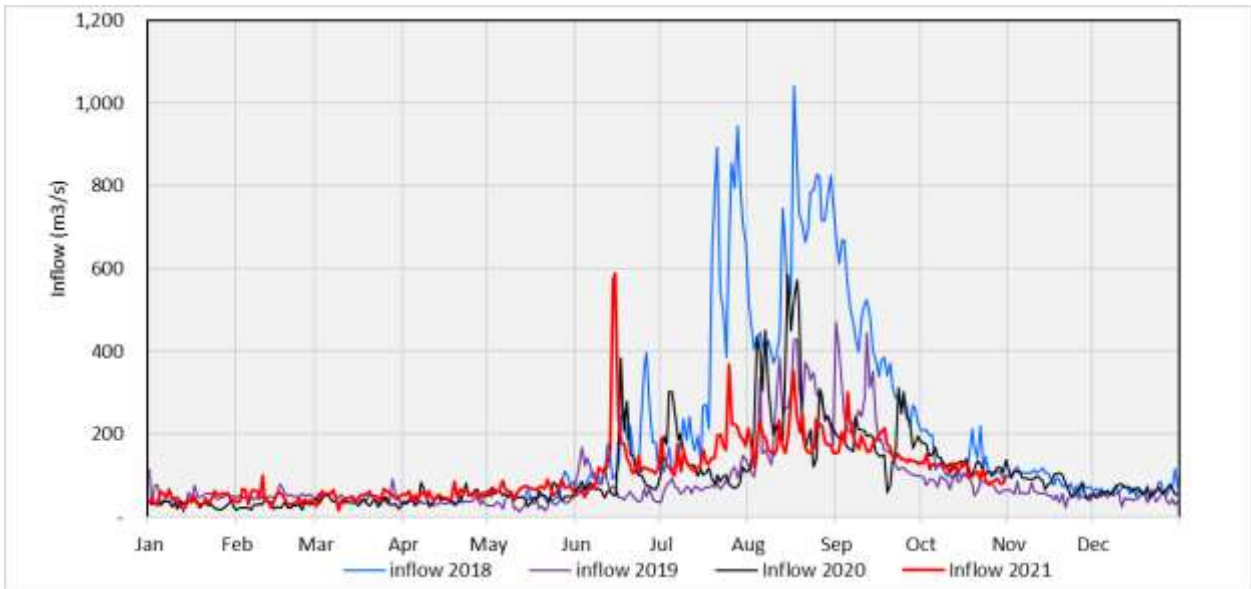
FIGURE 1-5: INFLOW TO THE MAIN RESERVOIR

During October 2021, the mean inflow to the main reservoir was 110 m³/s. The minimum and maximum inflows were 77 m³/s (on 25 October 2021) and 152 m³/s (on 03 October 2021) respectively.

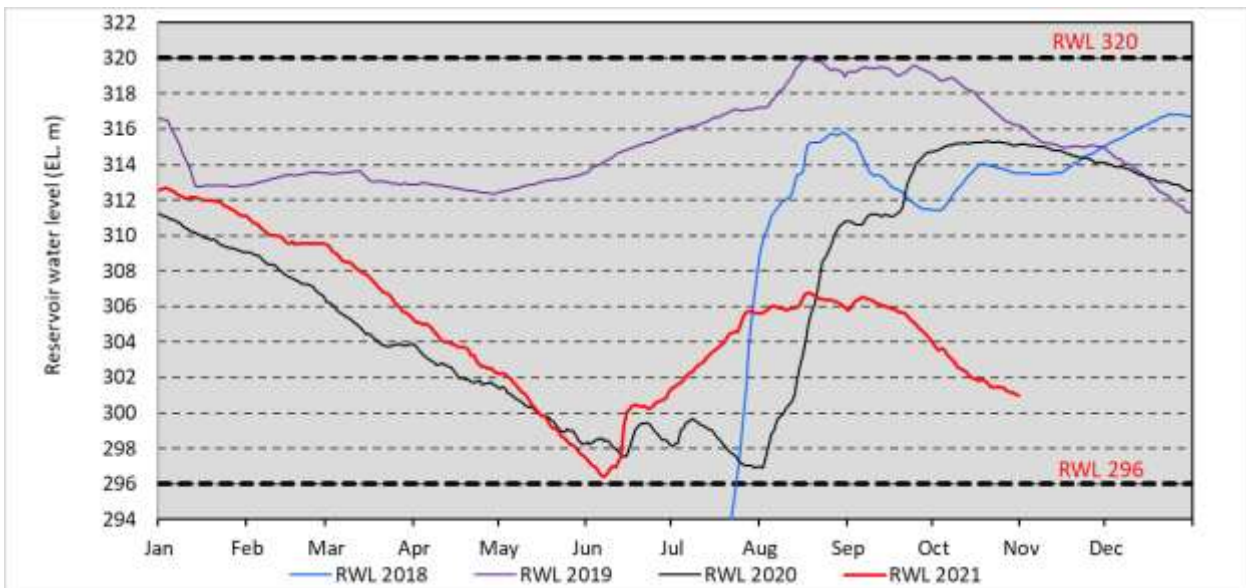
FIGURE 1-6: WATER LEVEL FOR THE MAIN RESERVOIR

From 01 to 31 October 2021, the water level in the main reservoir decreased from El. 303.88 m asl to El. 300.97 m.

Note: The 2018 and 2019 Reservoir Water Level represent the reservoir before the COD (05 September 2019)

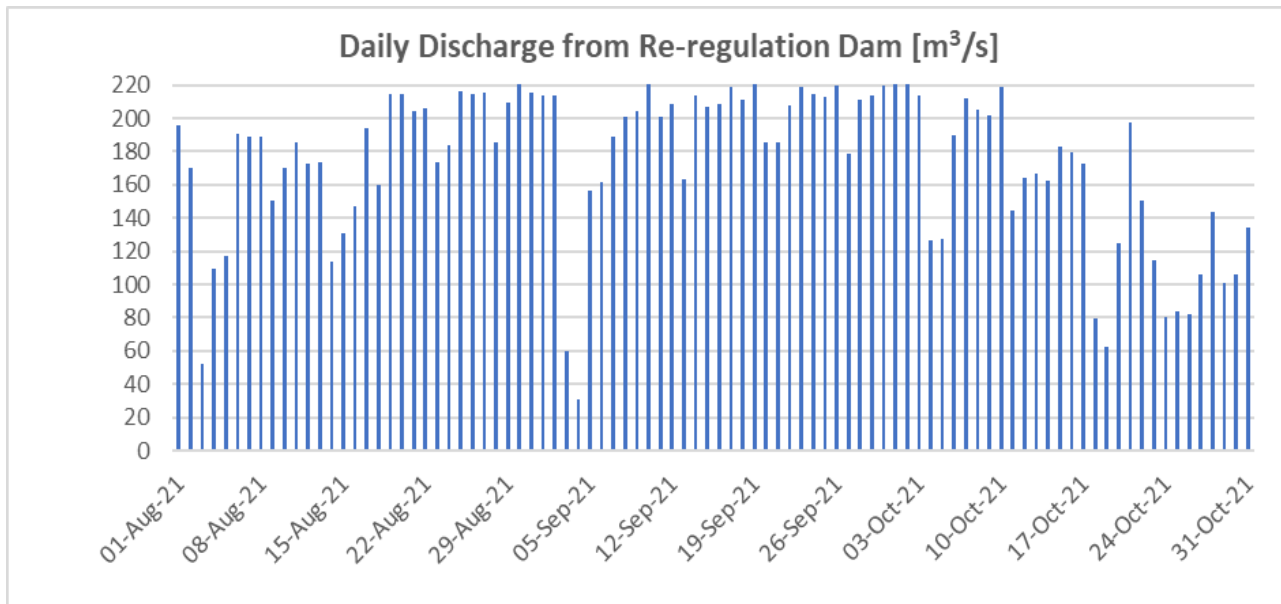
FIGURE 1-7: DAILY DISCHARGE MONITORING AT THE RE-REGULATION DAM IN AUGUST TO OCTOBER 2021

During October 2021, the mean daily discharge from the Re-regulation Dam was about 176 m³/s with hourly turbine discharges varying between 149 m³/s and 164 m³/s, hourly gate discharge

varied between 27 m³/s and 216 m³/s, and hourly total discharge varying between 27 m³/s and 235 m³/s. The hourly discharge was kept above the minimum flow requirement of 27 m³/s at all times.

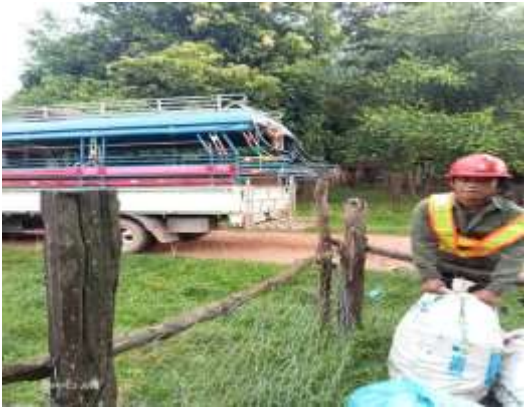
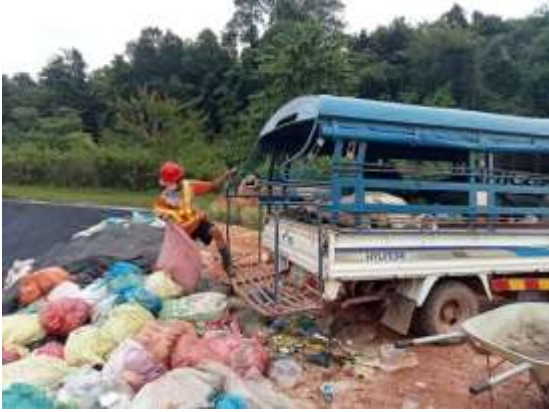
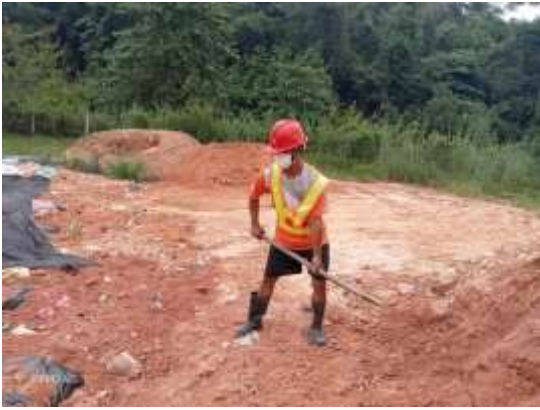
FIGURE 1-9: WASTE MANAGEMENT ACTIVITIES DURING OCTOBER 2021

During this reporting period, the local waste collection contractor conducted regular waste collection from the three villages and operated the Houy Soup landfill for two days per week. The work included waste collection, segregation and disposal, waste cover, grass cutting and repairing the perimeter fences.

WASTE COLLECTION FROM VILLAGE	WASTE DUMP AT HSL

DAILY WASTE COVER	DAILY LANDFILL MAINTENANCE (GRASS CUTTING)
