**NAM NGIEP 1**  
POWER COMPANY

## Nam Ngiep 1 Hydropower Project

# Environmental Management Monthly Monitoring Report

September 2017

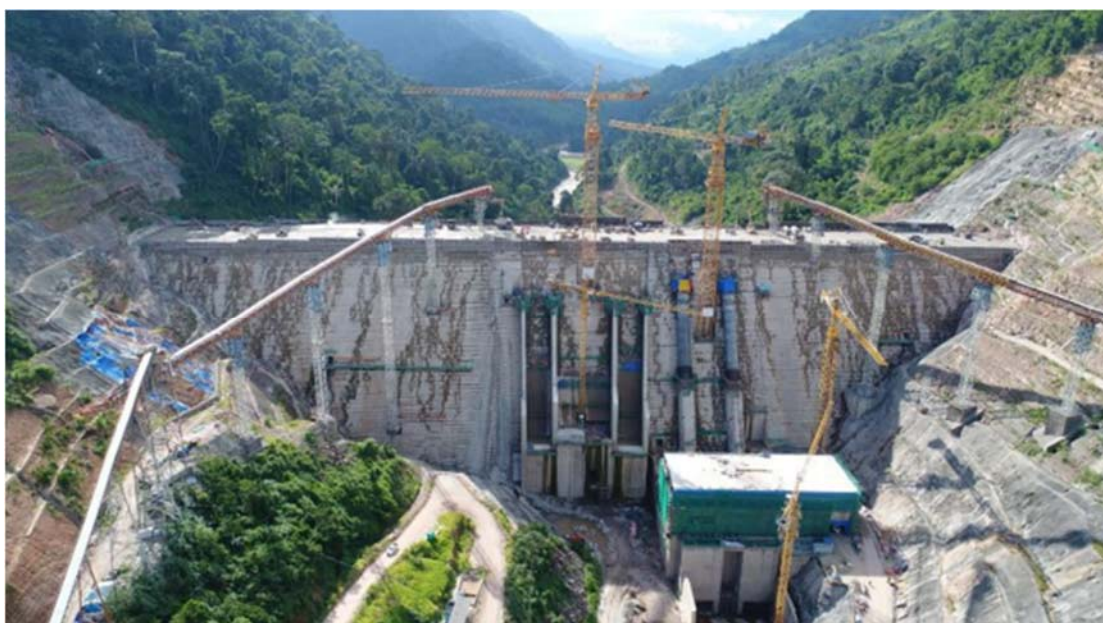
**Figure 2-2: Main Dam and Powerhouse from Overhead Looking Upstream**

After starting the main dam excavation works in October 2014 on the left bank, the works were about one month advanced when diversion of the Nam Ngiep River was achieved at the end of October 2015. However, excavated volumes were 20% greater than expected and part of this additional work is necessary to construct a 'shear key' structure due to the weak layers of rock encountered in the dam foundation. Following the efforts on Site, the additional excavation work was completed at the end of February 2016.

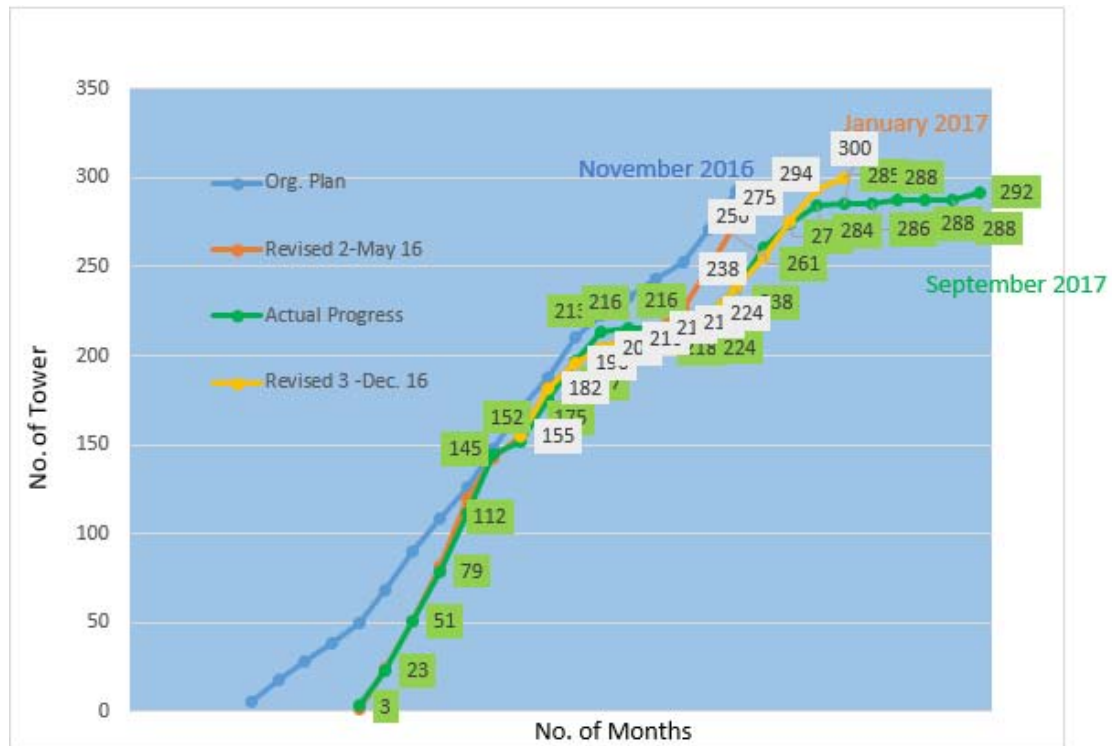
Figure 2-6: Cumulative Work Progress of Tower Foundation (Original Planned and Actual)

In respect of the delay to commencement of most works the Contractor is studying its programme to ensure that sufficient resources are committed as the works progress to ensure that completion is achieved in good time. Onset of daily rains has made access to all areas difficult but the Contractor follows its revised acceleration schedule, after the progress for the construction of tower foundations slowed after May, 2016 (See **Error! Reference source not found.**6 below)
