Nam Ngiep 1 Hydropower Project

Quarterly Environment Monitoring Report First Quarter of 2021

January to March 2021

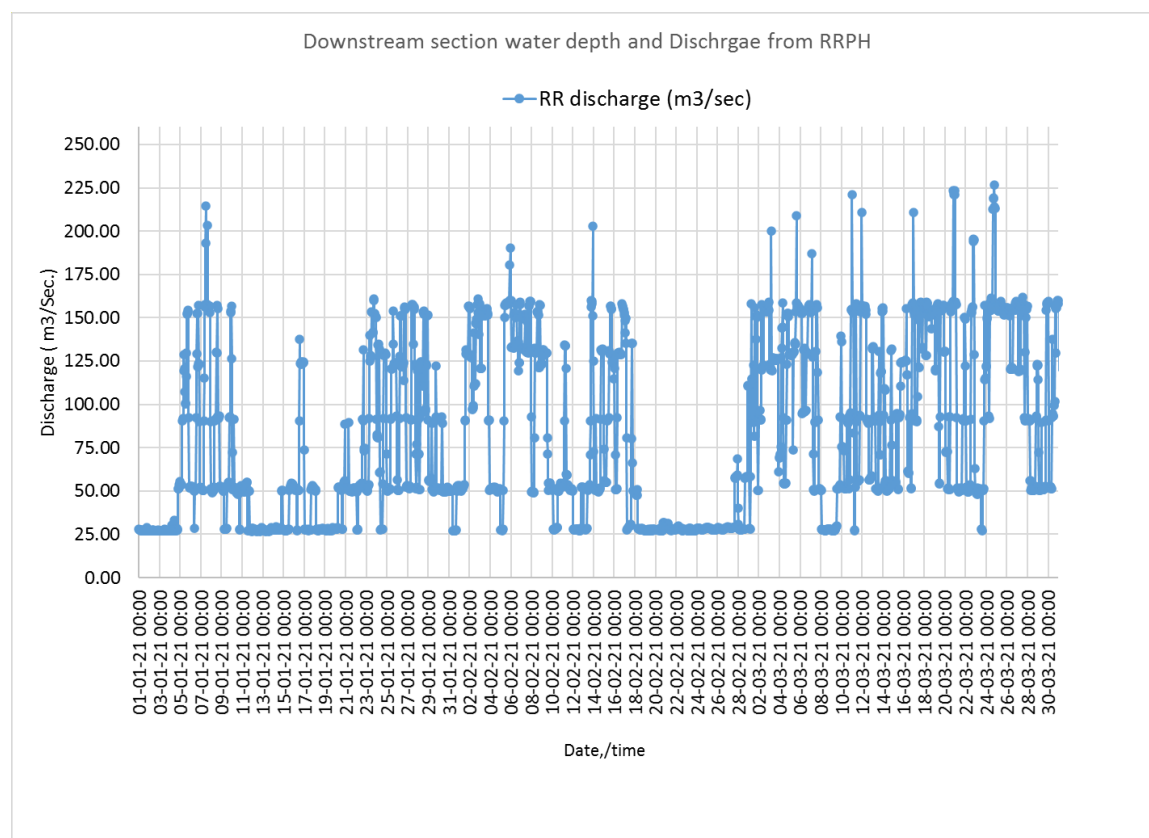
FIGURE 3-5: DISCHARGE FROM THE RE-REGULATION DAM DURING Q1 2021

The discharge monitoring data for the re-regulation dam during Q1 2021 indicates that the minimum flow requirement of 27 m³/s has been met at all times. The Re-regulation Dam discharge graph can be found in **Figure 3-5**.

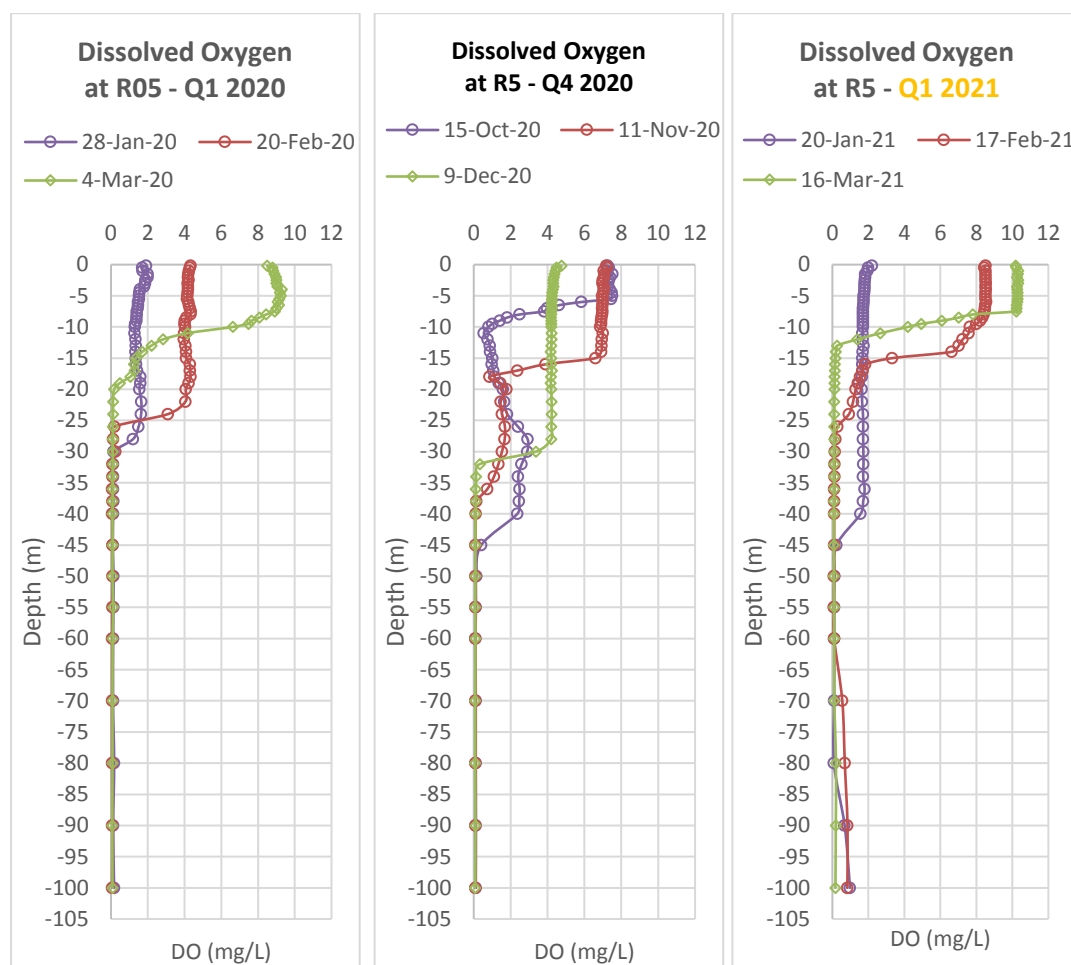
FIGURE 3-12: WATER TEMPERATURE AND DISSOLVED OXYGEN – DEPTH PROFILES IN THE MAIN RESERVOIR IMMEDIATELY UPSTREAM OF THE MAIN DAM (R05)

At R05 (the station closest to the main dam), as the water temperatures dropped over the course of the first 3 weeks of January 2021, the thermocline deepened to a depth of about 35 m, and over the course of the month, the DO levels in the upper 35 m dropped from about 5 mg/L to just below 2 mg/L - likely due to a gradually increased mixing and equalization of upper DO rich(er) water with DO deficient water in the lower layers enabled by the deepening of the thermocline.

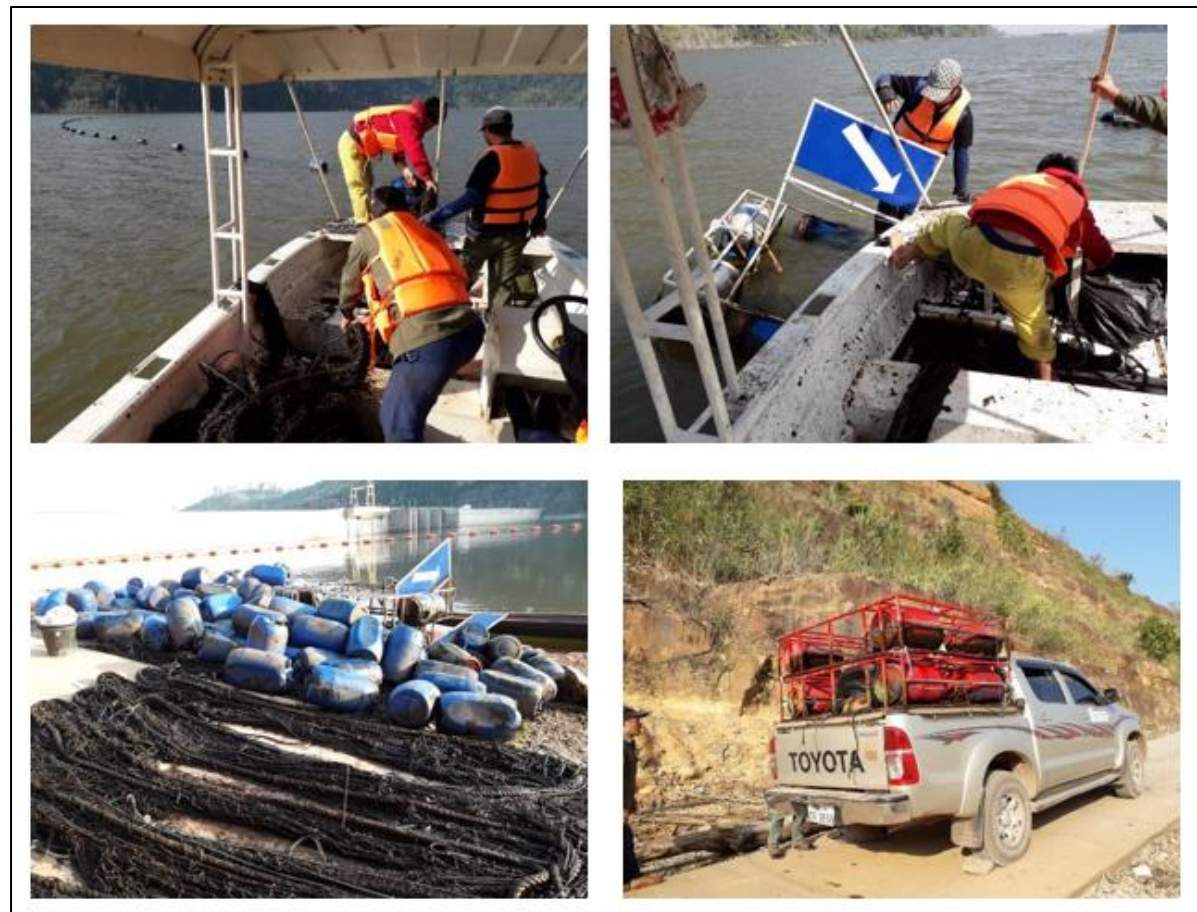
FIGURE 5-1: REMOVAL OF TEMPORARY LOG-BOOM FROM THE NNP1 MAIN RESERVOIR

NNP1PC EMO completed the removal of temporary log-boom from the main reservoir on 22 January 2021.
