Nam Ngiep 1 Hydropower Project

Environment Monitoring Report

First Quarter of 2016

January to March 2016

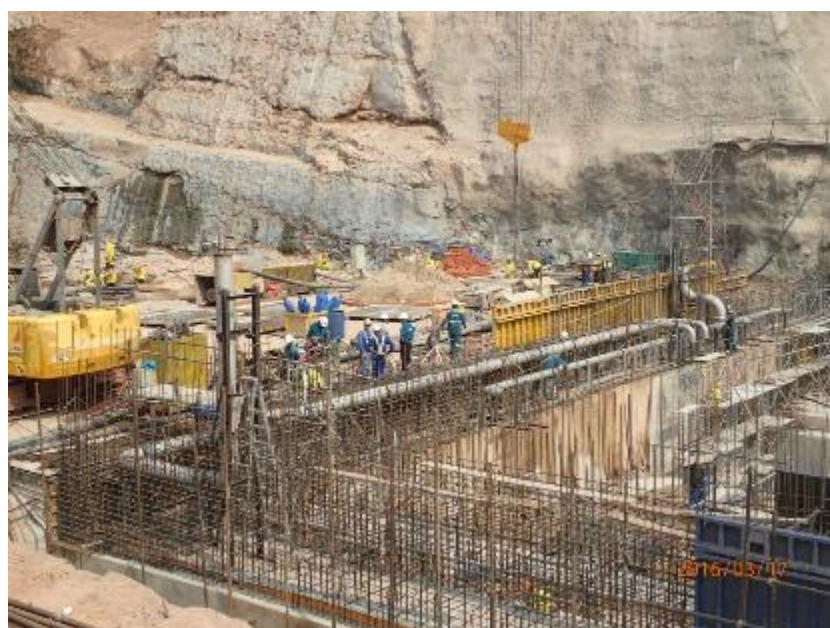
The grounding works for the main powerhouse and re-regulation power house are under way in coordination with concrete casting work.

Figure 3-4: Embedded piping installation (Main powerhouse)

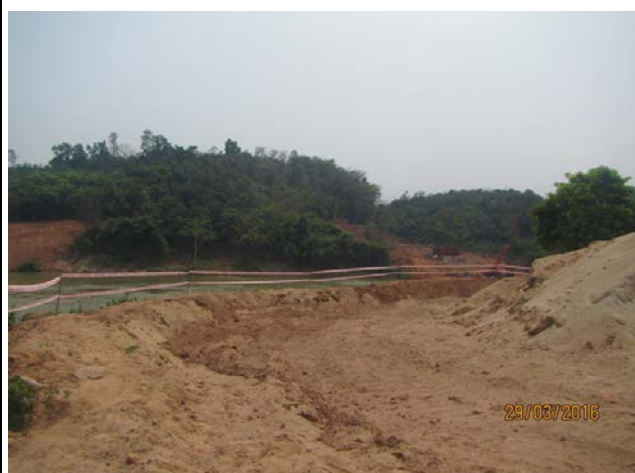
Photograph 3:

Weekly follow up inspection on the erosion and sediment control at the temporary sand and aggregate material stockpile yard, Nam Ngiep River on the left bank

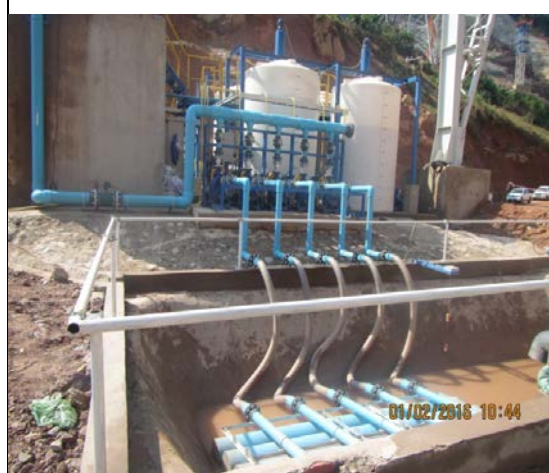
Photograph 4:

Joint bi-weekly inspection on the improvement of the WWTS for main dam and powerhouse areas

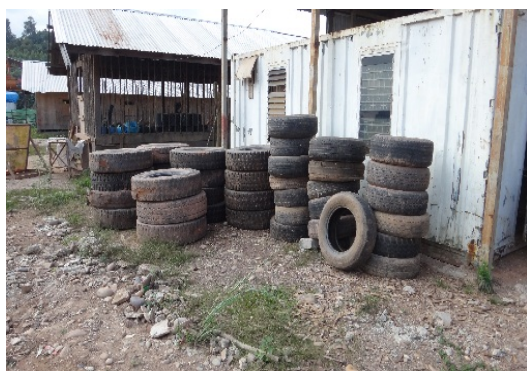
Photograph 5:
Used tyres at the TCM Camp

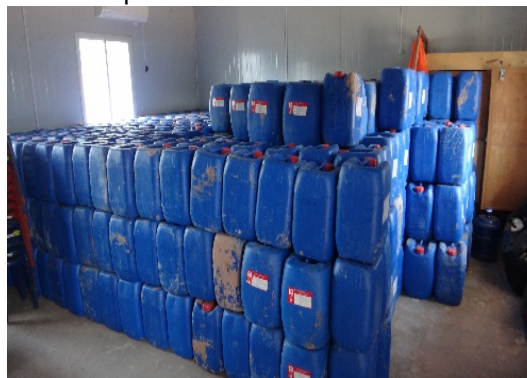
Photograph 6:
Used chemical containers being stored at the TCM Camp

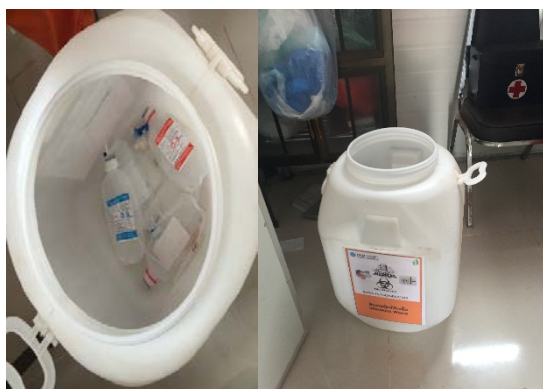
*Photograph 7:
Medical waste at Song Da No.2 Camp*

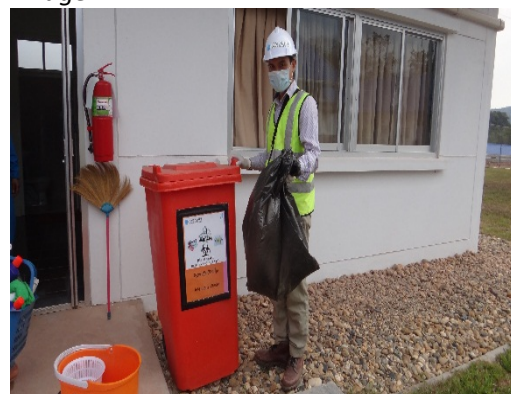
*Photograph 8:
Medical waste at the Owner's Site Office and Village*

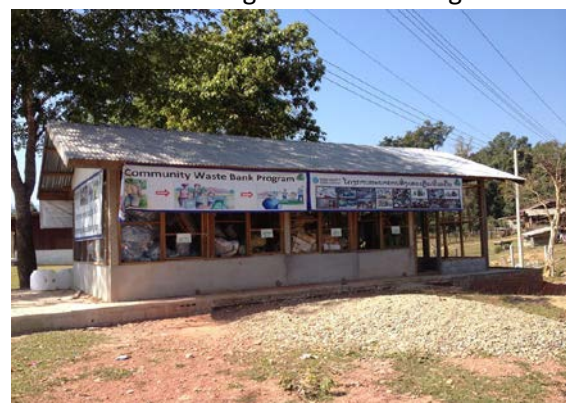
Photograph 13:

The extended storage area for ressing machine

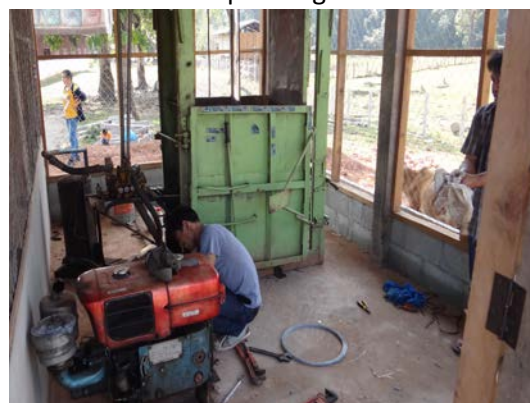
Photograph 14:

In order to provide an improved waste management system for the community, reducing the size of the storage space and increase the saleability of recycle materials, the EMO purchased a crushing machine to compress cans and plastic bottles received at the Recycle Bank and from the Owners' Site Office and Village. The extension of a storage area for the pressing machine was completed. The machine was installed and instructions were provided for its use. The machine will be tested for the first time in April 2016. The machine will be operational when all safety measures have been approved by NNP1PC, as shown in the photograph below.

Installation of the pressing machine
