## Nam Ngiep 1 Hydropower Project

# Environment Monitoring Report First Quarter of 2017

January to March 2017

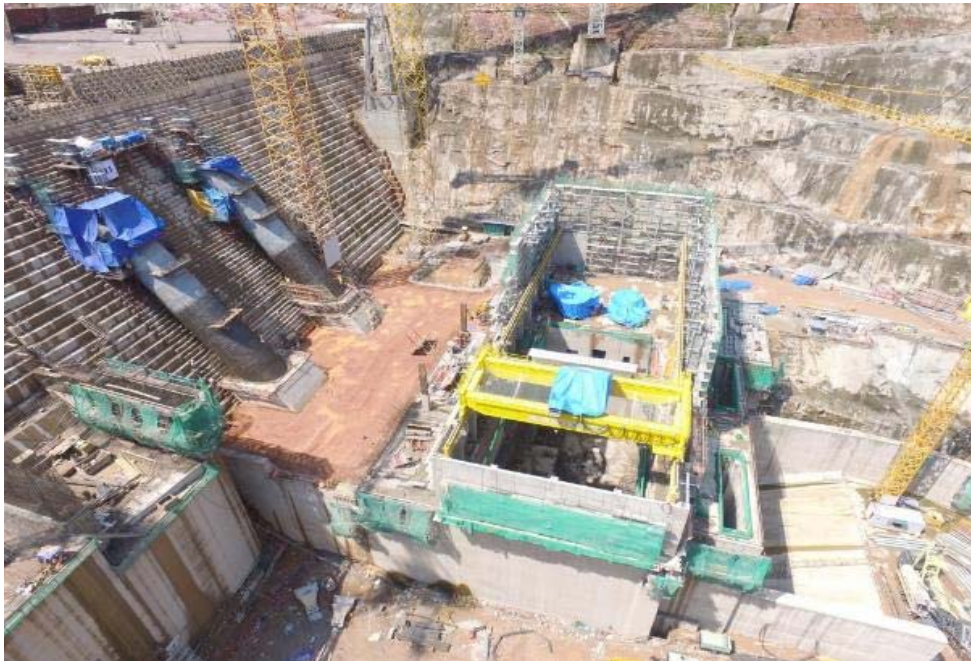
Location	Total Anticipated Volume (m³)	Completed (m³)	Progress (%)
Main Powerhouse	32,600	24,645	75
Penstock Embedment	10,117	7,150	70

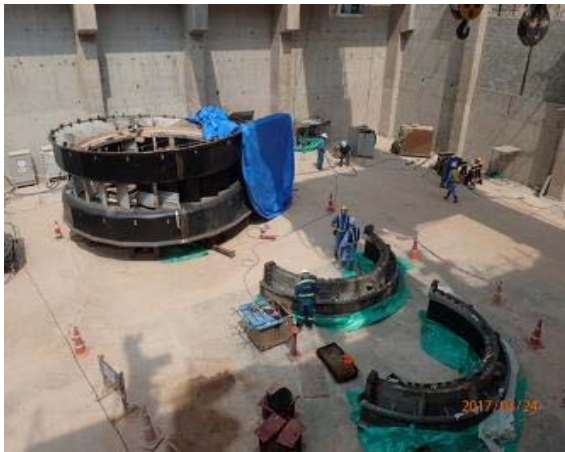
**FIGURE 3-4: PREPARATION FOR INSTALLATION OF STAY RING FOR UNIT 1 AT THE MAIN POWERHOUSE ON 24 MARCH 2017**

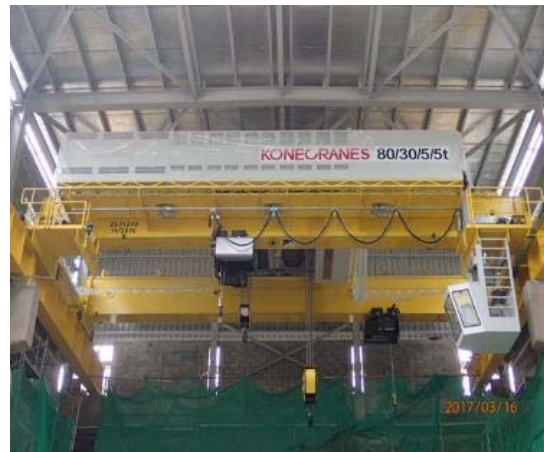
**FIGURE 3-5: INSTALLATION OF 80 TONNE OHTC AT THE RE-REGULATION POWERHOUSE**

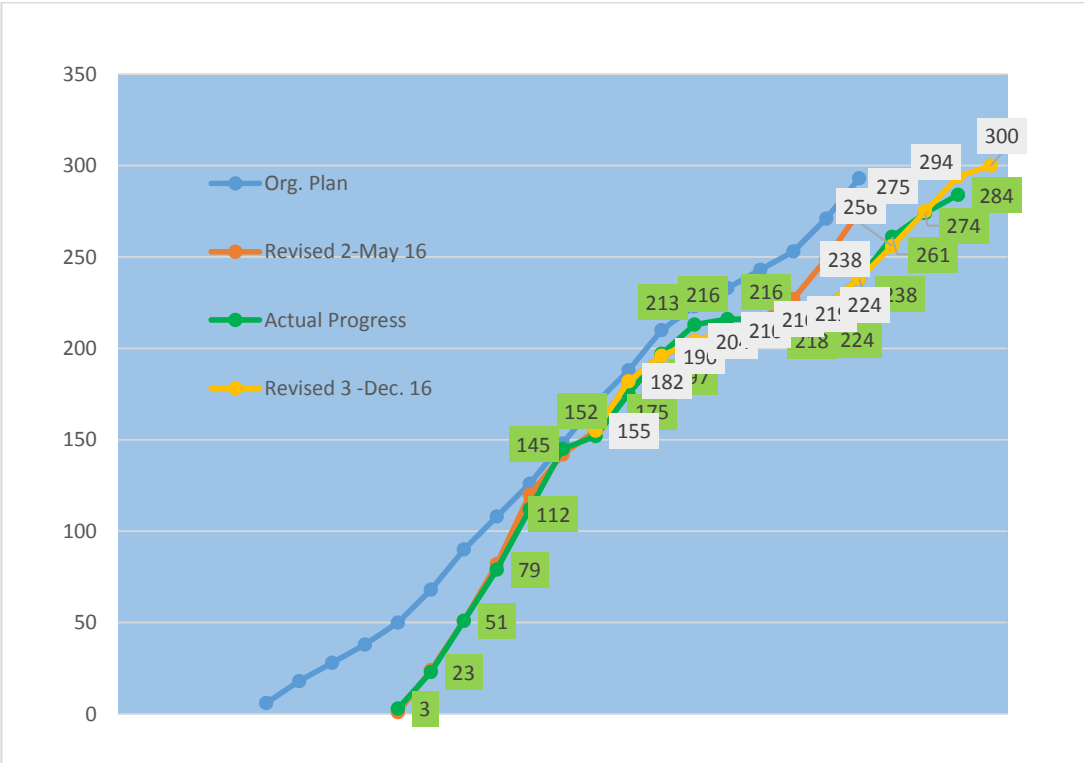
FIGURE 3-6: CUMULATIVE WORK PROGRESS OF TOWER FOUNDATION (ORIGINAL PLANNED AND ACTUAL)

The TLW Contract was executed between Loxley-Sri Consortium and NNP1PC on 11 July 2014 and the NTP was issued to the 230 kV TL Contractor on 03 October 2014. The cumulative work progress of the Transmission Line Works until the end of March 2017 was 84.1% (compared to planned progress of 84.8%). In respect of the delay to commencement of most works the Contractor is studying its programme to ensure that sufficient resources are committed as the works progress to ensure that completion is achieved in good time. Onset of daily rains has made access to all areas difficult but the Contractor follows its revised acceleration schedule, after the progress for the construction of tower foundations slowed after April, 2016 (See **Error! Reference source not found.6** below).

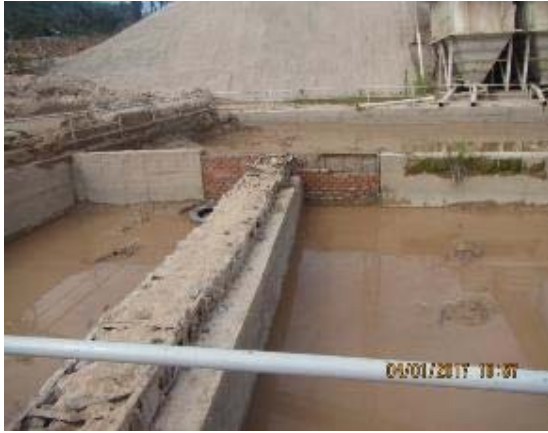
**Photo 1: Installation of concrete walls at RCC Plant's sediment ponds was to prevent turbid water leakage in January 2017**

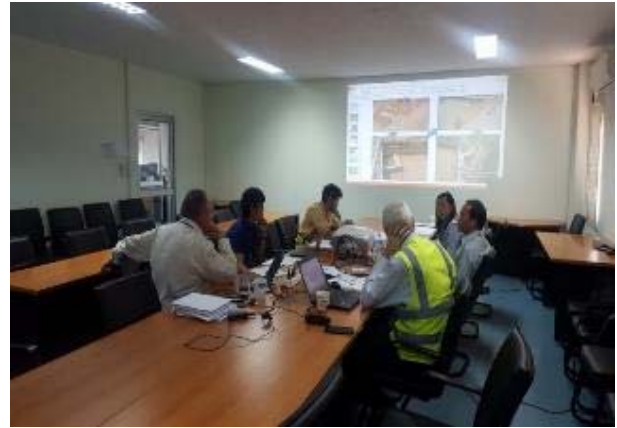
**Photo 3: NNP1PC and HM Hydro Contractor joint inspection for WWTS improvement in February 2017**

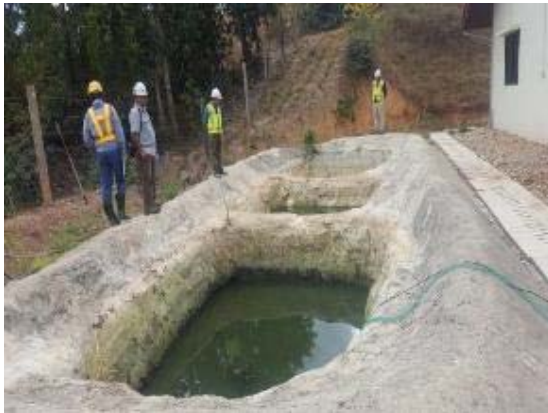
**Photo 4: Improvement of the WWTS embankment at Song Da5 Camp No. 1 in February 2017**

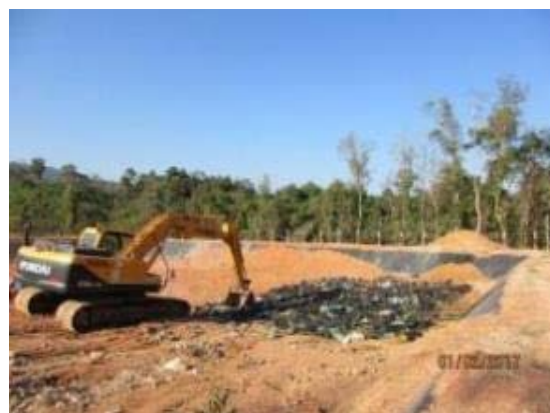
**Photo 5: Waste compaction and soil cover at the NNP1 Project Landfill**

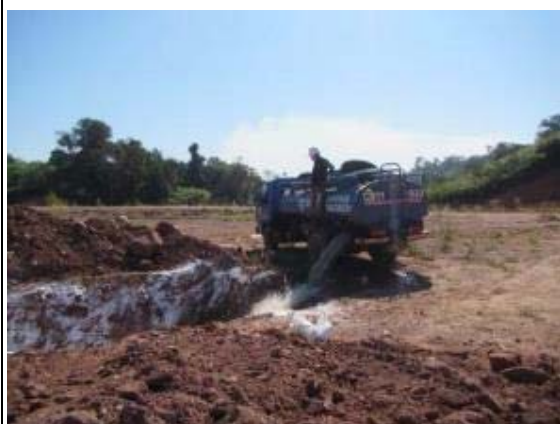
**Photo 07: Sewage sludge/black water from HIH and HM Hydro contractors were disposed of at the designated Spoil Disposal Area No. 6**

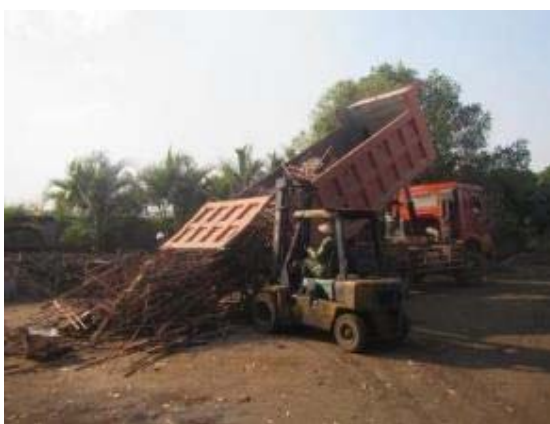
**Photo 08: Scrap metal from SECC contractor was sold to Khounmixay Process Factory in Paksan District, Bolikhamxay province**
