Nam Ngiep 1 Hydropower Project

Environment Monitoring Report Second Quarter of 2017

April to June 2017

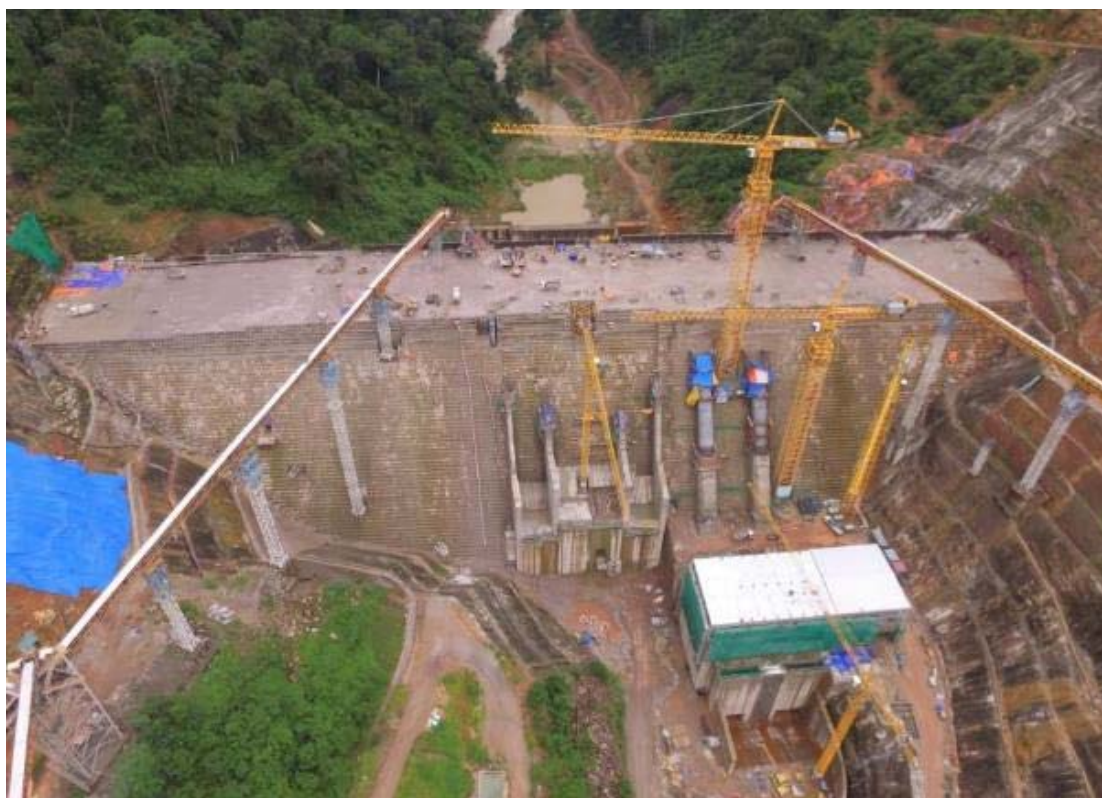
FIGURE 3-2: MAIN DAM AND POWERHOUSE FROM OVERHEAD LOOKING UPSTREAM

After starting the main dam excavation works in October 2014 on the left bank, the works were about one month advanced when diversion of the Nam Ngiep River was achieved at the end of October 2015. However, excavated volumes were 20% greater than expected and part of this additional work is necessary to construct a 'shear key' structure due to the weak layers of rock encountered in the dam foundation. Following the efforts on Site, the additional excavation work was completed at the end of February 2016.

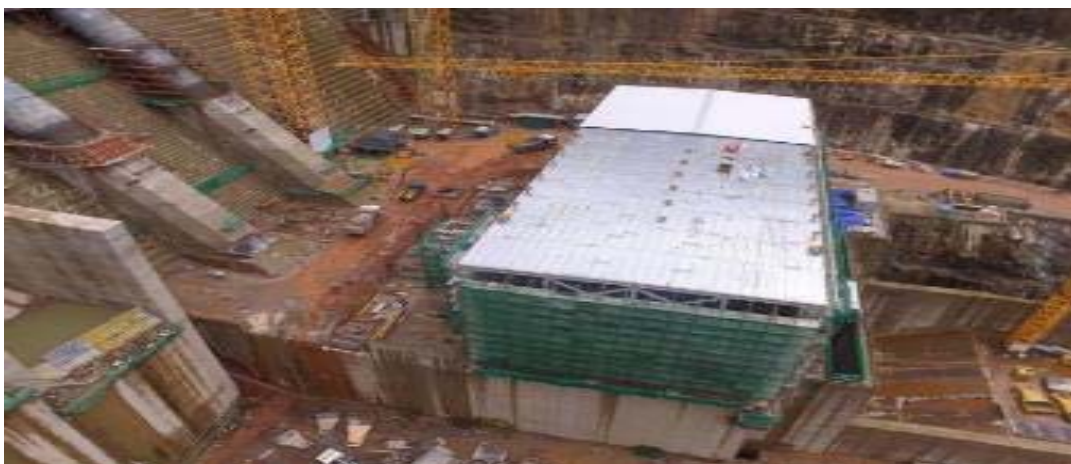
TABLE 3-2: PROGRESS OF MAIN POWERHOUSE SUB-STRUCTURE CONCRETE WORKS TO 30 JUNE 2017

Location	Total Anticipated Volume (m ³)	Completed (m ³)	Progress (%)
Main Powerhouse	32,600	25,184	77
Penstock Embedment	10,257	7,870	76

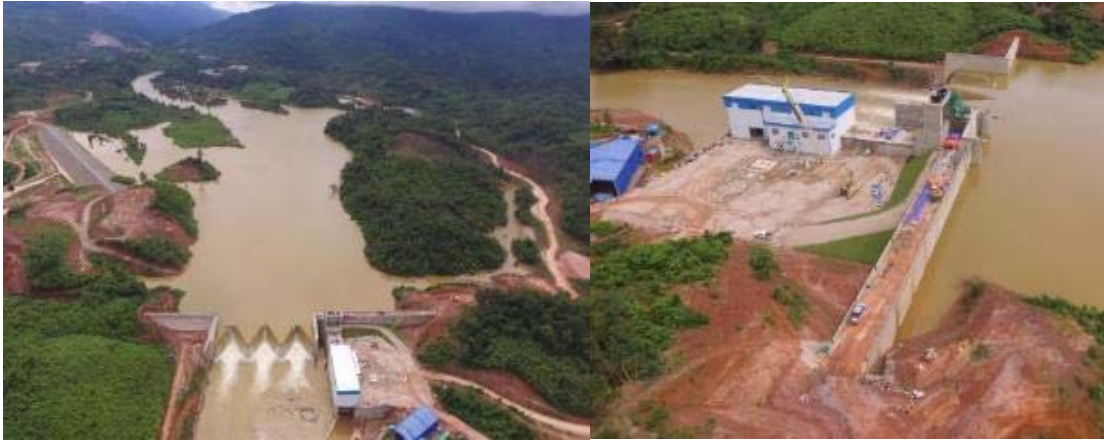
Status Of Construction Progress	2016				2017			
	1Q	2Q	3Q	4Q	1Q	2Q	3Q	4Q
Powerhouse (Substructure)	Planned (85%)				(15%)			
	Actual (85%)				2 nd Stage Concrete			
Powerhouse (Building)	Structural				Architectural

Powerhouse Building Works	Concrete Block Wall above El. 177.0 m	Plastering Block Wall First Layer	Plastering Block Wall Second Layer	Windows	Painting Inside and Outside	Siding Sheets above El. 189.5 m	Roofing	Switch Yard
	(m ²)	(m ²)	(m ²)	(No.)	(m ²)	(m ²)	(m ²)	(m ²)
Designed	1576	3126	3126	27	6135	510	1022	45,000
Completed	1576	3126	3126	26	4588	510	1022	45,000
Progress	100 %	100 %	100 %	96 %	75 %	100 %	100 %	100 %

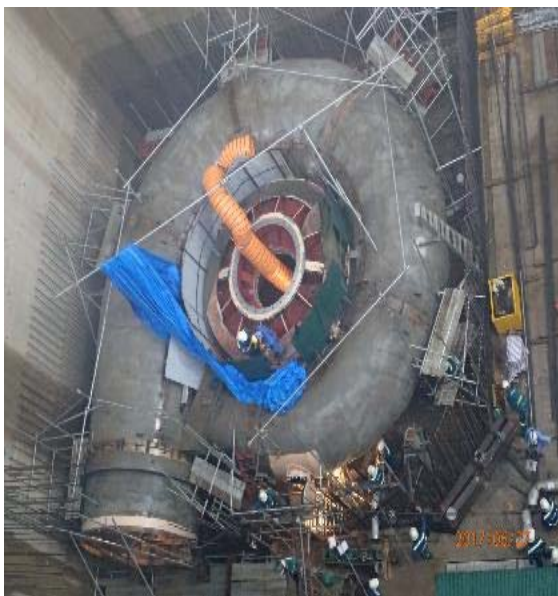
**FIGURE 3-4: PREPARATION FOR INSTALLATION OF STAY RING
INSTALLING OF UNIT 1 AT THE MAIN POWERHOUSE ON 30 JUNE 2017**

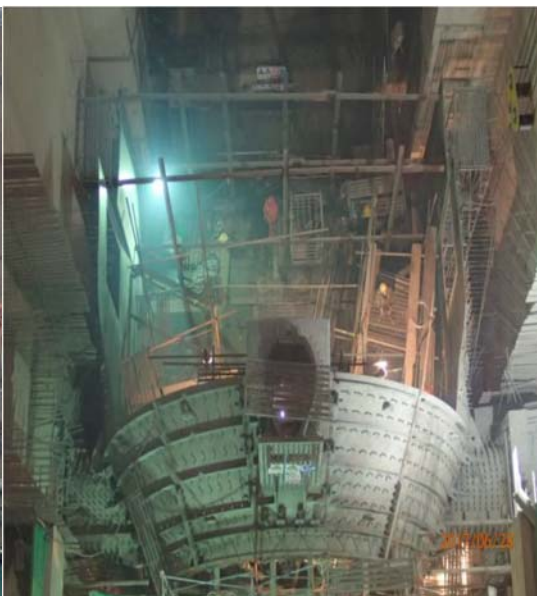
**FIGURE 3-5: PREPARATION FOR
STAY CONE AT THE RE-
REGULATION POWERHOUSE**

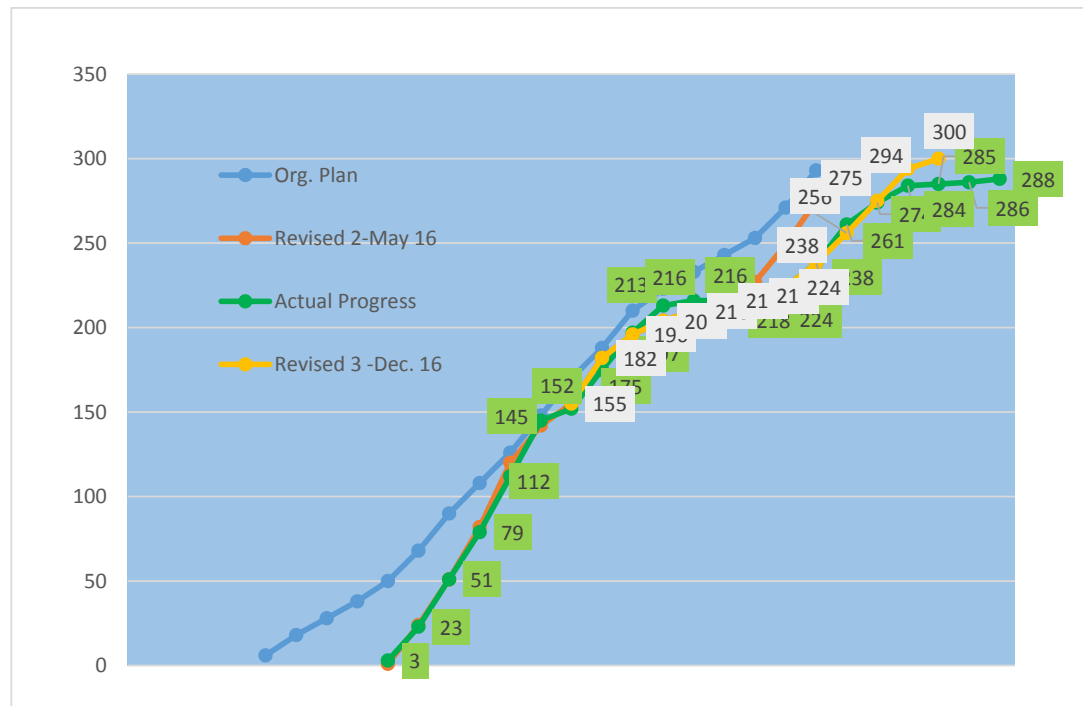
FIGURE 3-6: CUMULATIVE WORK PROGRESS OF TOWER FOUNDATION (ORIGINAL PLANNED AND ACTUAL)

In respect of the delay to commencement of most works the Contractor is studying its programme to ensure that sufficient resources are committed as the works progress to ensure that completion is achieved in good time. Onset of daily rains has made access to all areas difficult but the Contractor follows its revised acceleration schedule, after the progress for the construction of tower foundations slowed after May, 2016 (See **Figure 3-68** below).

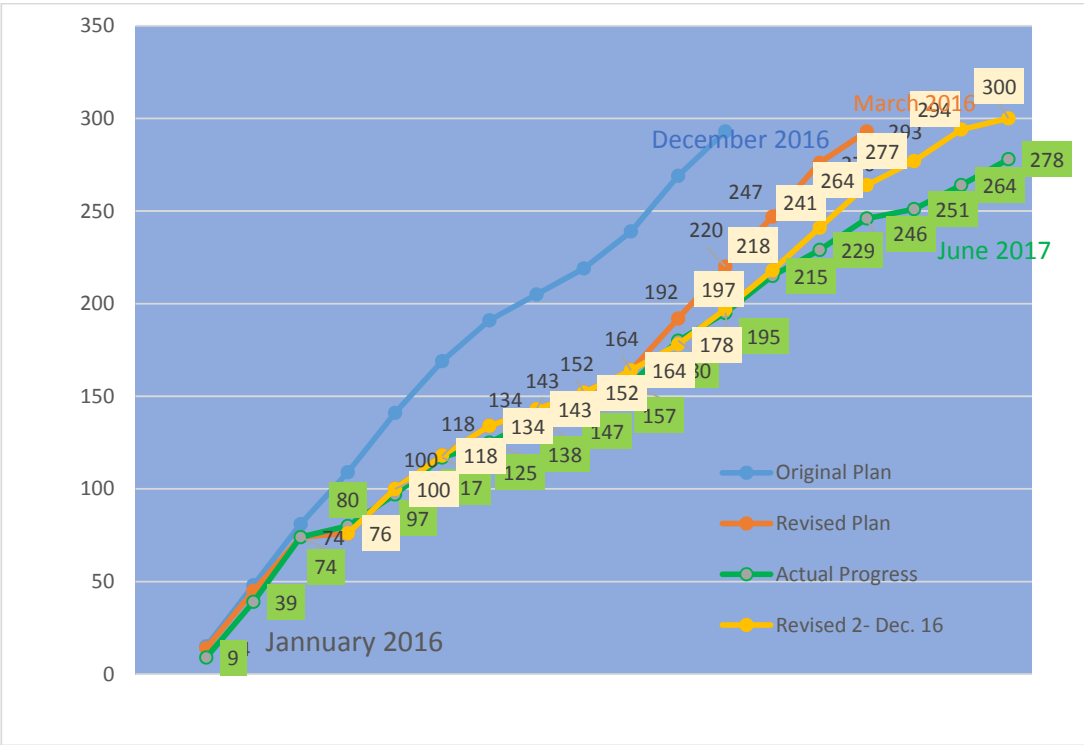
FIGURE 3-7: CUMULATIVE WORKS PROGRESS OF TOWER FOUNDATION (REVISED PLANNED & ACTUAL)

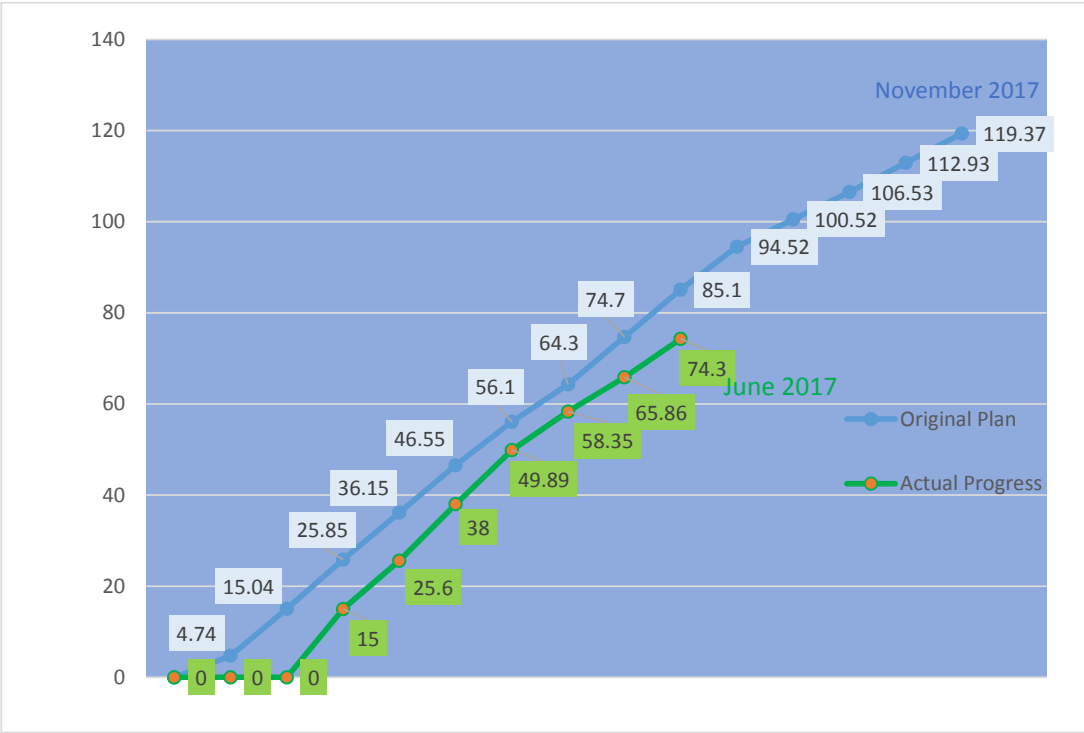
FIGURE 3-8: REVISED CUMULATIVE WORKS PROGRESS OF TOWER ERECTION (PLANNED & ACTUAL)

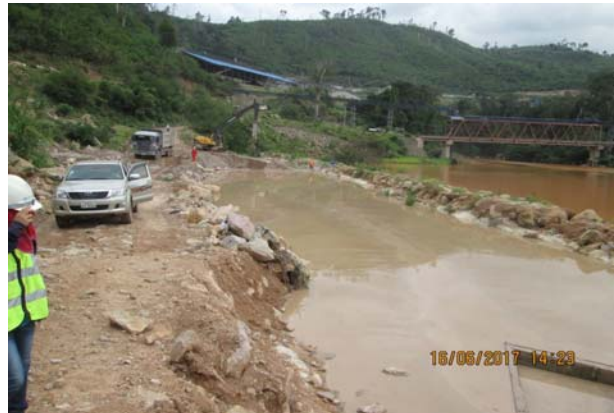
PHOTOGRAPH 2: DAILY SEDIMENT POND CLEANING-UP AT THE AGGREGATE PLANT ON 16 JUNE 2017

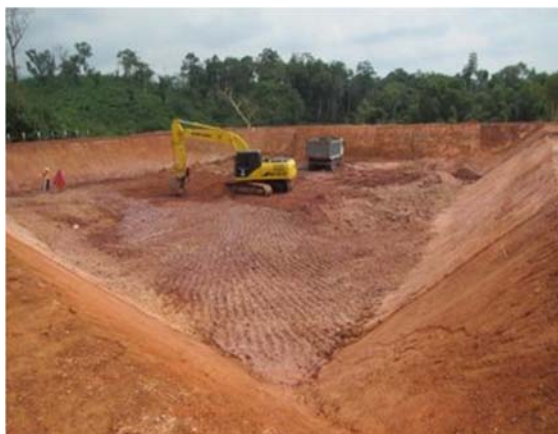
PHOTOGRAPH 5: CONTRACTION OF HSRA LANDFILL

A joint work completion inspection was carried out by NNP1PC and the landfill contractor on 08 June 2017. The contractor will revise the Detailed Work Plan & SS-ESMMP for the second stage of NNP1 Project landfill construction again which includes Site Decommissioning Plan and re-submission to NNP1PC for review and approval.

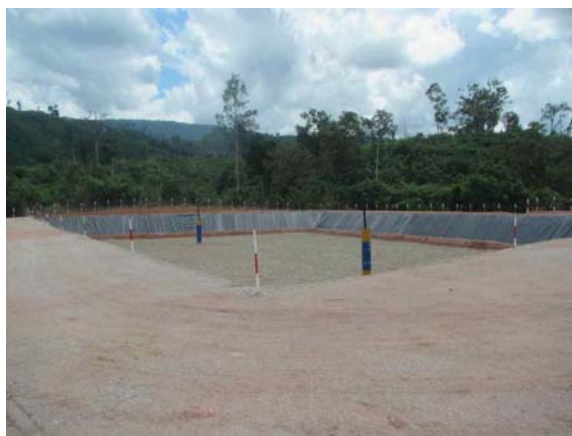
PHOTOGRAPH 6: THE COMPLETED HSRA LANDFILL

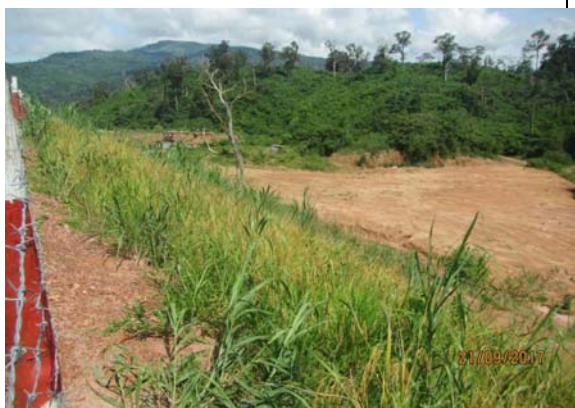
PHOTOGRAPH 7: VEGETATION FOR SLOPE PROTECTION AT HSRA LANDFILL

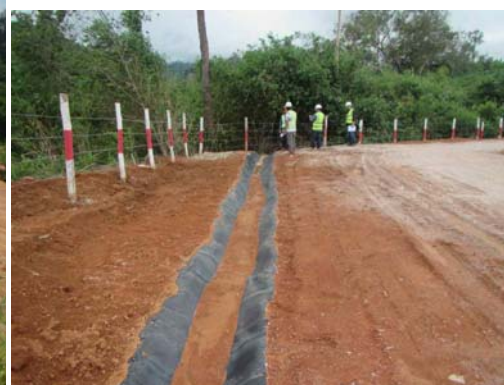
PHOTOGRAPH 8: DRAINAGE AT HSRA LANDFILL

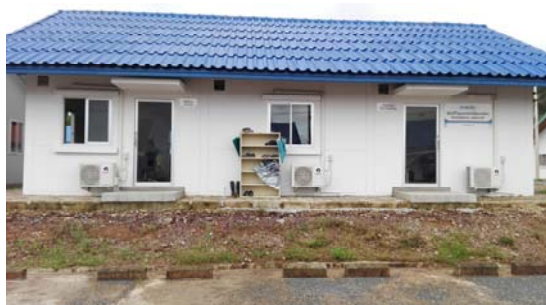
**PHOTOGRAPH 12 NNP1 PROJECT LABORATORY
(EXTERNAL VIEW)**

During the impounding of the re-regulation reservoir from 15 to 25 May 2017, daily water quality monitoring for physical parameters (pH, dissolved oxygen, conductivity, Total Dissolved Solids (TDS), temperature and turbidity) were conducted followed by weekly monitoring after impounding. A part-time local consultant was recruited to provide training on laboratory operation including performance verification in collaboration with UAE laboratory, data analysis, Quality Assurance/Quality Control (QA/QC) and establish standard operation procedures for the laboratory.
