**Nam Ngiep 1 Hydropower Project**

**Environment Monitoring Report**  
**Third Quarter of 2017**

**July to September 2017**

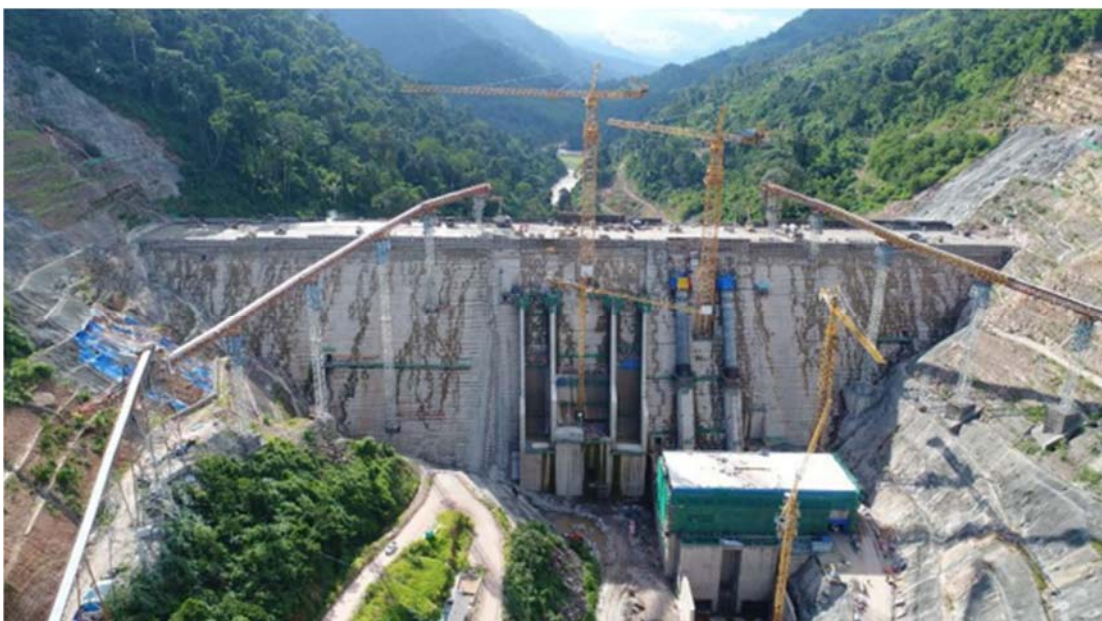
**FIGURE 3-2: MAIN DAM AND POWERHOUSE FROM OVERHEAD LOOKING UPSTREAM**

After starting the main dam excavation works in October 2014 on the left bank, the works were about one month advanced when diversion of the Nam Ngiep River was achieved at the end of October 2015. However, excavated volumes were 20% greater than expected and part of this additional work is necessary to construct a 'shear key' structure due to the weak layers of rock encountered in the dam foundation. Following the efforts on Site, the additional excavation work was completed at the end of February 2016.

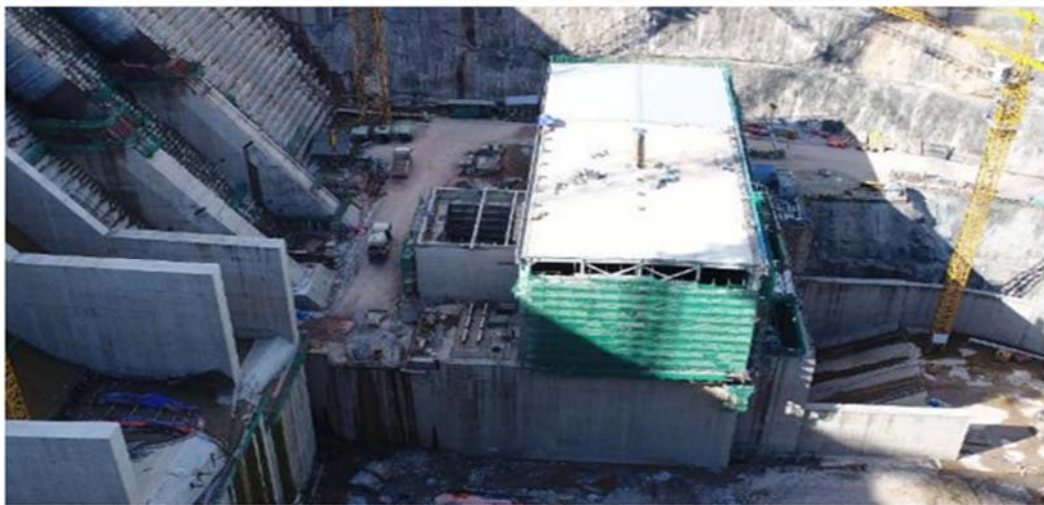
**TABLE 3-2: PROGRESS OF MAIN POWERHOUSE SUB-STRUCTURE CONCRETE WORKS TO 30 SEPTEMBER 2017**

Location	Total Anticipated Volume (m <sup>3</sup> )	Completed (m <sup>3</sup> )	Progress (%)
Main Powerhouse	32,600	27,495	84
Penstock Embedment	10,257	8,185	79

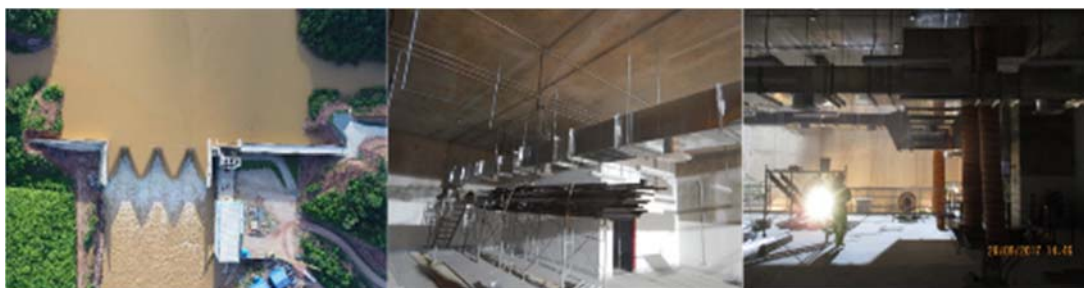
Powerhouse Building Works	Concrete Second Phase	Painting Inside and Outside	Doors	Electrical Conduit and Wire	Handrail	Duct Work	Fire Alarm System (Conduit)
	(m <sup>3</sup> )	(m <sup>2</sup> )	(Unit)	(m)	(m)	(m)	(m)
Designed	3,496	6,135	18	2,510	460	345	1,208
Completed	2,989	5,024	18	1,900	250	271	1,172
Progress	89 %	82 %	100 %	75 %	54 %	79 %	97 %

The powerhouse concreting has advanced well and secondary concrete embedment for the draft tube liner was completed at the end of April 2016. The left bank structure was re-

designed as roller compacted concrete (RCC) and was completed on 18 March 2016. Installation of the re-regulation waterway gate and stop log and re-regulation intake gate and structural concrete works for the retaining wall to support the substation yard were completed in October 2016. Building superstructure work continued for the powerhouse with the commencement of construction of concrete columns.

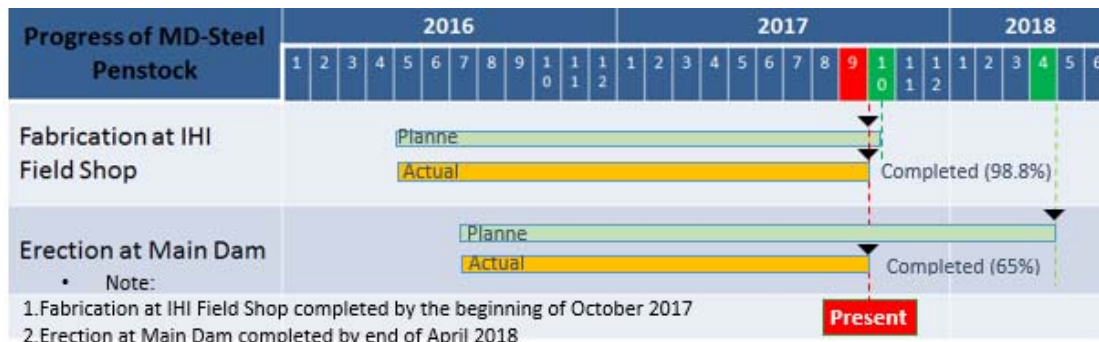
**TABLE 3-3: PROGRESS OF THE PENSTOCK PIPE FABRICATION AT THE IHI FIELD SHOP AS AT THE END OF SEPTEMBER 2017**

The latest progress of penstock pipe fabrication at IHI field shop and erection at main dam as of the end of September 2017 in **Table 3-3** below

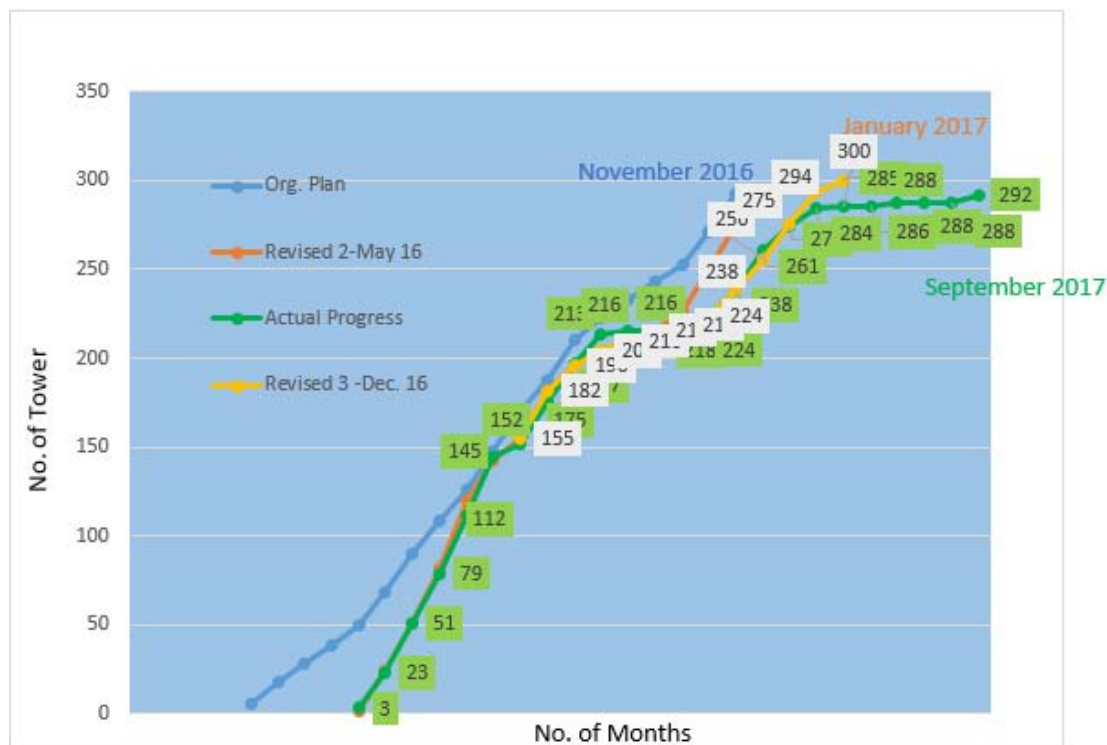
**FIGURE 3-4: CUMULATIVE WORK PROGRESS OF TOWER FOUNDATION (ORIGINAL PLANNED AND ACTUAL)**

In respect of the delay to commencement of most works, the Contractor is studying its programme to ensure that sufficient resources are committed as the works progress to ensure that completion is achieved in good time. Onset of daily rains has made access to all areas difficult, but the Contractor follows its revised acceleration schedule, after the progress for the construction of tower foundations slowed after May 2016 (See **Figure 3-4** below).

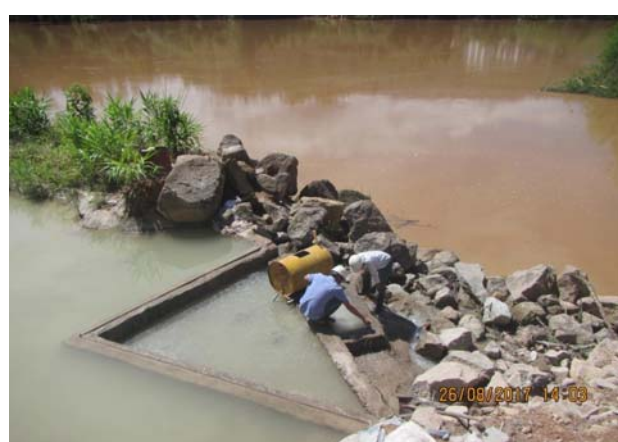
**PHOTOGRAPH 2: DAILY SEDIMENT CONTROL BY APPLYING ALUMINIUM SULPHATE AT AGGREGATE PLANT SEDIMENT POND**

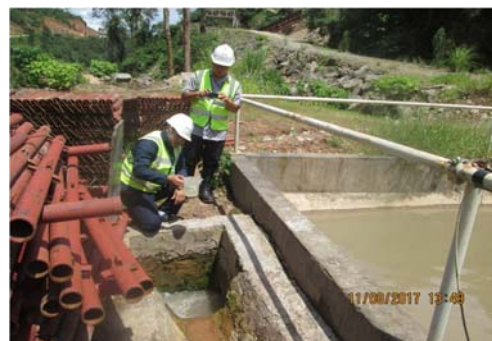
**PHOTOGRAPH 3: THE EFFLUENT DISCHARGE MONITORING AT THE MAIN DAM'S WASTE WATER TREATMENT PLANT**

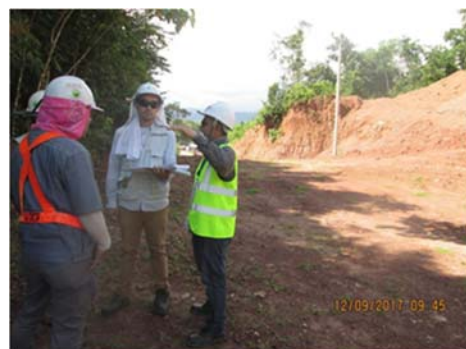
**PHOTOGRAPH 4: BI-WEEKLY JOINT SITE INSPECTIONS FOR BORROW PIT CLOSURE**

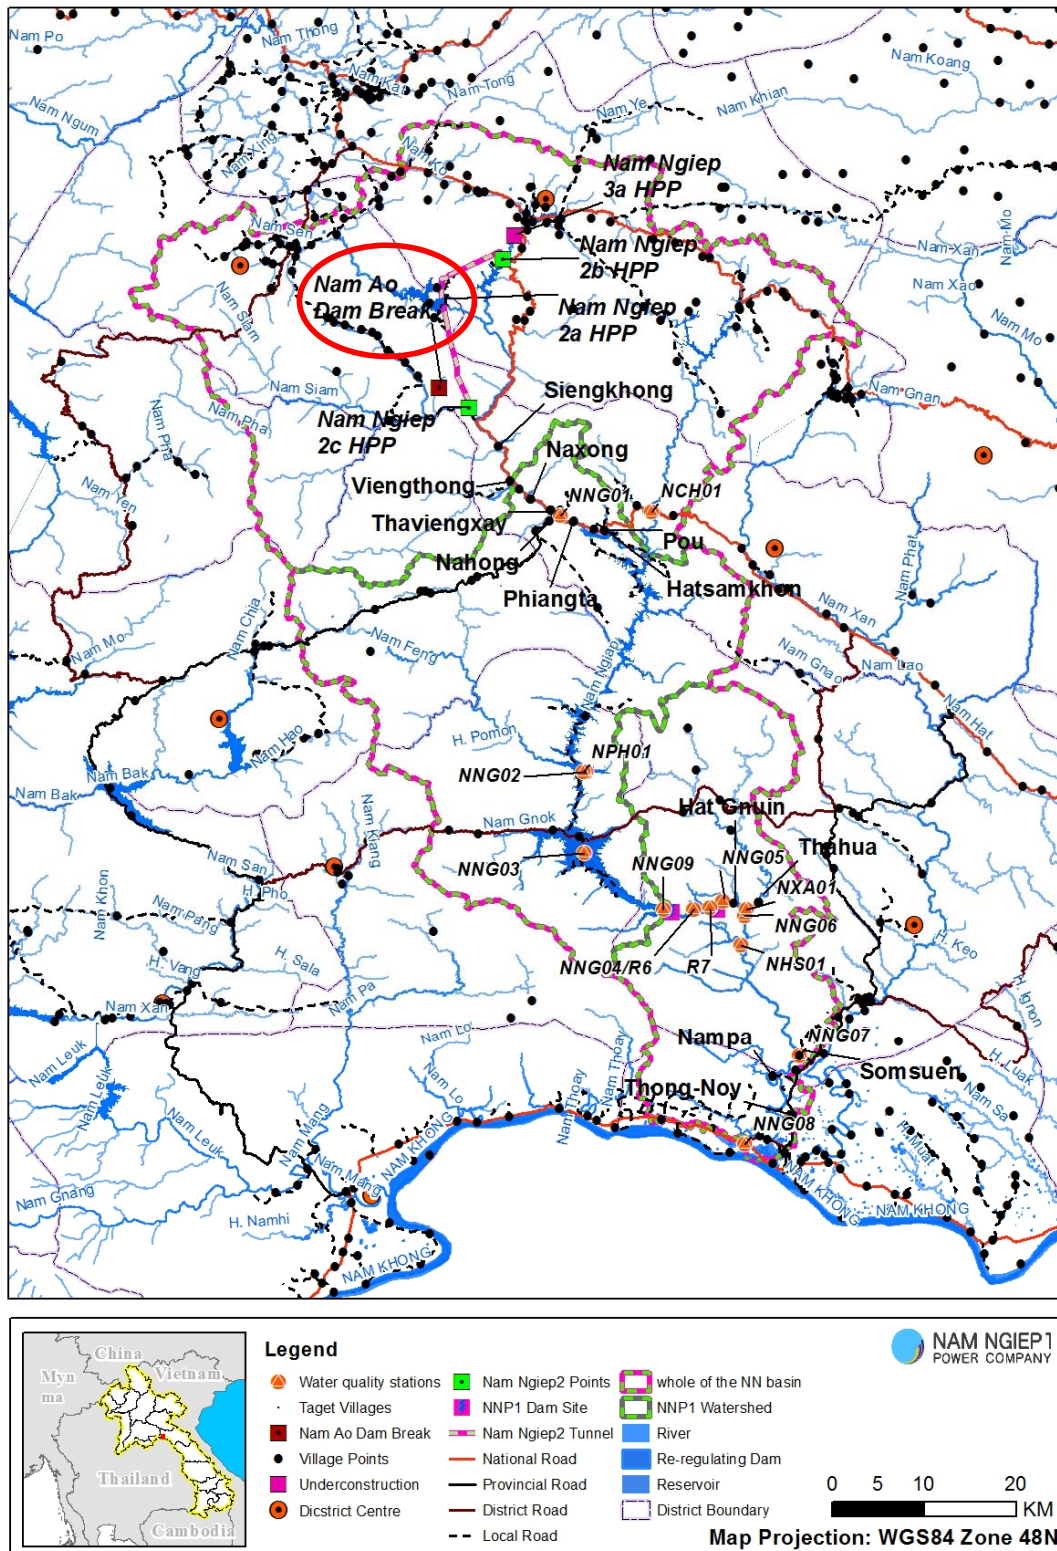
FIGURE 4-5 OVERVIEW MAP WITH LOCATION OF NAM AO DAM BREAK

On 11 September 2017 at 13:45 hours, an earth-fill dam of the Nam Ao Hydropower Project on the Nam Ao stream in Phaxai District, Xieng Khuang Province failed and sent a flood wave of mud, water, and debris down a three-kilometre reach of Nam Ao, into Nam Siem and continued into Nam Ngiep – see overview map in **Figure 4-5**. The dam failure site is located about 92 km upstream of the main dam of Nam Ngiep 1 Hydropower Project.

There has been no reports of loss of human life or serious injuries as a consequence of the dam break, but according to a report from the secretariat of the Nam Ngiep 1 Watershed and Reservoir Protection Office in Xaysomboun Province dated 14 September 2017, damages to property has been reported in the following eight villages downstream of the dam: Siengkong, Viengthong, Nasong, Thaviengxay, Phiengta, Nahong, Hatsamkhone, and Pou (see Overview Map in **Figure 4-5**).
