Nam Ngiep 1 Hydropower Project

Quarterly Environment Monitoring Report Third Quarter of 2021

July to September 2021

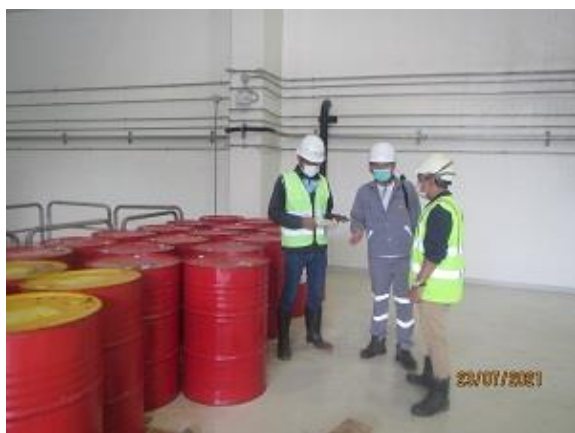
PHOTOGRAPH 2: SITE INSPECTION AT RE-REGULATION POWERHOUSE'S TEMPORARY STORAGE AREA

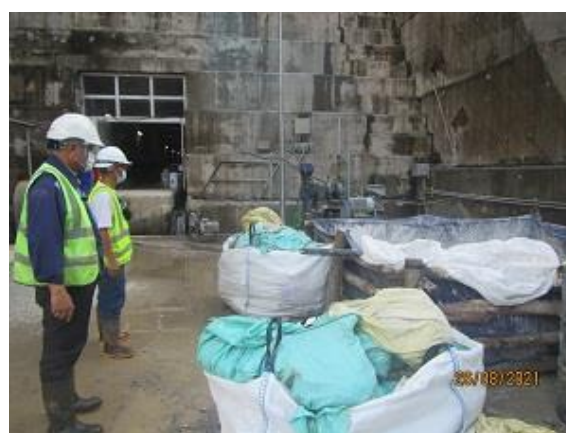
PHOTOGRAPH 3: SITE INSPECTION AT MAIN DAM GROUTING AREA

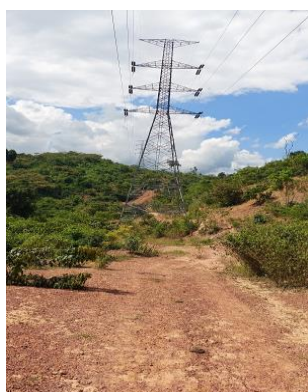
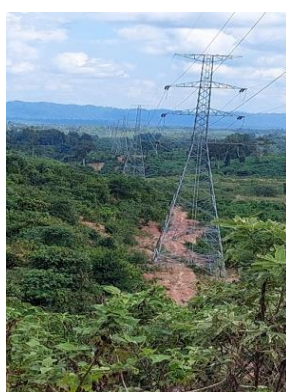
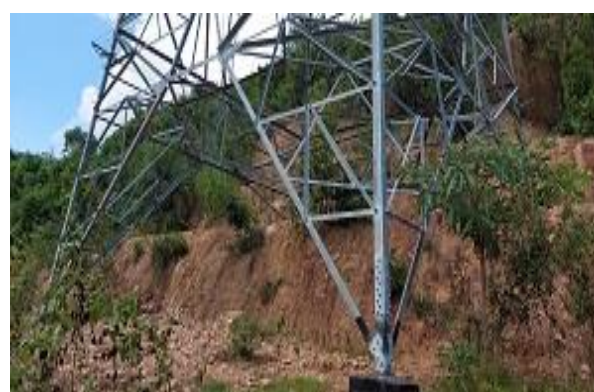
PHOTOGRAPH 4: SITE INSPECTION AT ALONG THE TL 230 KV (TOWER 01 – 10)

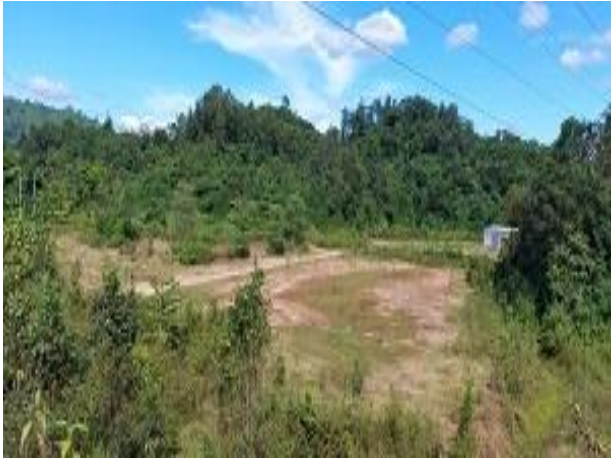
PHOTO OF THE LILAMA10 CAMP	
<p>PHOTOGRAPH 1: Q2 2021</p>

The photos below present the vegetation cover of two sites (the former LILAMA10 camp and the Irrigation rock disposal area), and the aerial photos provide an overview of the rehabilitated construction areas.

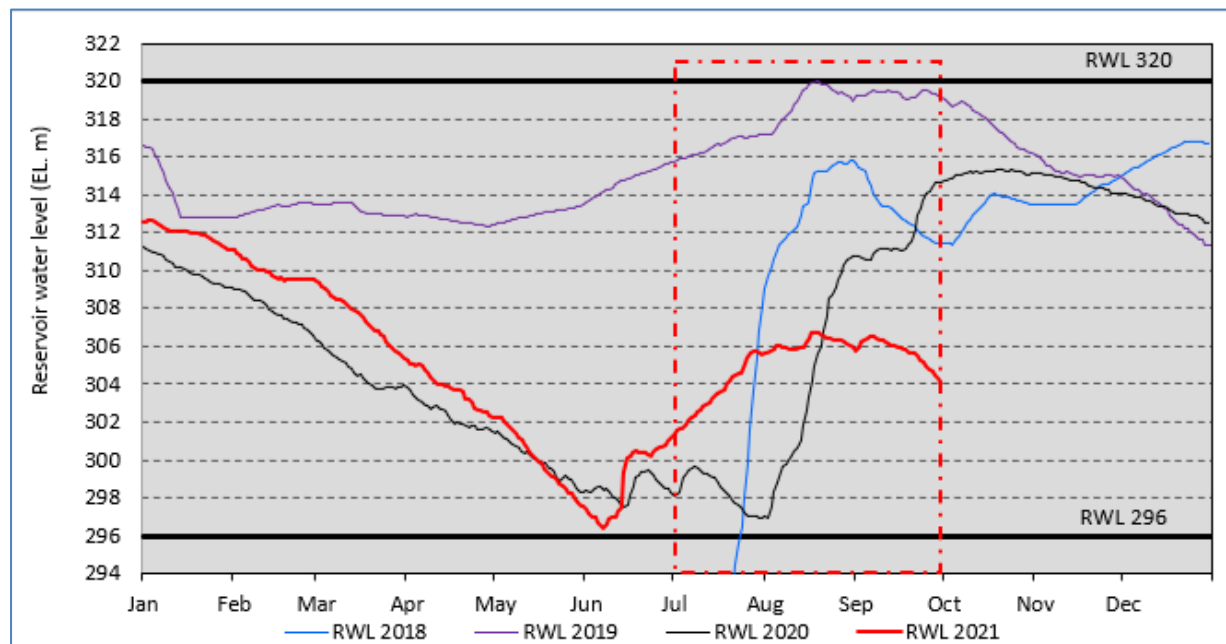
FIGURE 3-4: WATER LEVEL OF THE MAIN RESERVOIR

The water level in the main reservoir increased with 5.36 m from El. 301.39 m asl. on 01 July 2021 to El. 306.75 m asl. on 18 August 2021, whereafter the water level decreased to El. 303.96 m asl. on 30 September 2021.

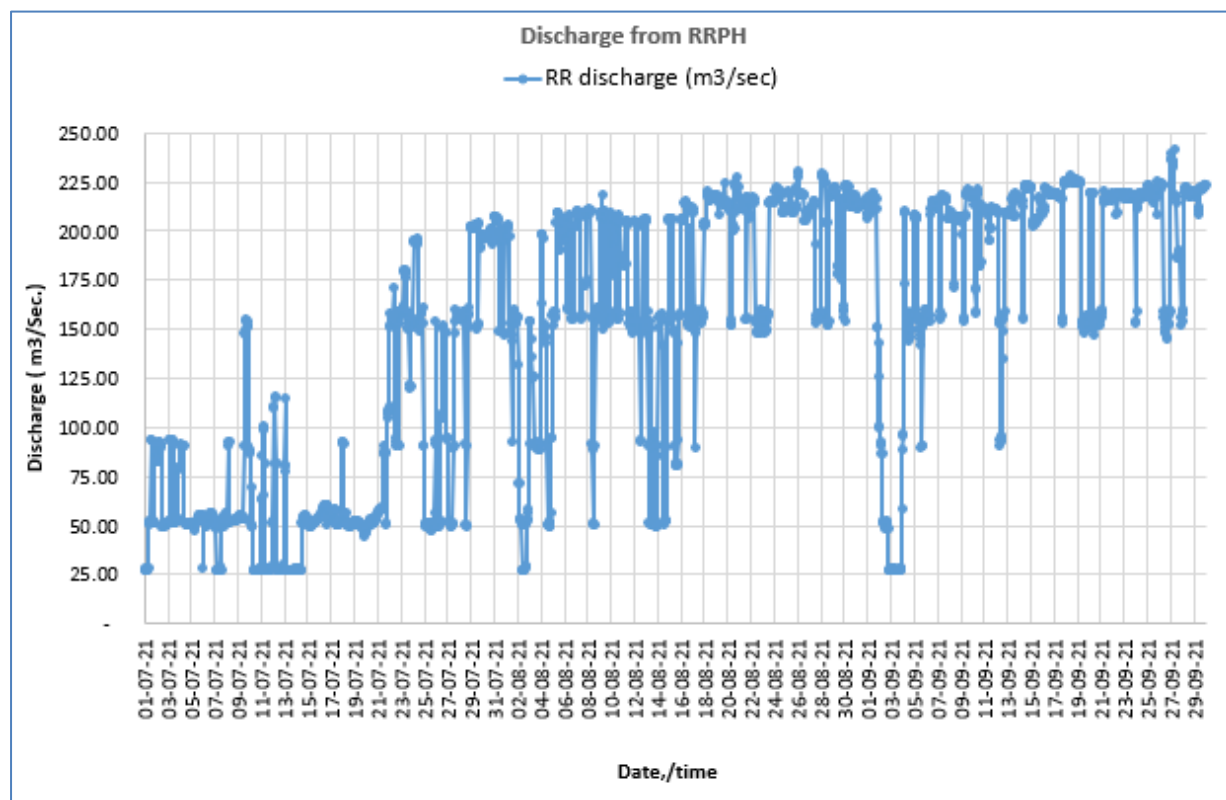
FIGURE 3-6: DISCHARGE FROM THE RE-REGULATION DAM DURING Q3 2021

The discharge monitoring data for the re-regulation dam during Q3 2021 indicates that the minimum flow requirement of 27 m³/s has been met at all times. The Re-regulation Dam discharge graph can be found in **Figure 3-6**.

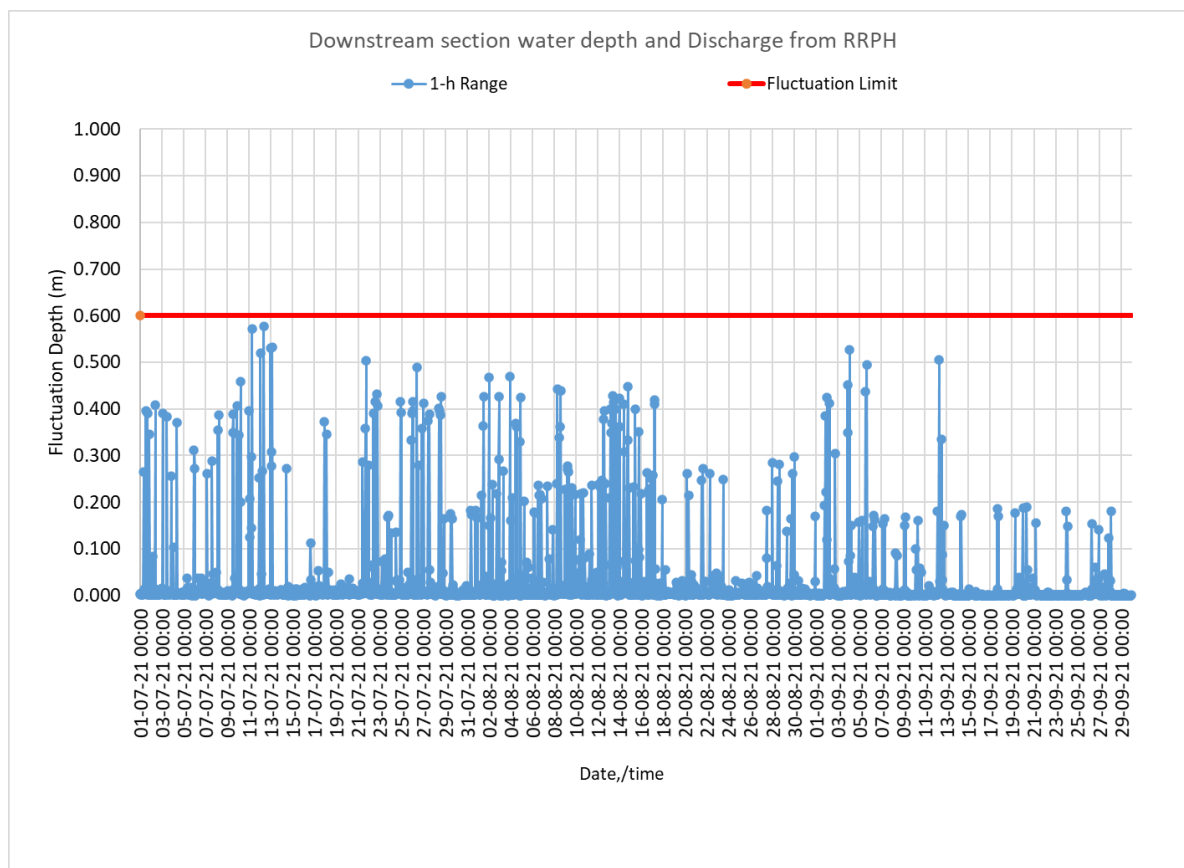
FIGURE 3-8: HOURLY STAGE HEIGHT FLUCTUATIONS DURING Q3 2021

During Q3 2021, the maximum rate of change of 0.6 m over 1-hour was complied with for 100% of the hourly fluctuations. The results are presented in **Figure 3-8**.

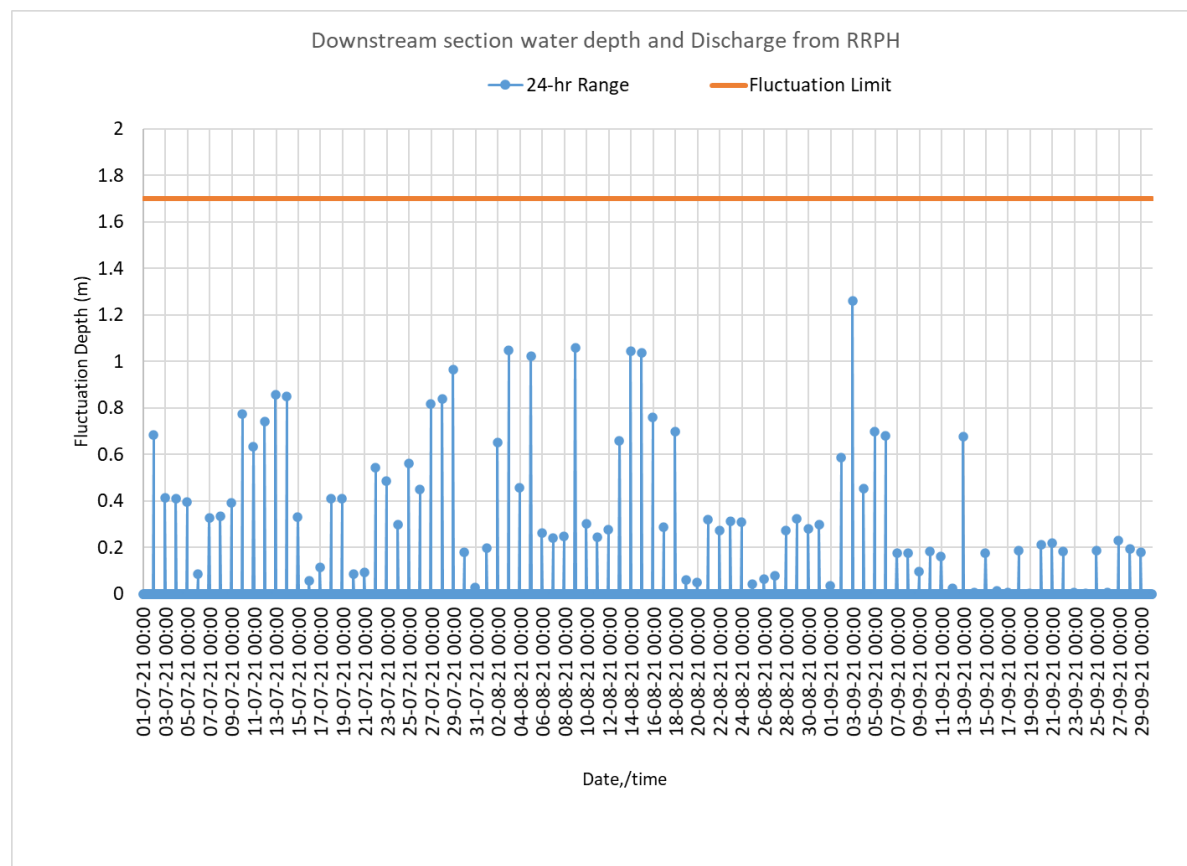
FIGURE 3-9: 24-HOUR STAGE HEIGHT DIFFERENCE (M) DURING Q3 2021

During Q3 2021, the maximum range in stage of 1.7 m over 24-hour was complied with for all 24-hour periods (00:00 – 23:00).

The results of the monitoring are presented in **Figure 3-9**.

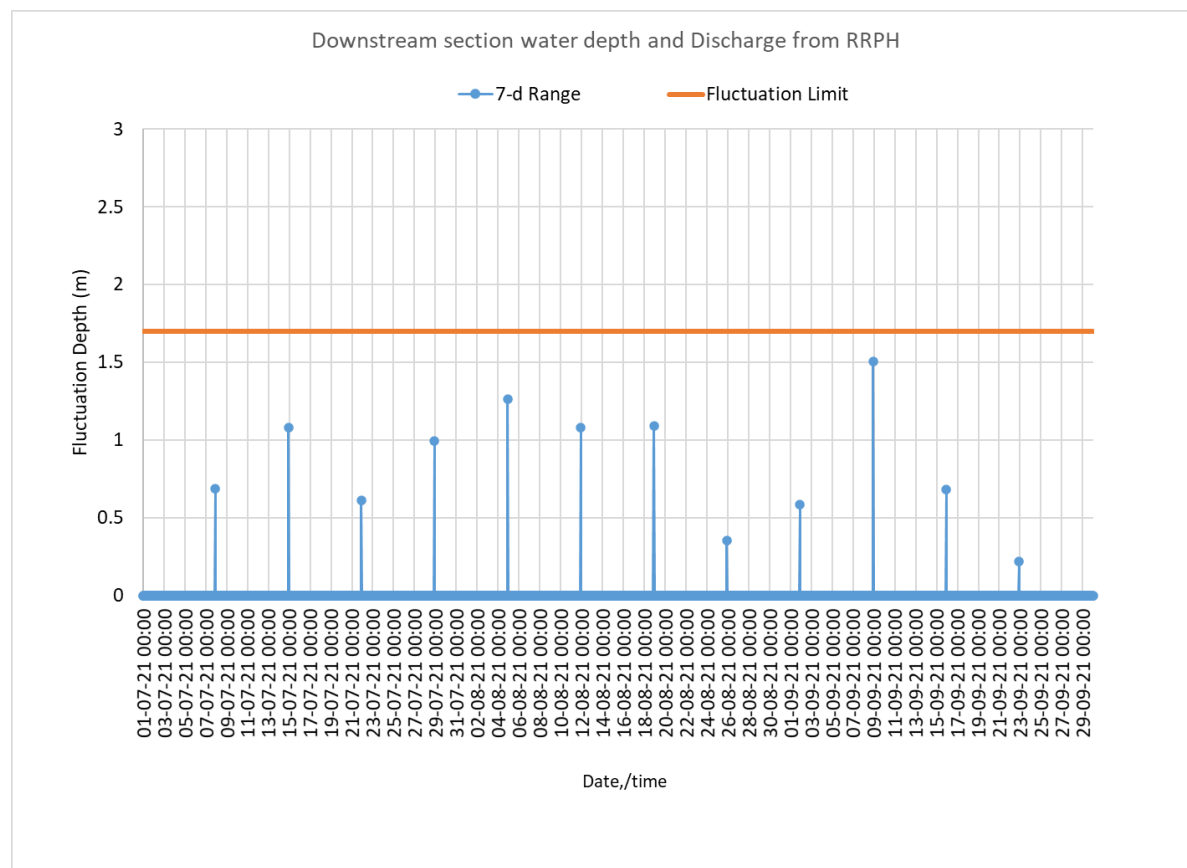
FIGURE 3-10: 7-DAY STAGE HEIGHT DIFFERENCE (M) DURING Q3 2021

During Q3 2021, the maximum range in stage of 1.7 m over 7-days was complied with for all 7-day periods. The results are presented in **FIGURE 3-10: 7-day Stage Height Difference (M) during Q3 2021**

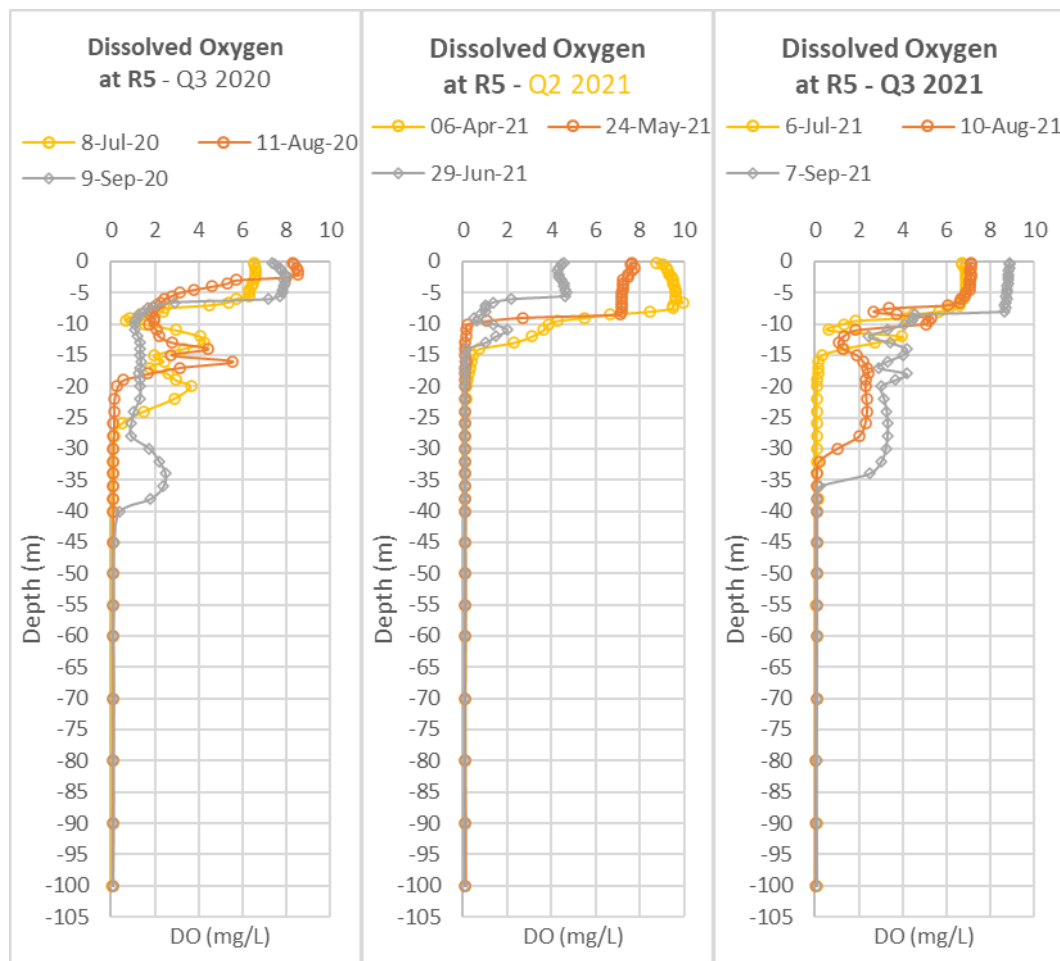
FIGURE 3-13: WATER TEMPERATURE AND DISSOLVED OXYGEN – DEPTH PROFILES IN THE MAIN RESERVOIR IMMEDIATELY UPSTREAM OF THE MAIN DAM (R05)

The water temperature and DO depth profiles in the main reservoir at R05 during Q3 2020, Q2 2021 and Q3 2021 are presented in **Figure 3-12** to **Figure 3-14**.

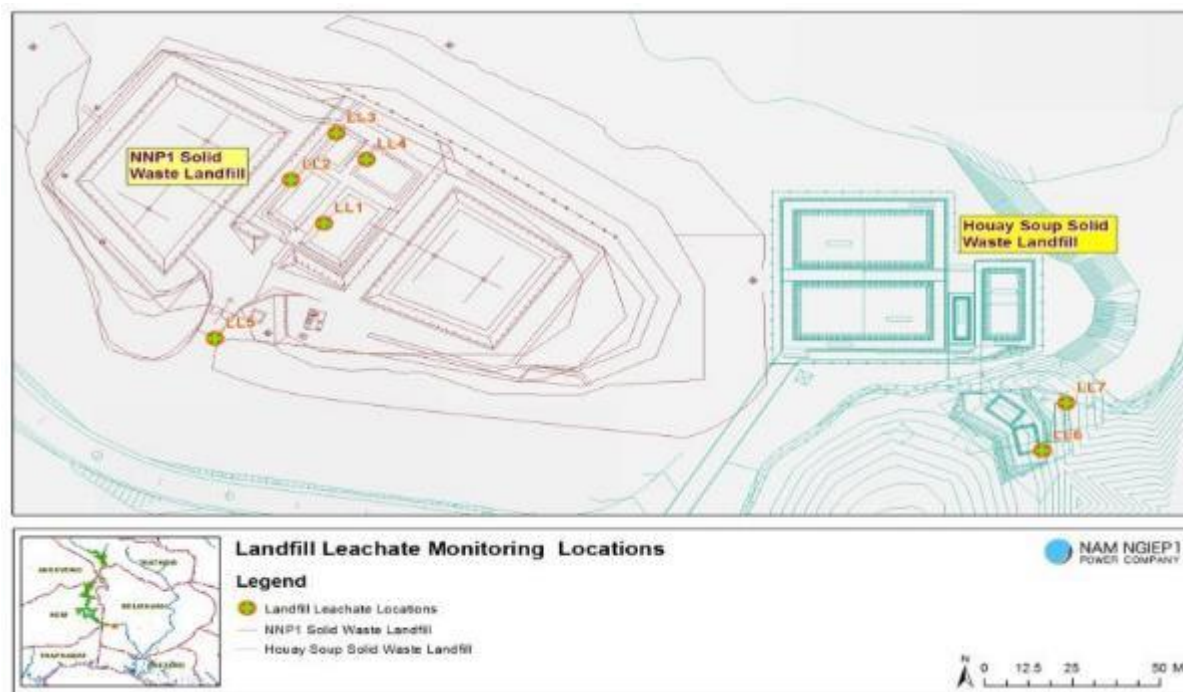
FIGURE 3-18: LANDFILL LEACHATE MONITORING LOCATION

The landfill leachate treatment systems at NNP1 Project landfill and Houay Soup landfill are monitored to control the functioning of the treatment process and ensure compliance with effluent standards. The monitoring locations are presented in the **Figure 3-18**.

The monitoring results in Q3 2021 indicate compliance with the applicable standards for monitored parameters, except pH (August 2021) and total coliform (Q3 2021) for NNP1 Project Landfill and pH (August 2021), faecal coliform (July 2021) and total coliform (Q3 2021) for Houay Soup Landfill. The monitoring data can be found in **Appendix 5.6**.

6	Landfill Leachate Monitoring for NNP1 Project and Houay Soup Landfills were not complied with the Standard on total coliform parameters for Q3 2021.	<ul style="list-style-type: none"> - Site observations were conducted during the routine water sampling, it was observed that faeces of livestock inside the landfill areas and this may contribute to the presence of bacterial contamination while the faeces washed into the leachate ponds during the rains. - Regular maintenance of the fence to prevent livestock entering to the landfills. 	<ul style="list-style-type: none"> - Total coliform contamination in landfill leachate was decreased in October 2021. - Continue regular maintenance of perimeter fence to prevent livestock from entering

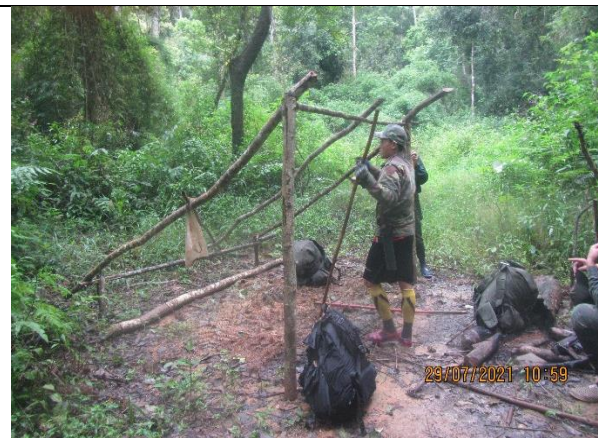
FIGURE 4-3: FRESH FISHING CAMP FOUND BY TEAM 2 AT NAM HOUNG IN JULY 2021

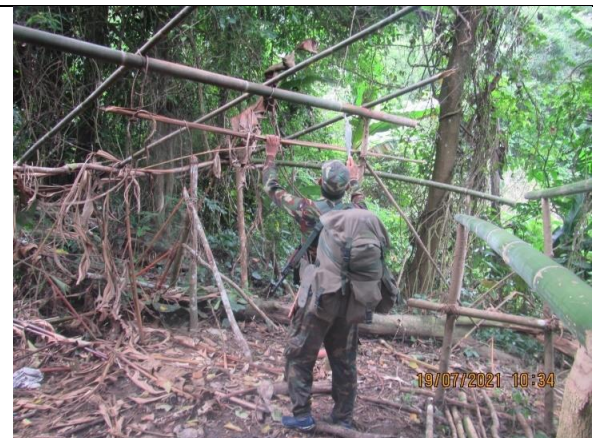
FIGURE 4-4: OLD FISHING CAMP FOUND BY TEAM 3 AT NAM MA IN JULY 2021
