Nam Ngiep 1 Hydropower Project

Quarterly Environment Monitoring Report Fourth Quarter of 2021

October to December 2021

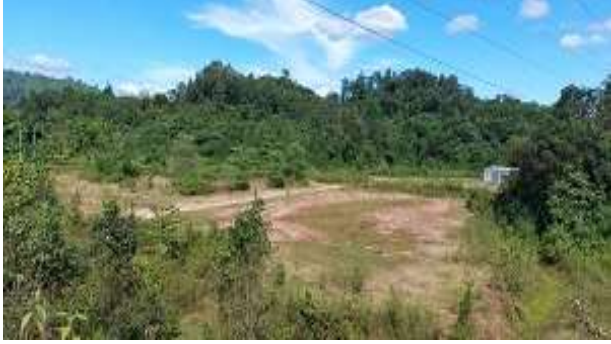
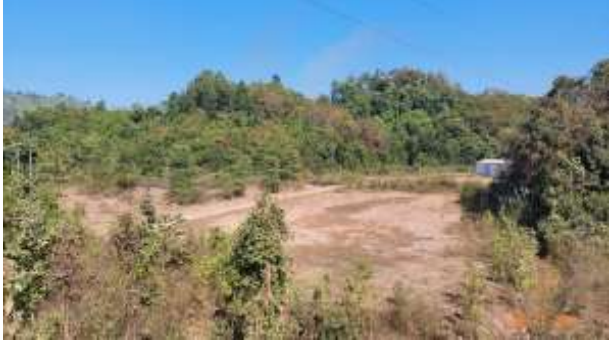
FORMER LILAMA10 CAMP COMPARE Q3 AND Q4 2021	
Q3 2021

The photos below present the vegetation cover of two sites (the former LILAMA10 camp and the disposal area for rock excavated for the irrigation canal). The overall status of vegetation cover percentage in Q4 2021 is the same as in Q3 2021, although the green colour is slightly less noticeable during the dry season in Q4 of 2021.

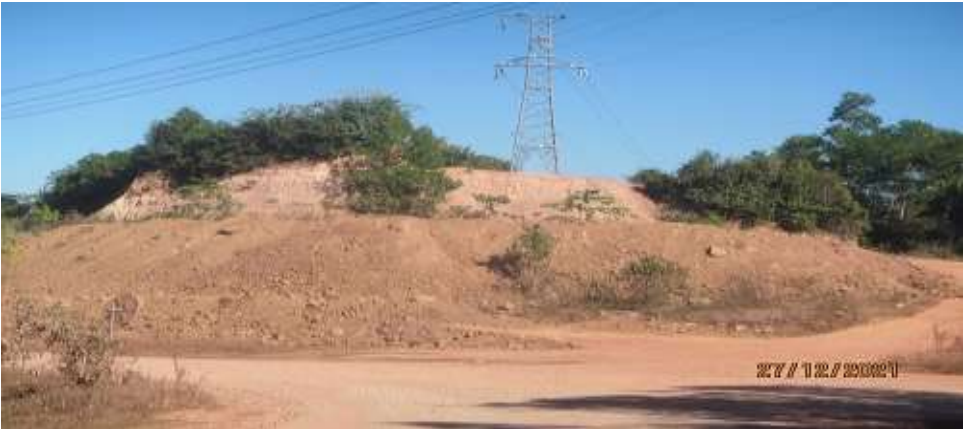
During Q4 2021, EMO continued to monitor the progress of revegetation at two sites including the former LILAMA10 camp and the Phouhomxay village's irrigation canal spoil disposal both of which the EMU had not accepted during their site visit in January 2021. EMO also inspected the other 30 rehabilitated sites that were initially accepted by the EMU. Additional topsoil was placed on some part of the former LILAMA10 camp by NNP1PC to promote revegetation. The overall percentage of vegetation cover on all 32 sites (except Borrow pit P1) were assessed to be similar to the observed vegetation cover in Q3 2021. The borrow pit P1-site is occupied by EDL to develop for a substation.

BORROW PIT P1 CURRENTLY OCCUPIED BY EDL

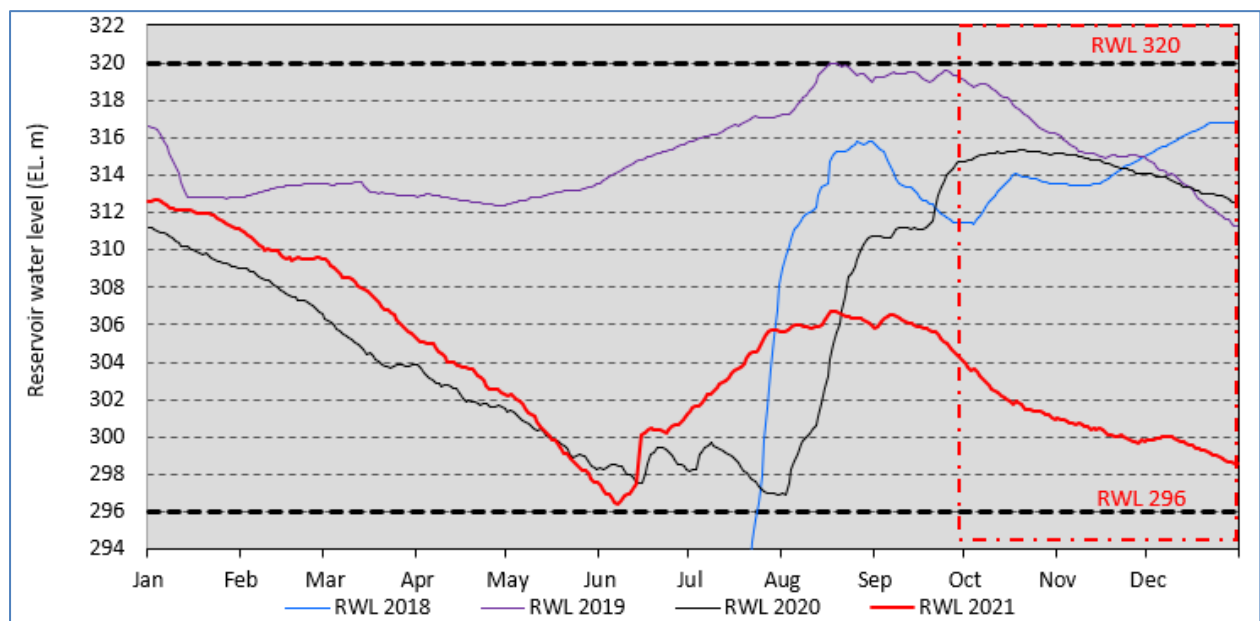
The water level in the main reservoir decreased with 5.32 m from El. 303.88 m asl. on 01 October 2021 to El. 298.56 m asl. on 31 December 2021.

FIGURE 3-4: WATER LEVEL OF THE MAIN RESERVOIR

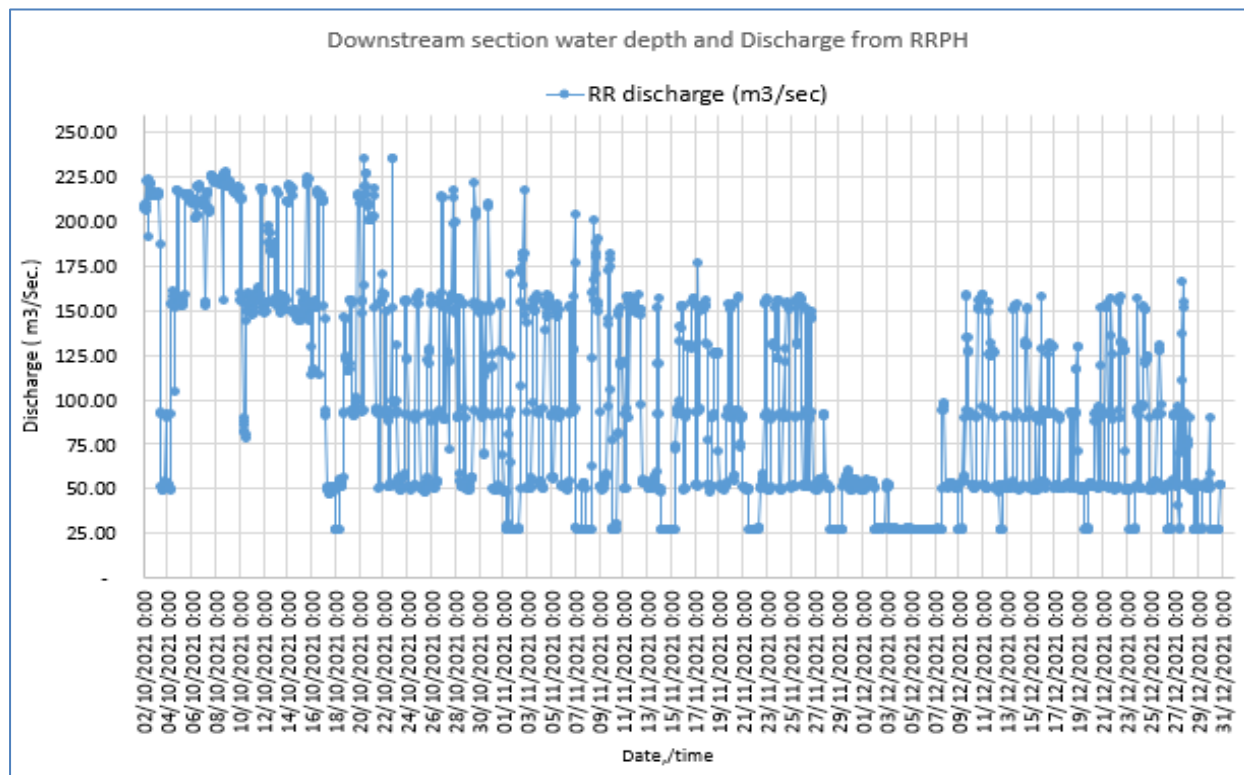
The discharge monitoring data for the re-regulation dam during Q4 2021 indicates that the minimum flow requirement of 27 m³/s has been met at all times. The Re-regulation Dam discharge graph can be found in **Figure 3-6**.

FIGURE 3-6: DISCHARGE FROM THE RE-REGULATION DAM DURING Q4 2021

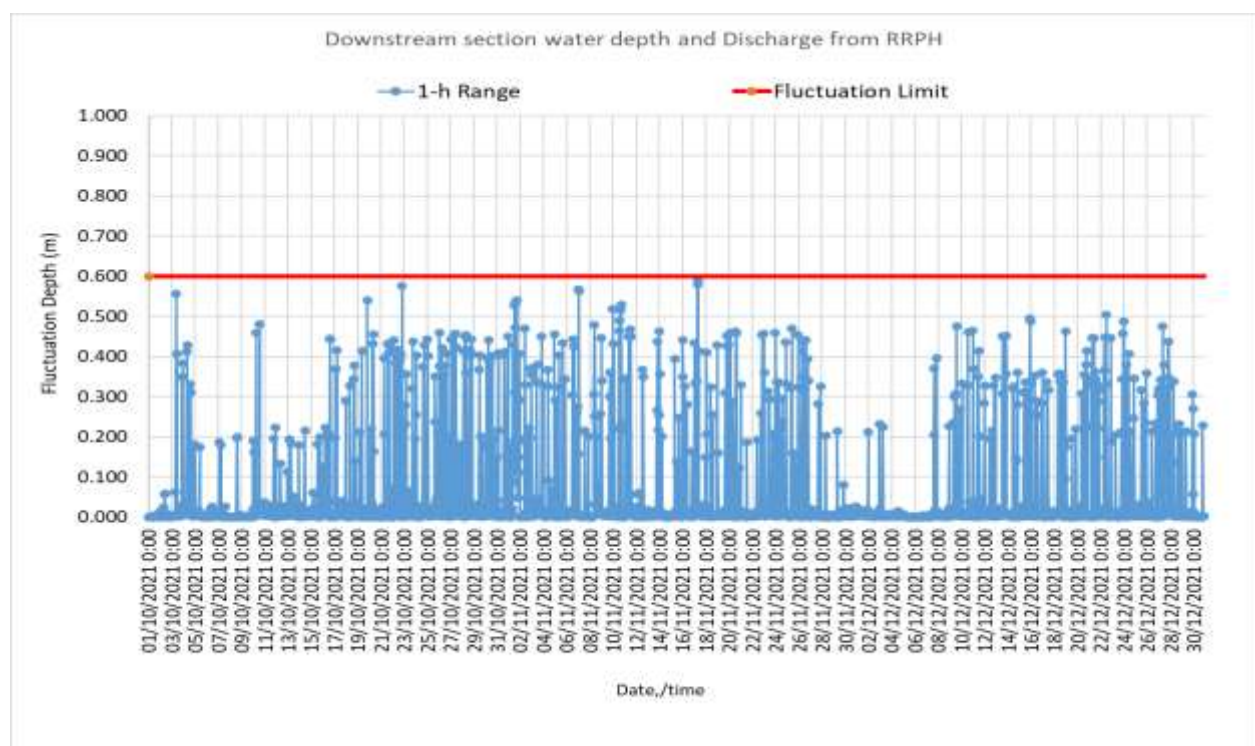
During Q4 2021, the maximum rate of change of 0.6 m over 1-hour was complied with for 100% of the hourly fluctuations. The results are presented in **Figure 3-8**.

FIGURE 3-8: HOURLY STAGE HEIGHT FLUCTUATIONS DURING Q4 2021

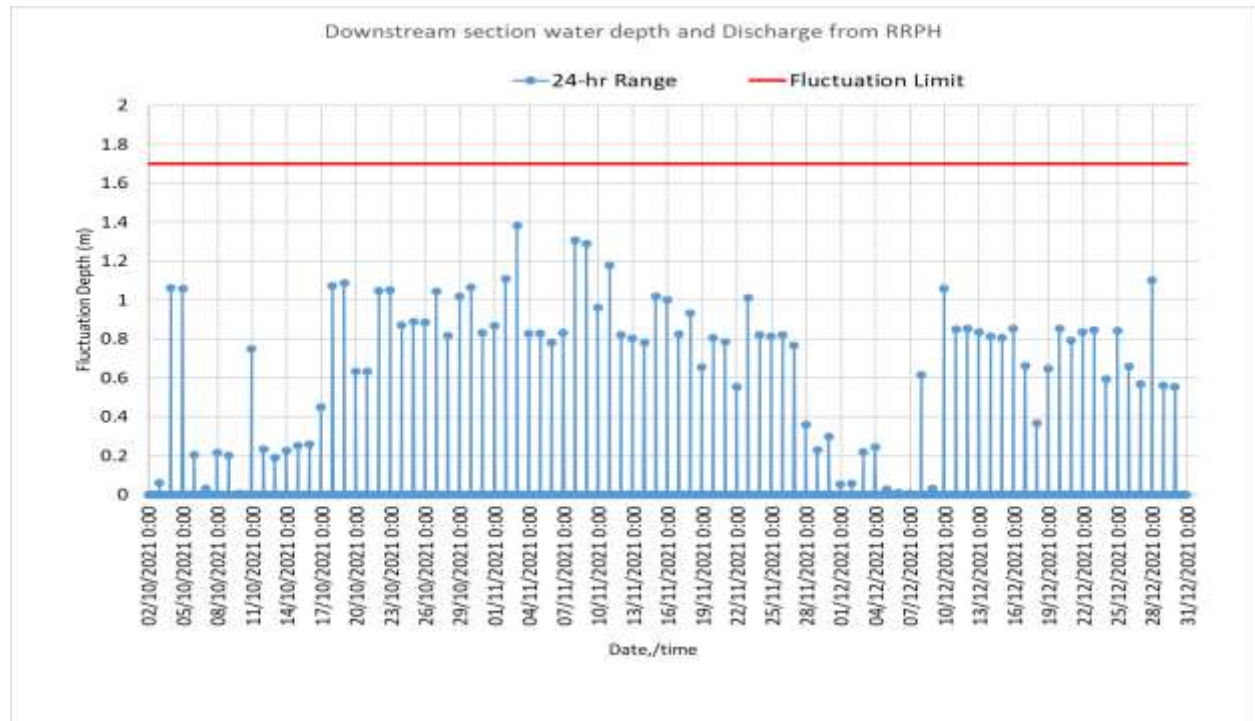
During Q4 2021, the maximum range in stage of 1.7 m over 24-hour was complied with for all 24-hour periods (00:00 – 23:00).

FIGURE 3-9: 24-HOUR STAGE HEIGHT DIFFERENCE (M) DURING Q4 2021

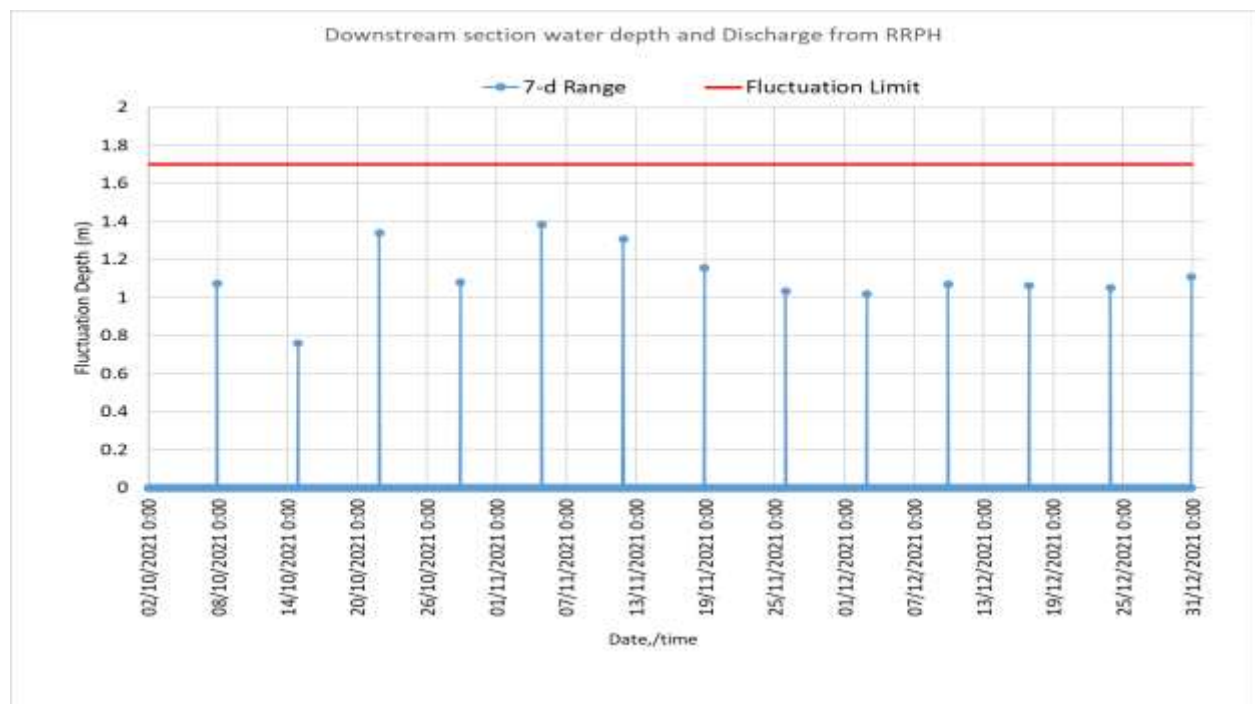
During Q4 2021, the maximum range in stage of 1.7 m over 7-days was complied with for all 7-day periods. The results are presented in **Figure 3-10**.

FIGURE 3-10: 7-DAY STAGE HEIGHT DIFFERENCE (M) DURING Q4 2021

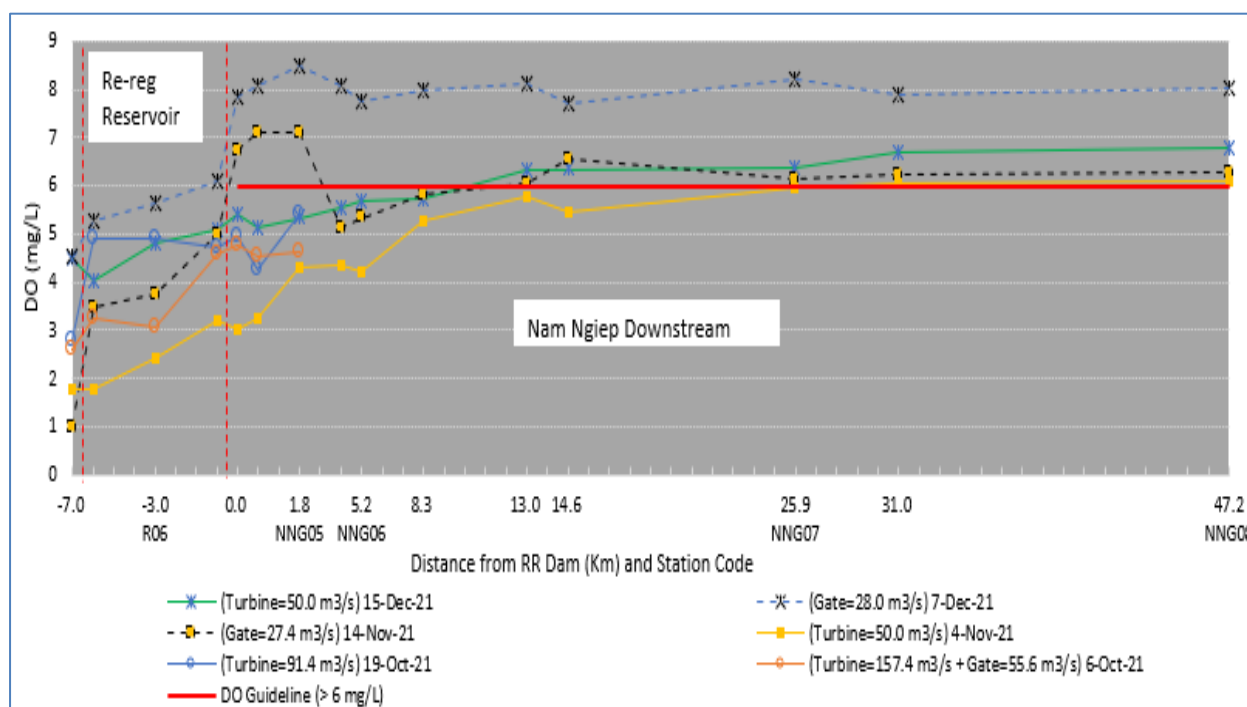
FIGURE 3-11: DISSOLVED OXYGEN LONG PROFILE MEASUREMENT FROM THE RE-REGULATION RESERVOIR TO THE CONFLUENCE WITH THE MEKONG RIVER

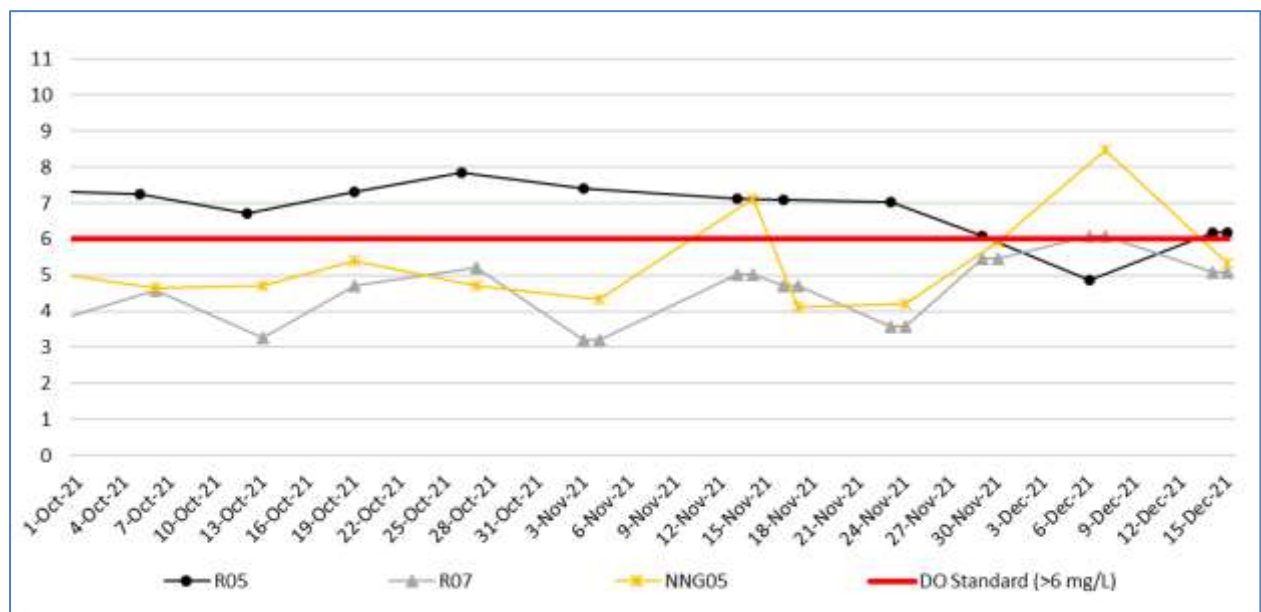
The results of DO measurements for station R05, R07 and NNG05 are compared in **Figure 3-12**. For R05 (located in the main reservoir approximately 500 m upstream of the main dam) the DO measurements are shown for the surface level and for the level of the intake (276 m asl.). For R07 (in the re-regulation reservoir), the DO measurements represent the surface level.

FIGURE 3-12: DISSOLVED OXYGEN IMMEDIATELY UPSTREAM AND DOWNSTREAM OF THE MAIN DAM

NNP1PC continues to carefully compile and assess all monitoring data to determine if any additional water aeration measures may be necessary to improve the DO levels in Nam Ngiep River downstream the Re-regulation Dam.

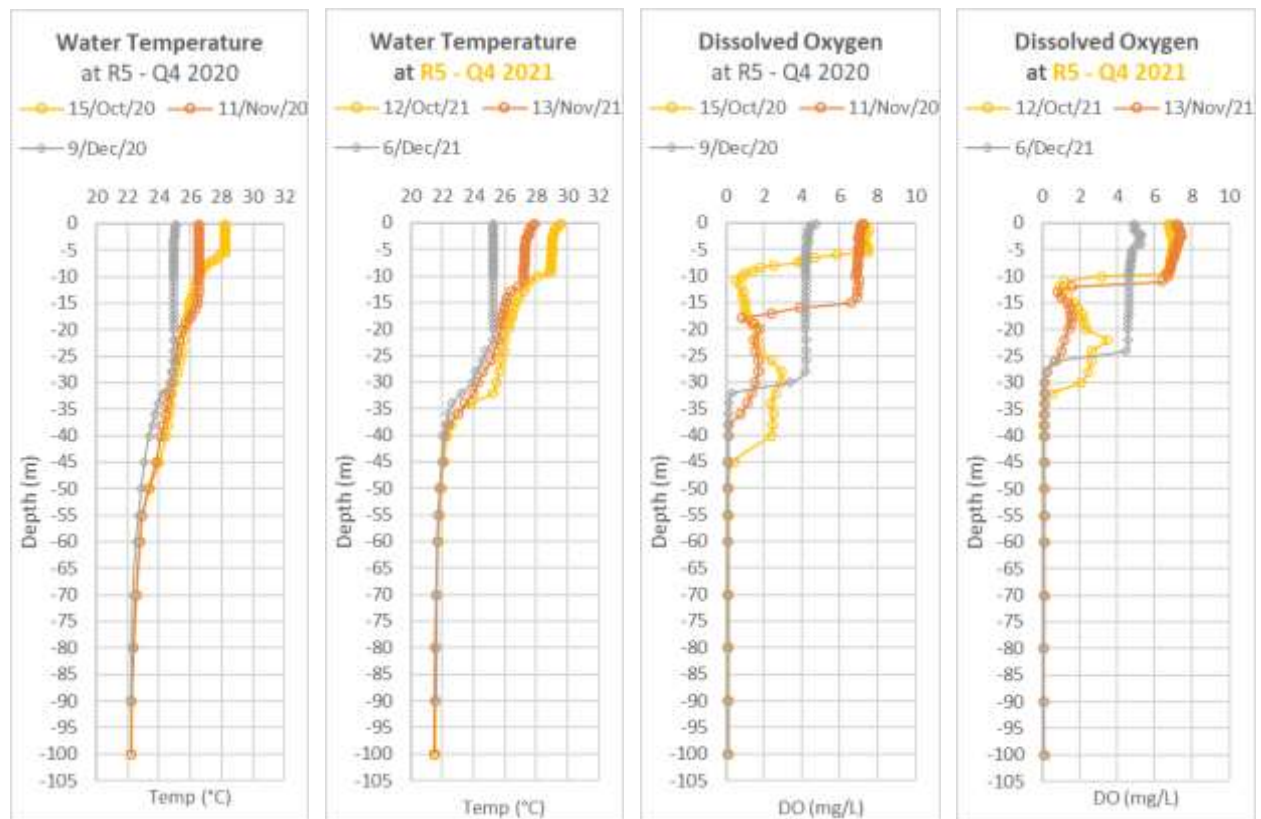
FIGURE 3-14: WATER TEMPERATURE AND DISSOLVED OXYGEN – DEPTH PROFILES IN THE MAIN RESERVOIR IMMEDIATELY UPSTREAM OF THE MAIN DAM (R05)
