## Nam Ngiep 1 Hydropower Project

# Quarterly Environment Monitoring Report Third Quarter of 2024

July to September 2024

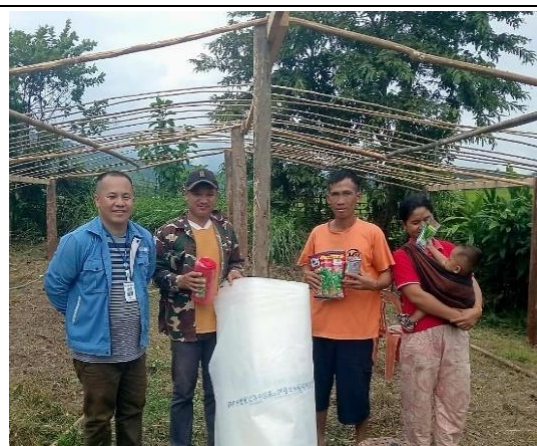
The follow up of greenhouse vegetable construction on 25 September 2024
