## Nam Ngiep 1 Hydropower Project

# Quarterly Environment Monitoring Report Third Quarter of 2025

July to September 2025

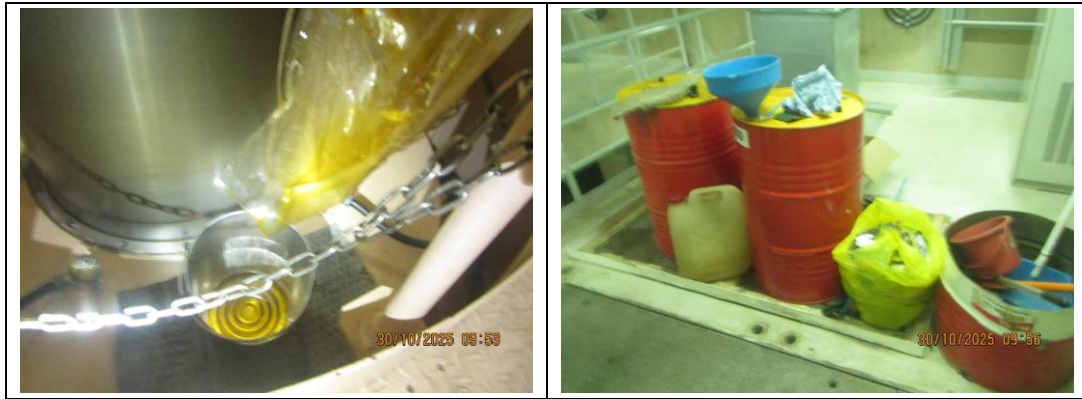
- **Oil leakage status at the Main Dam Powerhouse**

The oil leakage was first detected in June 2023. The permanent resolution is still under discussion, as a repair will require a prolonged it power. In the meantime, temporary countermeasures are in place. Currently, the oil leakage from unit 1 in the Main Powerhouse, of about 5 Liters/month or less, is being collected in a bucket using plastic sheets and regularly transferred to the designated hazardous waste storage. Daily monitoring by TD has confirmed that no oil contamination has occurred outside this room, including any discharge to the river. During the monthly joint environmental site inspections, special attention is consistently given to this area to ensure that the leakage remains fully contained. The permanent countermeasure has not yet been determined as the place of leakage is not accessible and can only be checked and repaired when Unit No. 1 is closed down. This will be done during a scheduled major revision (2027?).

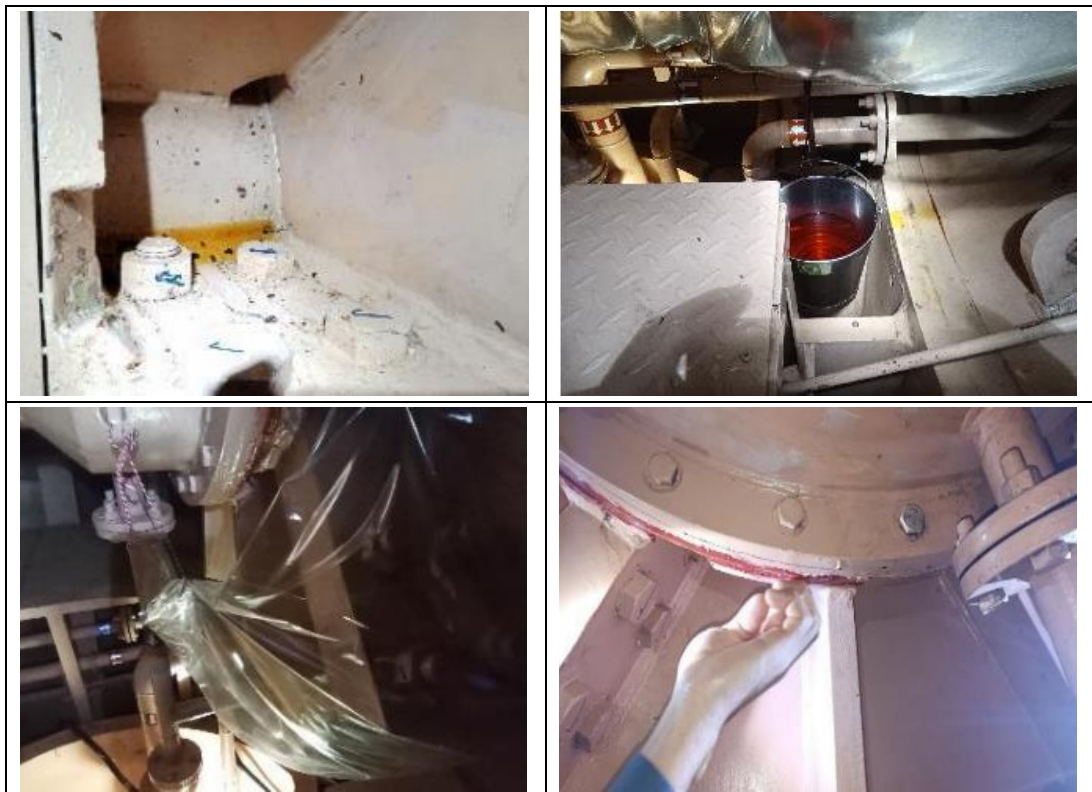
- **Oil leakage status at the Re-regulation Powerhouse**

In the Re-regulation Powerhouse, an oil leakage from the combined bearing housing (thrust bearing) was detected in July 2022. Currently, the oil leakage of about 3 Liters/month or lower is contained and collected in buckets and transferred to designated hazardous waste storage facility. As a temporary measure, the maintenance engineer has applied silicone to seal the leakage. The permanent countermeasure has not yet been determined. This will be done during a scheduled major revision (2027?).
