## Nam Ngiep 1 Hydropower Project

# Quarterly Environment Monitoring Report First Quarter of 2026

January to March 2026

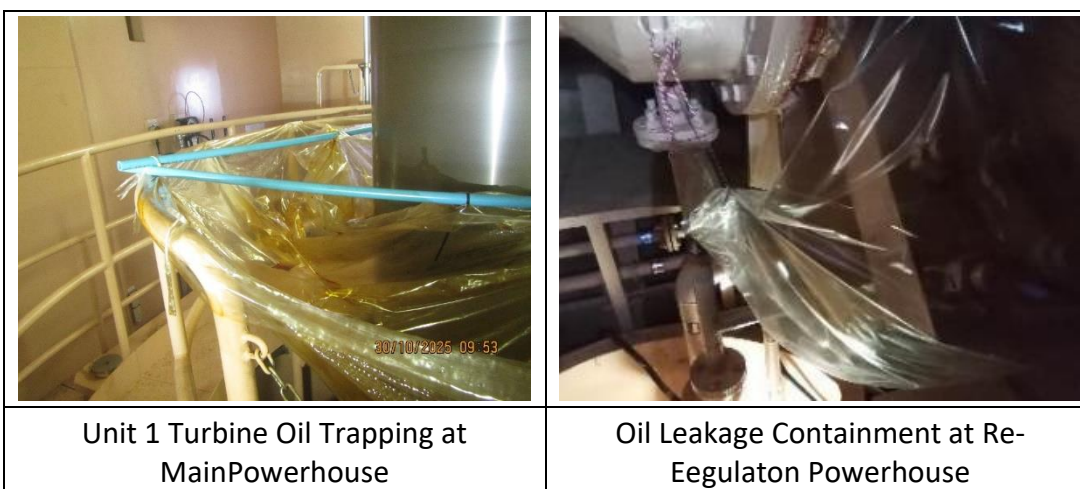
The situation regarding oil losses from the Unit 1 turbine within the main powerhouse remains unchanged, with leakage persisting at an estimated rate of 25 to 40 Liters per month. Previously, it was anticipated that this issue would be permanently resolved during an overhaul in 2027.

Because there is no immediate permanent solution for oil leak, temporary containment measures must continue. To date, the actions taken by the Technical Department (TD) to keep the situation under control have been highly successful, ensuring that no oil has reached the river. The established waste handling chain continues as follows:

- Leaking oil is actively trapped and collected directly beneath the Unit 1 turbine.
- The captured oil is initially accumulated in a temporary storage setup inside the main powerhouse.
- The oil is then systematically transferred to the designated Hazardous Materials Storage Facility for safe containment before authorized disposal.

- The oil trapping and containment systems are managed continuously without any overflow.
- The temporary storage setups remain fully secure and clear of environmental pathways.
- Spill response resources are kept fully stocked on-site to maintain an absolute safeguard for the river ecosystem.

- **2027 Planned Works:** Maintenance teams will make dedicated attempts to reduce the leakage to the extent possible, but the underlying cause will not be addressed.
- **2030 Major Overhaul:** The permanent repair is planned for 2030. As a result, this situation is now expected to persist for approximately four more years.

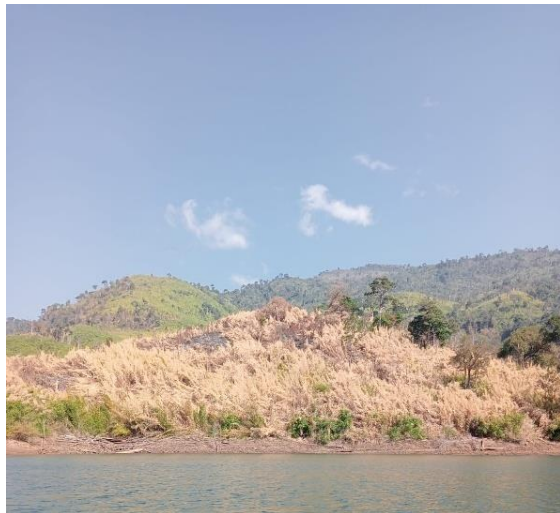
Forest burning within the NNP1 watershed

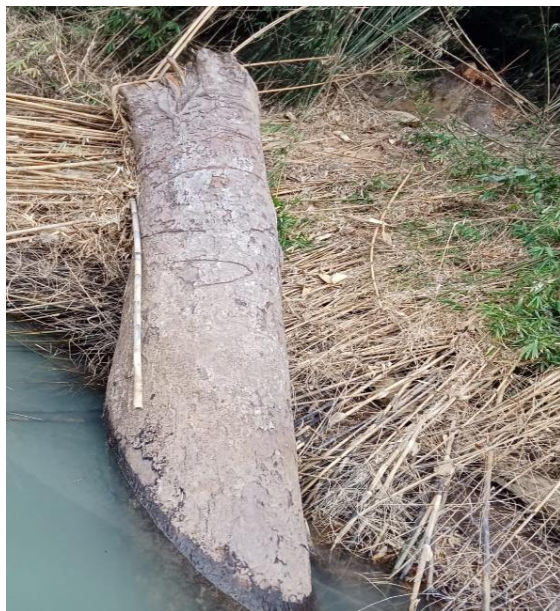
Illegal logging identified within the NNP1 reservoir TPZ
