## Nam Ngiep 1 Hydropower Project

# Quarterly Environment Monitoring Report Second Quarter of 2026

April to June 2026

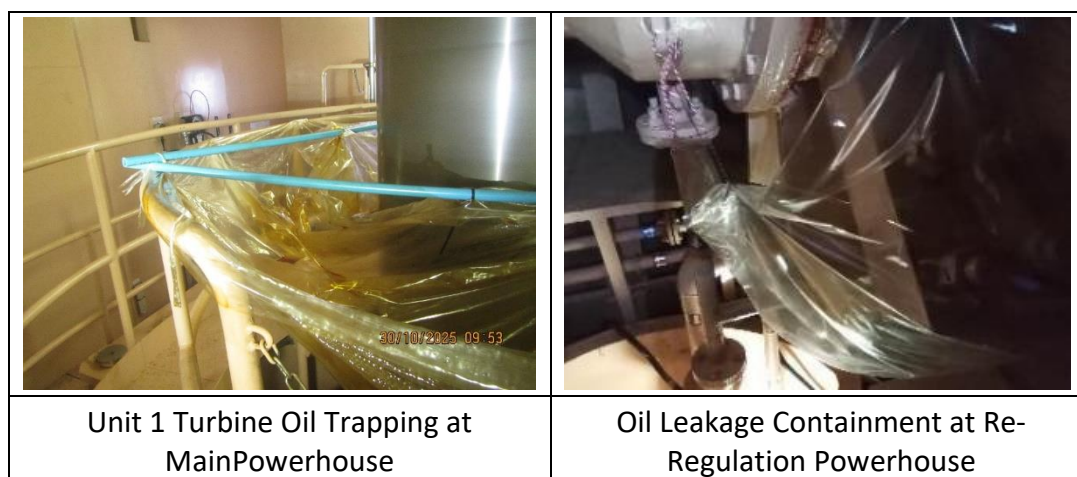
**FIGURE 2.5-1: OIL LEAKAGE FROM THE UNIT 1 TURBINE WITHIN THE MAIN POWERHOUSE AND RE-REGULATION DAM POWERHOUSE**

The situation regarding oil leakage from the Unit 1 turbine within the main powerhouse and re-regulation dam powerhouse remains unchanged as shown in **Figure 2.5-1**, with leakage persisting at an estimated rate of 25 to 40 liters per month. A permanent solution is currently planned to be implemented during the next partial overhaul scheduled for January and February 2027.

Because there is no immediate permanent solution for oil leak, temporary containment measures must continue. To date, the actions taken by the Technical Department (TD) to keep the situation under control have been highly successful, ensuring that no oil has reached the river. The established waste handling chain continues as follows:

- Leaking oil is actively trapped and collected directly beneath the Unit 1 turbine at main powerhouse and re-regulation powerhouse thrust bearing.
- The captured oil is initially accumulated in a temporary storage setup inside the main powerhouse and re-regulation dam powerhouse.
- The oil is then systematically transferred to the designated Hazardous Materials Storage Facility for safe containment before authorized disposal.

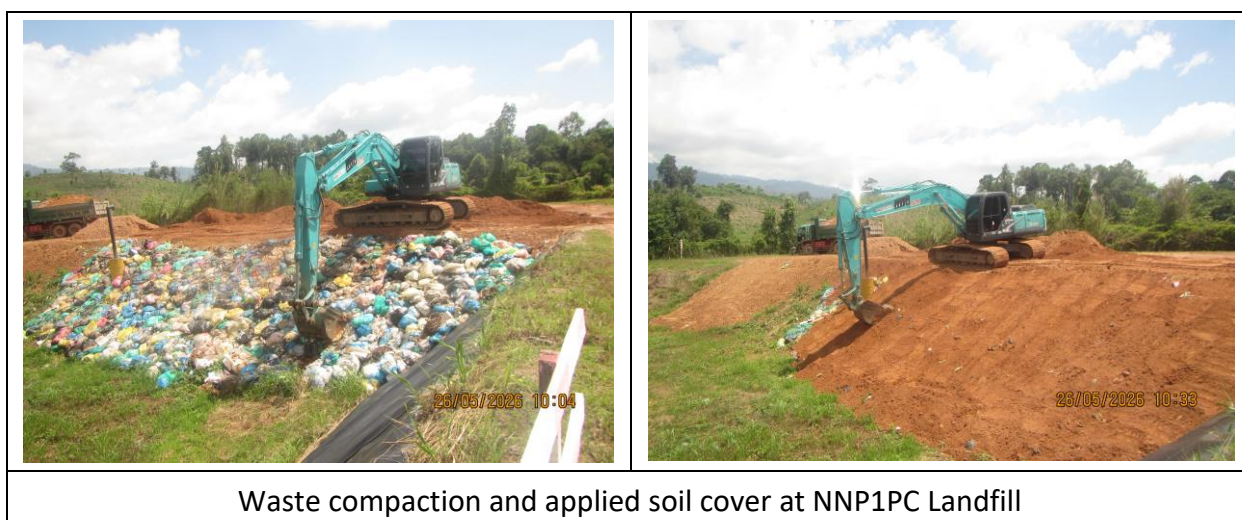
In Q2 2026, a total of 13.93 m<sup>3</sup> solid waste from NNP1 project sites and camps was disposed of at the NNP1 Project Landfill, an increase of 0.16 m<sup>3</sup> compared with Q1 2026. The local waste management contractor has maintained routine waste collection and operation of the NNP1 Project Landfill management throughout Q2 2026. On 26 May 2026, the local waste management contractor conducted waste compaction and applied soil cover at the NNP1PC landfill in accordance with the landfill operation manual. **Approx. 18.52 m<sup>3</sup>** of waste was compacted.

Waste compaction and applied soil cover at NNP1PC Landfill
