# Nam Ngiep 1 Hydropower Project

# **Environmental Management Monthly Monitoring Report**

December 2019

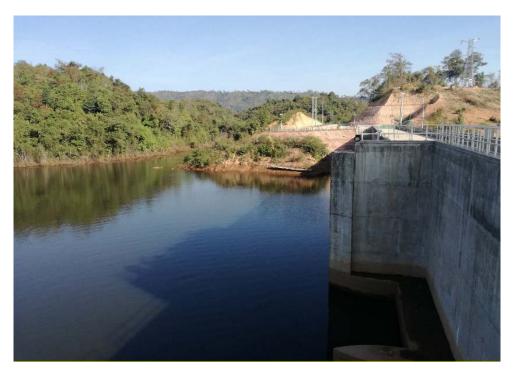
FIGURE 2-3: COMPLETED RE-REGULATION DAM AND POWERHOUSE AT THE END OF JUNE 2018

Structural concrete works were commenced in March 2015, in coordination with installation of the grounding system. The progress of overall re-regulating dam and powerhouse works at the left bank section and the right bank and labyrinth weir are shown in Figure below. After the completion of the re-regulation dam above, impounding of the reservoir has been carried out having been commenced on 15 May and been completed on 24 May 2017. After Main Dam impounding started, the reservoir storage of the re-regulation dam has been used for the riparian discharge to downstream in accordance with the Concession Agreement.

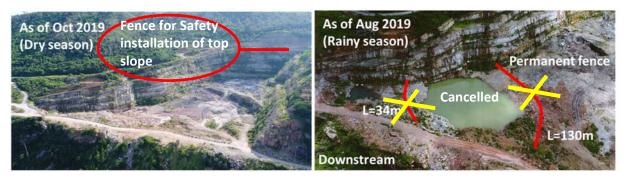
Figure 2-4: Quarry Area View

The surface clearing, topsoil and overburden removal works at the extension area were completed in December 2016 and its development works was commenced in January 2017. The final blasting was carried out 27 March 2018. GOL have acknowledged that the quarry operation is complete. After several inspections by GOL and ADB for the Lenders, the quarry site has been improved by such as partial levelling, vegetation at the berms of slopes and large rock installation at top of slopes from an environmental and a safety point of view. Furthermore, a fence around the pond, which is created at the quarry only during the rainy season and is dry during dry season, will be installed to prevent people and animals from entering the pond, subject to ADB approval. A gate near the steel bridge also a barrier to public access. Permanent fence installation around pond as shown in the below picture will not be installed and fence for road safety will be installed at the top of the right bank upper quarry roadside. The levelling of quarry bottom will be implemented from January 2020.
